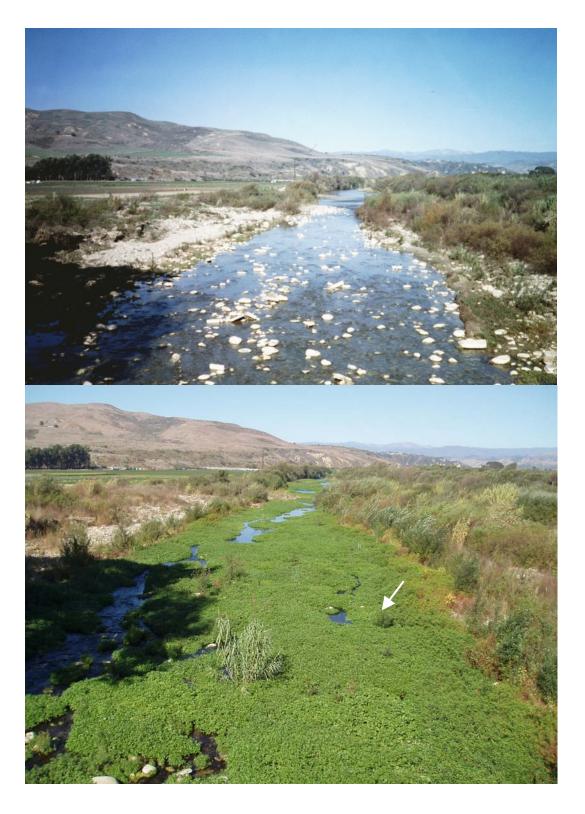
Figure 1. Upstream from the Main Street Bridge (VR01): December 2005 top, November 2006 bottom. The river is now covered with two types of plant cover. Most of what can be seen is watercress, however, the arrow marks a line of slightly darker, and taller, vegetation near the stream edge: *Ludwiga hexapetala* or water primrose. Lacking a big wet winter during the next few years this plant will come do dominate the lower river.

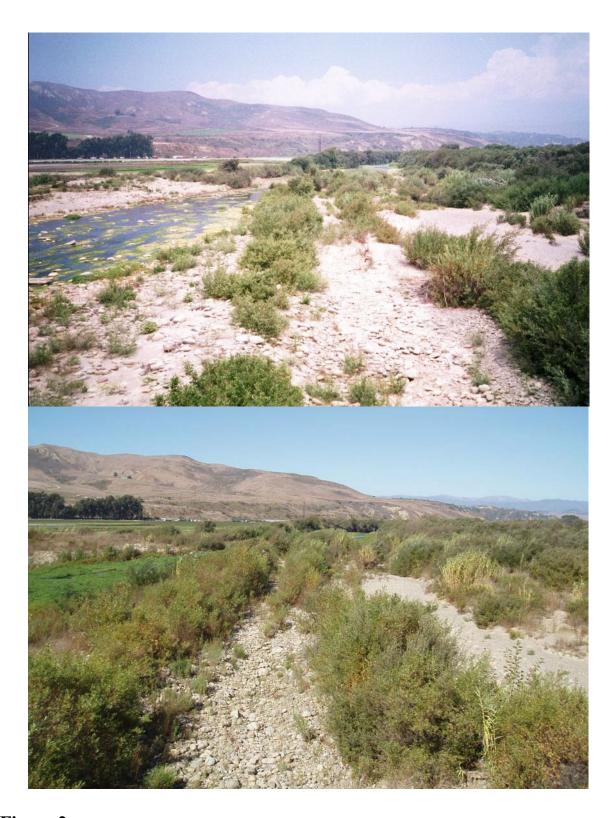
Figure 2. Upstream from the Main Street Bridge (VR01): December 2005 top, November 2006 bottom. The view here is similar to Figure 1, but taken further east on the bridge to document the change in riparian vegetation. Both brush and Arundo have made a substantial comeback over the past year.

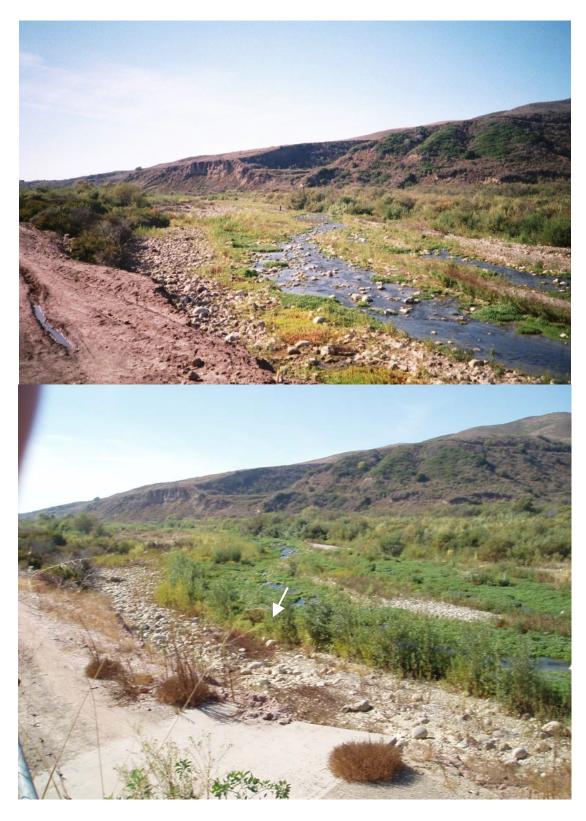
Figure 3. VR02 from the levee near Stanley Road: December 2005 top, November 2006 bottom. While aquatic plants have also come to dominate the river here, the most interesting development is the rapid growth of willows (indicated by the arrow), now head-high in the riparian zone.

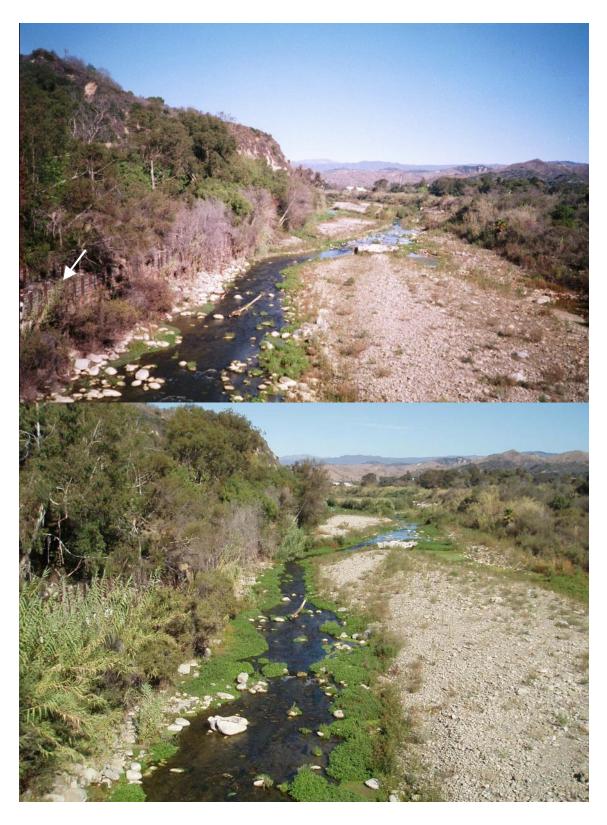
Figure 4. Upstream from the Shell Road bridge: December 2005 top, November 2006 bottom. Although the changes in aquatic vegetation are not as noticeable here, riparian brush and trees have grown considerably. Note that the bank stabilization structure visible in the upper photo (arrow) can hardly be seen in the lower.

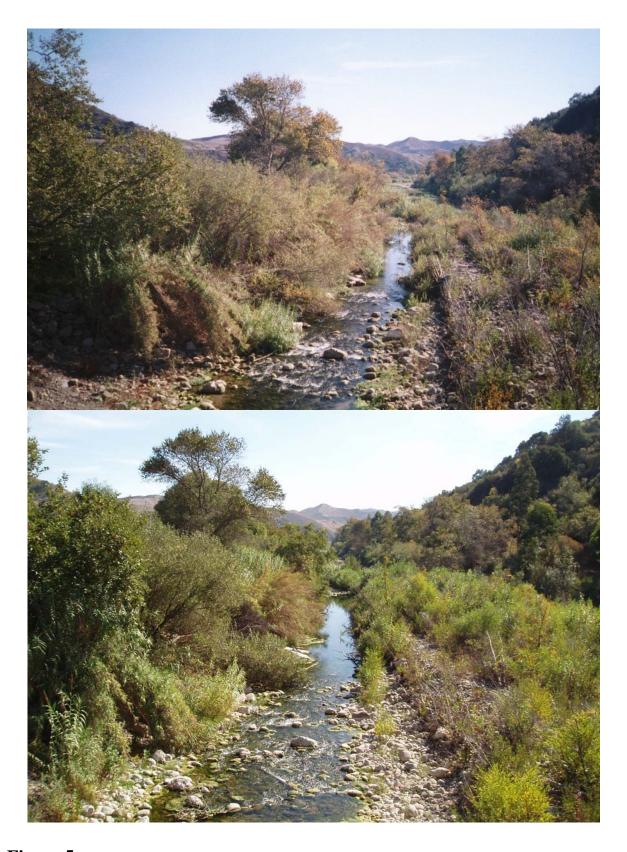
Figure 5. Downstream from the Foster Park bridge: December 2005 top, November 2006 bottom. The change here has mostly been in the growth of riparian brush and trees. What used to be a walk across rocks to access the sampling site is now a fight through dense brush.
