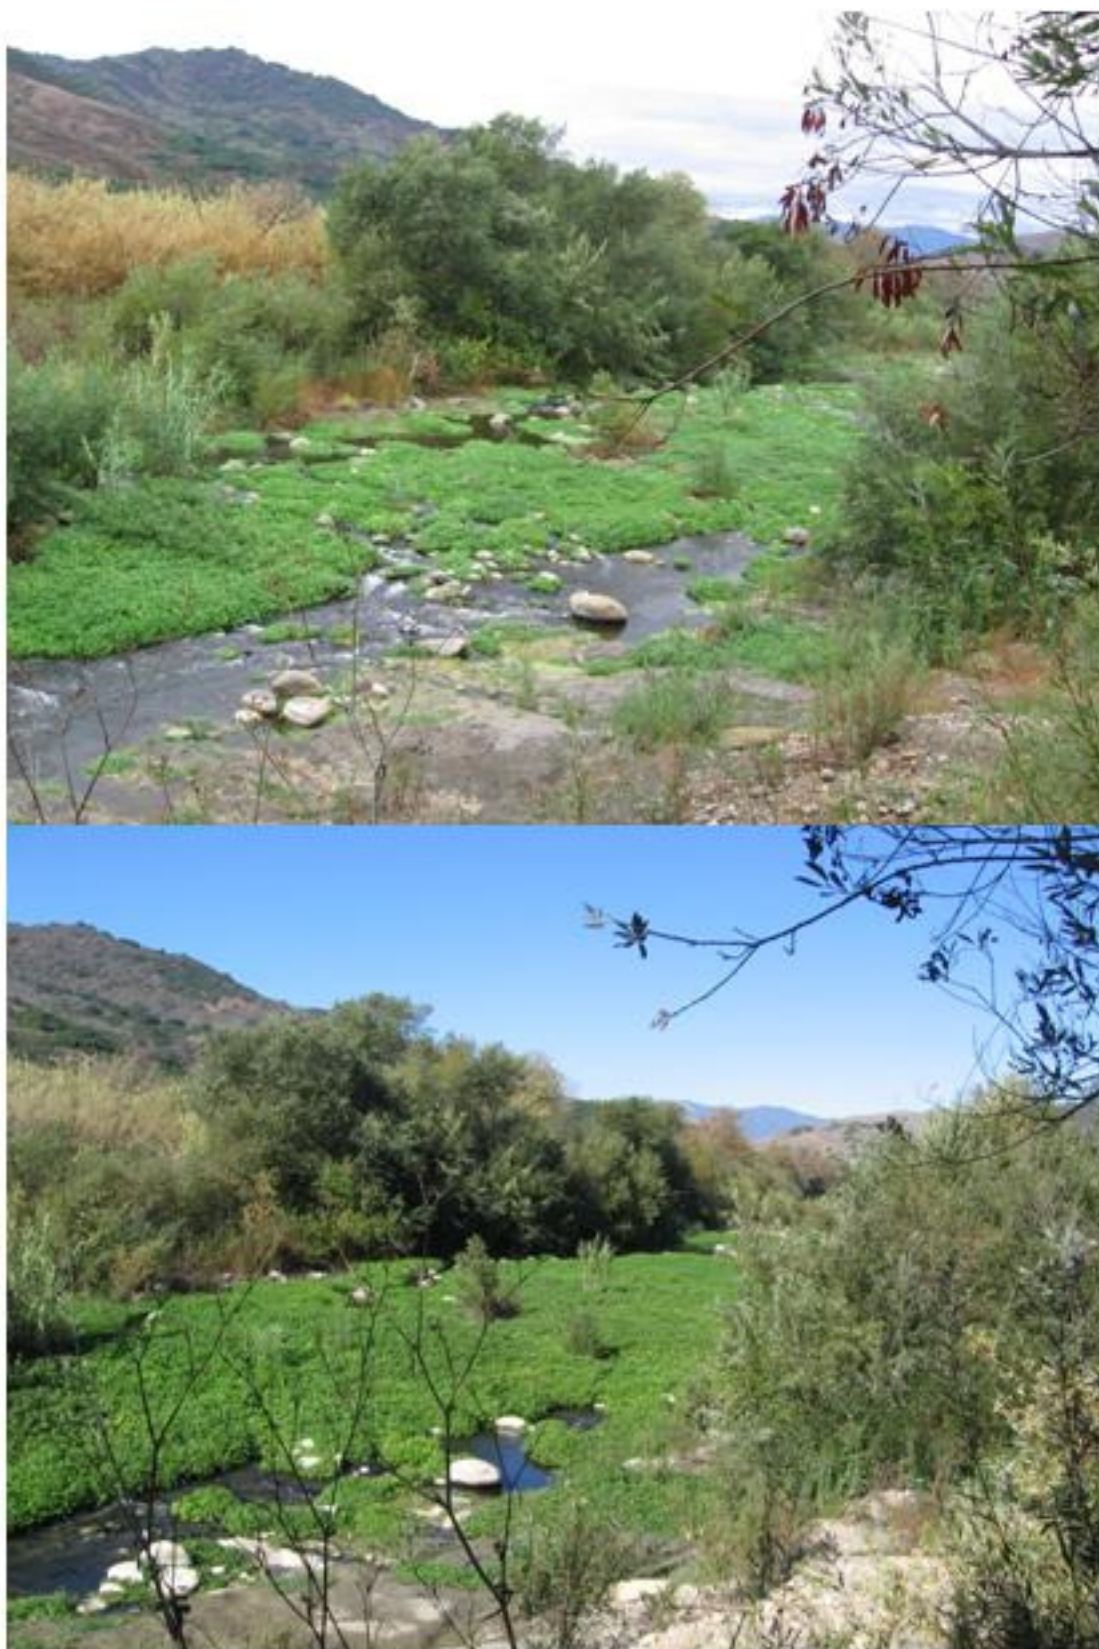
During the December 6th 2008, Channelkeeper sampling on the Ventura River we noticed an extraordinary change (to me at least) at the Canada Larga confluence. We were met by a field of green (lower photo, Figure 1), the “green” being a late-season revival of watercress. It was extraordinary in that the month was December, but more interestingly, because the month before, on the first of November, the dominant plant was Ludwigia but is now – Holy plant succession, Batman – watercress (the great majority of green plants shown in the upper, November, photo of Figure 1 are Ludwigia which began to dominate this location after the great plant die-off of August 2008 – see my “Attack of the Killer Effluent.pdf”). Let me repeat that: a December revival of watercress has overwhelmed three months of Ludwigia growth. Yeah, I know; it rarely gets any better than this.

Figure 1. (upper photo) View overlooking the reach just above the Canada Larga confluence on November 1, 2008. Most of the plants visible are Ludwigia. (lower photo) The same scene on December 6. Almost all the “green” is now water cress. Note also that a greater extent of the water way is now covered.

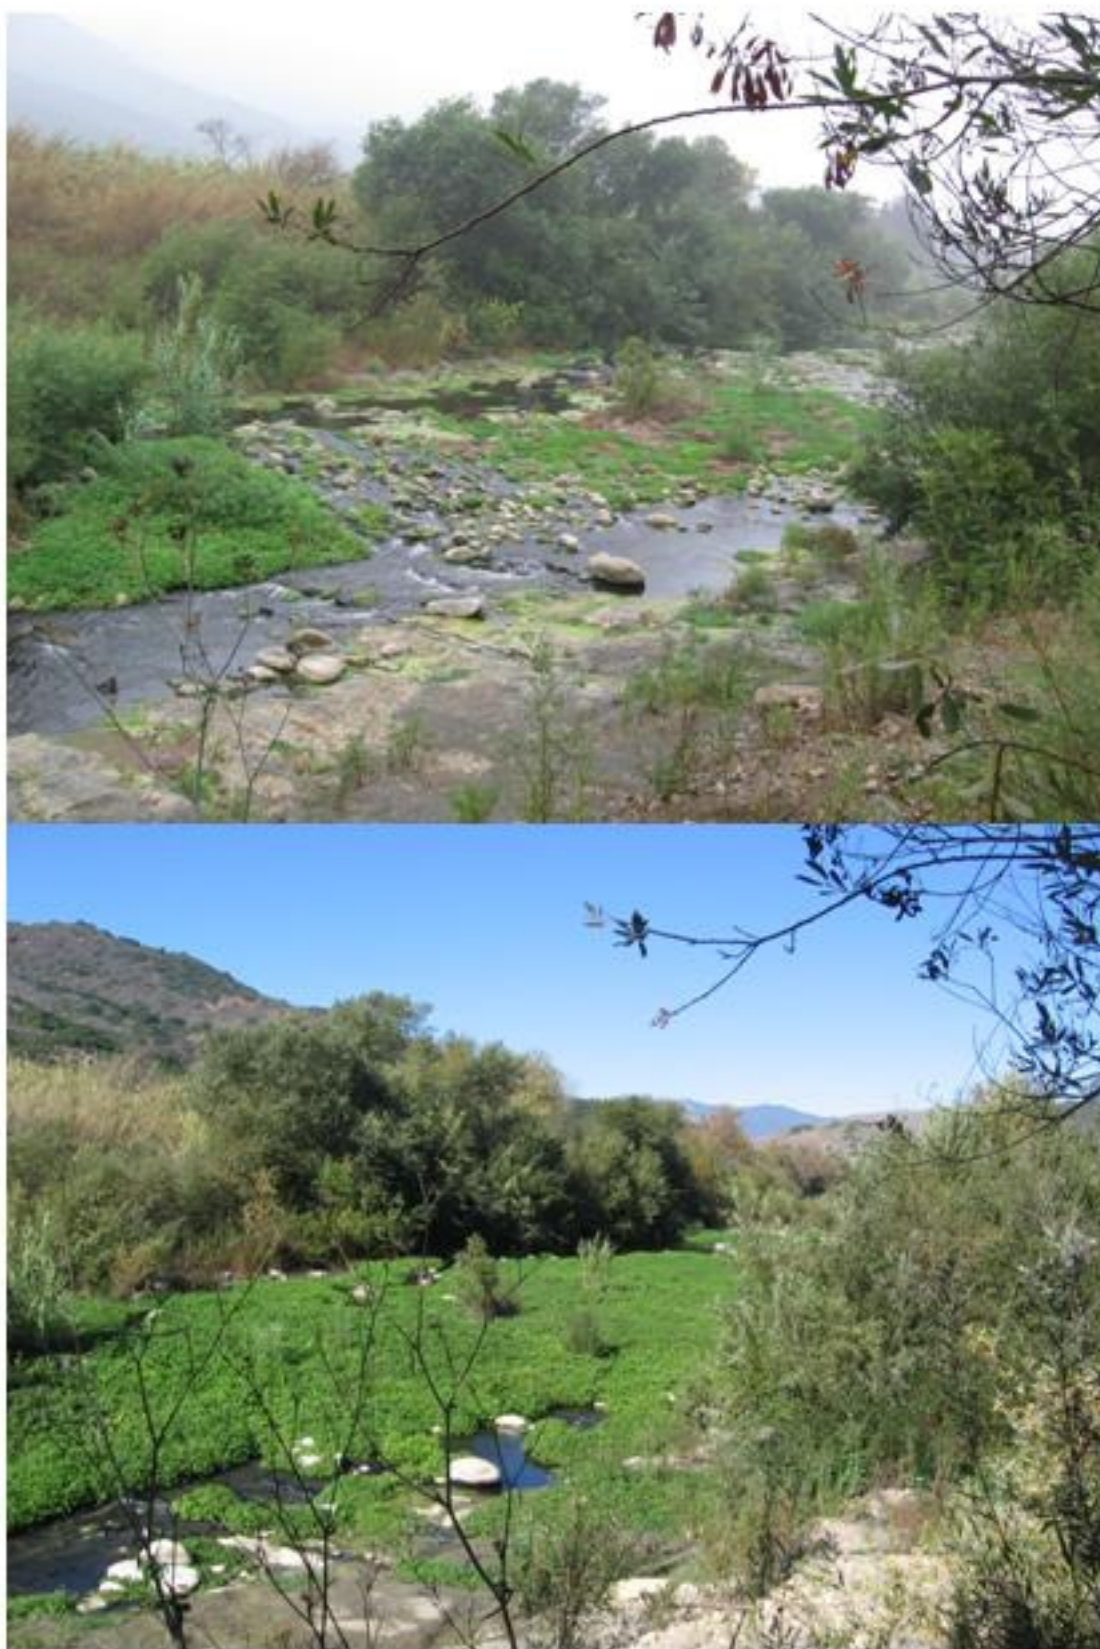
The bottom photo in Figure 2 is the same December 6th photo shown in Figure 1, but I’ve replaced the November photo with one taken on October 4th. Back in October a lot of the dead vegetation was still visible – and there was a lot more open water – but Ludwigia can be seen to be making great progress. Invariably, plant succession in the past has been the other way around: taller Ludwigia overshadowing watercress and causing it’s extinction – the less firmly rooted water cress always being rapidly displaced on the lower Ventura.

Figure 2. This is a similar comparison to that shown in Figure 1, the lower photo is the same (overlooking the reach just above the Canada Larga confluence on December 6th), but the upper photo is one taken a month earlier, on October 4, 2008. The killed vegetation was still visible and the new stuff was mostly *Ludwigia* (*Ludwigia hexapetala*, aka water primrose).

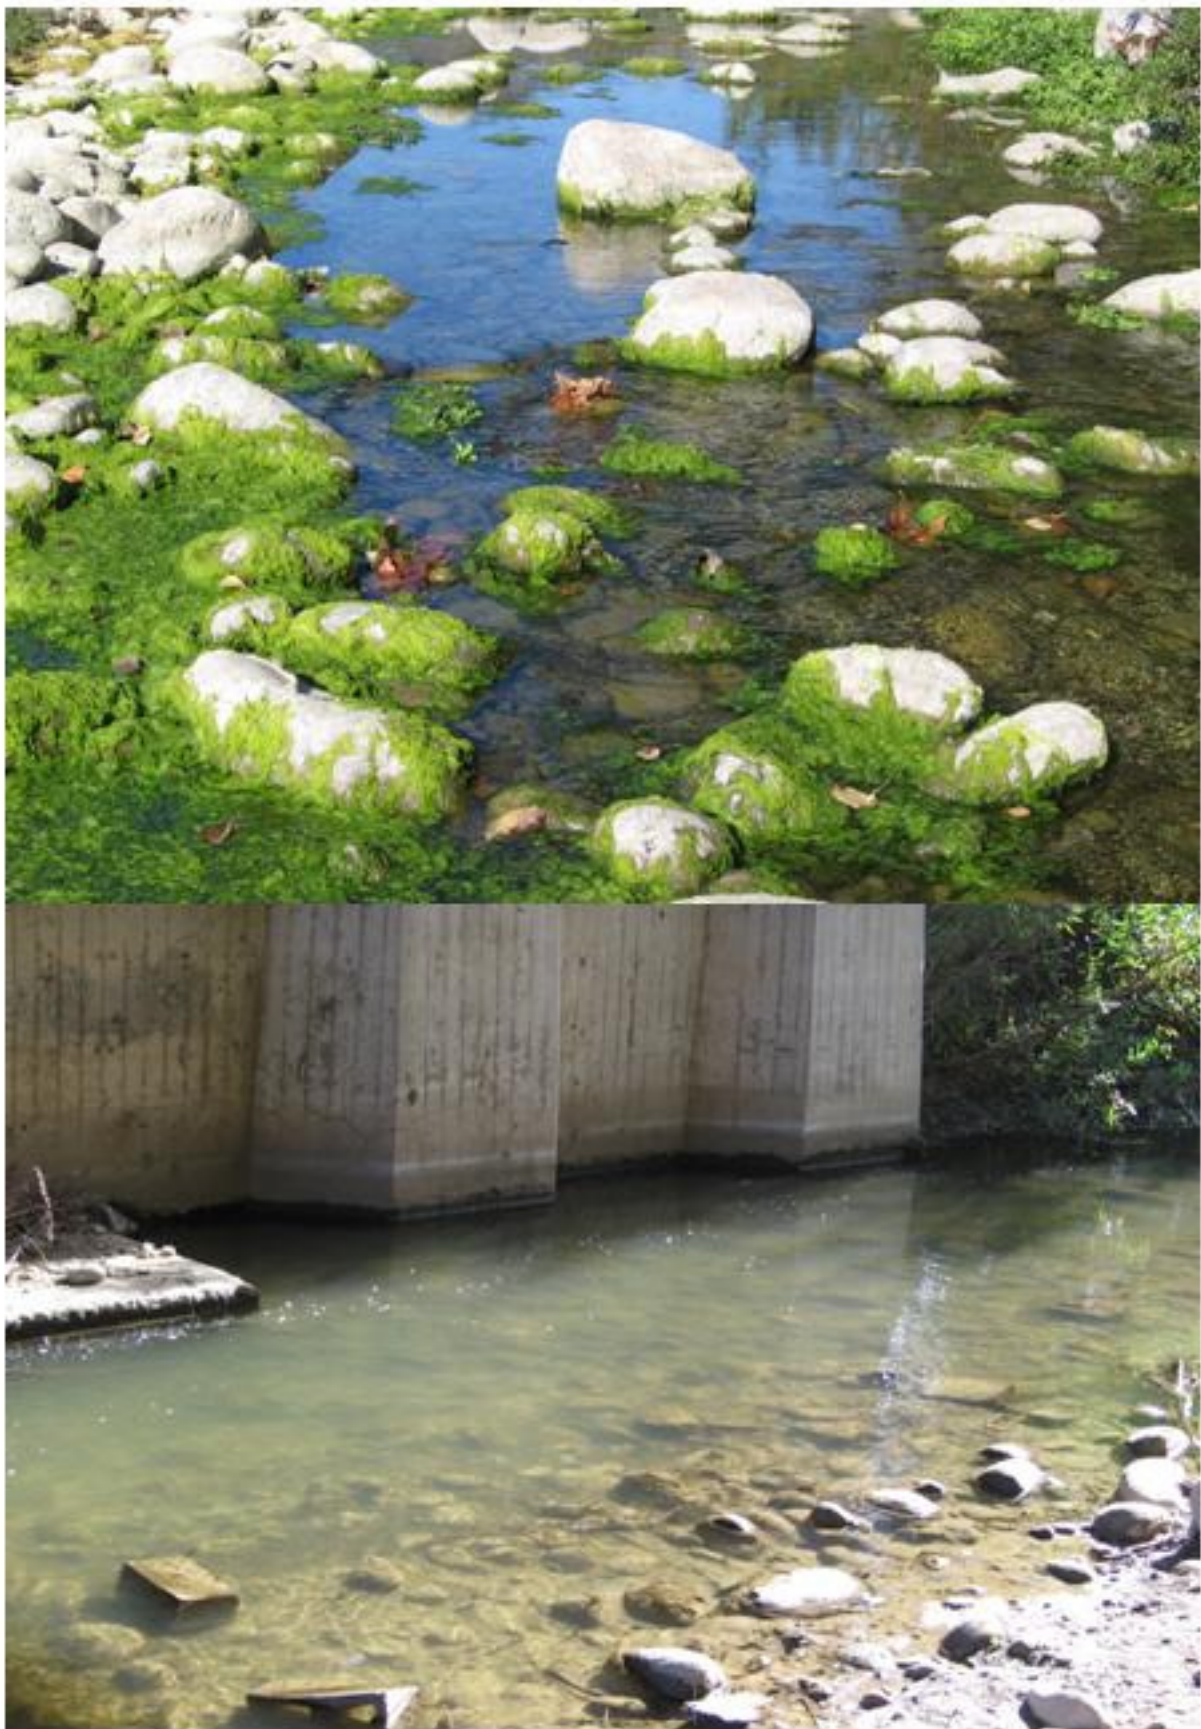
The upper photo in Figure 3 shows what a rise of a few inches in water level during the storm did do above the San Antonio confluence: it moved enteromorpha from upstream and the center of flow off to the side, and left it stranded when levels dropped a short time later. All that luscious green, and the red roots of the Ludwigia, kinda gave me that Christmassy feeling. Perhaps we should think of all that new watercress as a Christmas present. After all, Ludwigia is regarded as noxious aquatic weed, an exotic invasive from South and Central America (but there is some doubt about this, a few experts believing it to be native), while watercress . . . On second thought, I'll let Wikipedia explain (<http://en.wikipedia.org/wiki/Watercress>):

Figure 3. December 6, 2008: (upper photo) *Enteromorpha* stranded on rocks above the San Antonio confluence, (lower) turbidity caused by agricultural sediment entering river above Main Street.

My last topic concerns the sediment problem we’ve been seeing at Main Street throughout the summer and fall. The lower photo in Figure 3 shows what the water looked like this month. Contrast it with the water clarity in the photo above (December turbidities elsewhere on the river were measured at 0.0 NTU). The sediment source is agricultural operations on the land to the west. Drainage from this property enters the river a few hundred meters upstream of the bridge. Up to now Channelkeeper has been unable to get a good look at the actual drain since the area around the outlet is covered by a dense growth of willows and brush (access via the river is difficult – and inability to often see the bottom makes it more so). However, given a good river-cleaning storm later this winter, access should become easier, and the actual situation clearer.

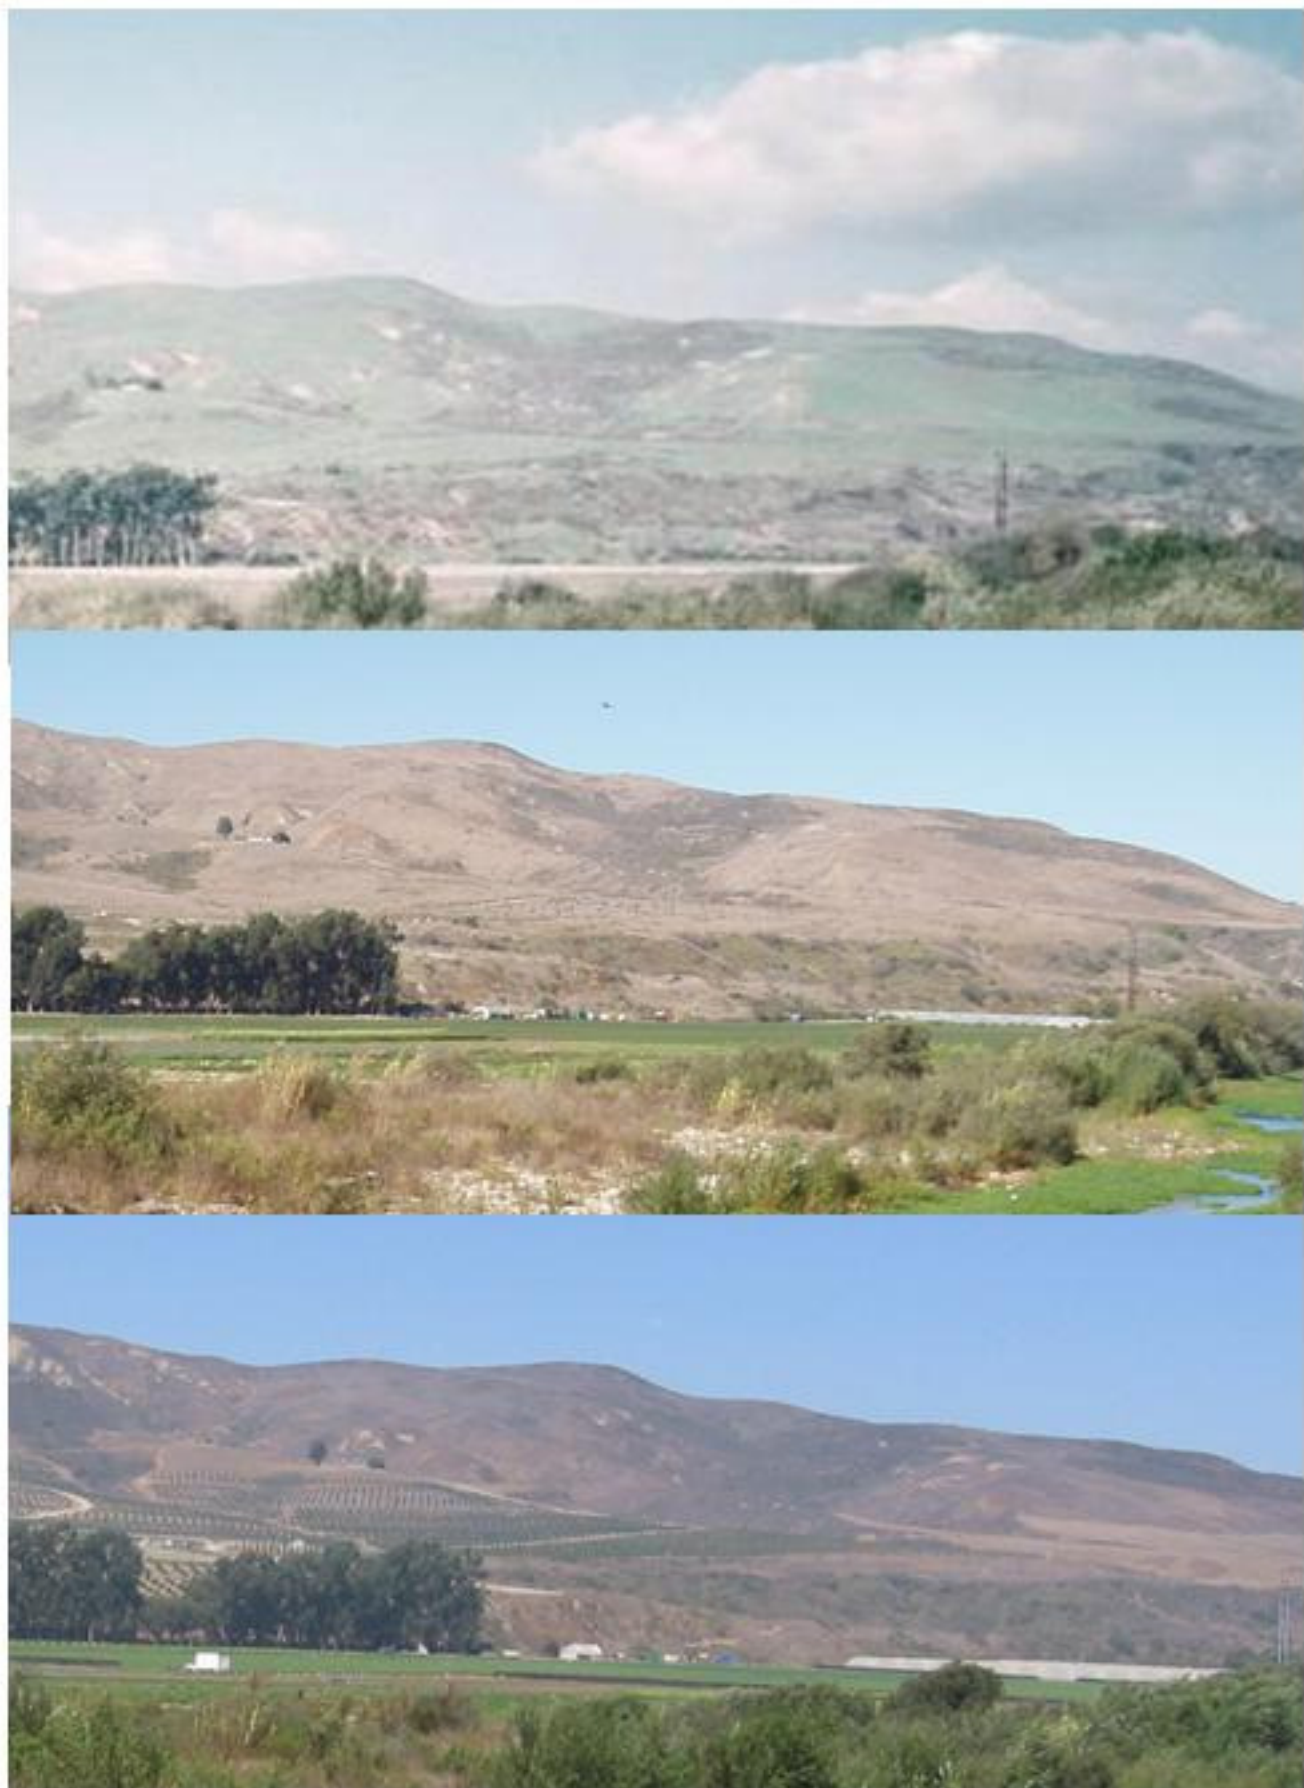
In point of fact, agricultural development on this parcel of land has grown appreciably over the course of Channelkeeper sampling and I decided to dig out a bunch of older photos to show its progress. The following three Figures show photos (or parts of photos) from 2002 and 2008 (and 2006 in the middle panel of Figure 4). (Unfortunately, there are surprisingly few photos available, most of camera work having been concentrated on conditions and changes within the river channel itself.).

Back in 2002, and up through the winter of 2005, agricultural operations were rather modest, confined mainly to bottom land on the flood plain. I have no information about the kinds of crops that were grown (it might be useful for someone to investigate the changes in cultivation that have been made over the years and how those might have had varying impacts on the river), but in 2006 an extensive series of greenhouses (seen on the lower right in Figure 4) were constructed. This was followed by extensive new cultivation on mid-elevation slopes. This up-the-slope expansion continues further south than my photos show, and has now rounded the ridge and is proceeding further west on the back side.

Figure 4. Northern view: (above) March 2002, (middle) November 2006, (below) September 2008

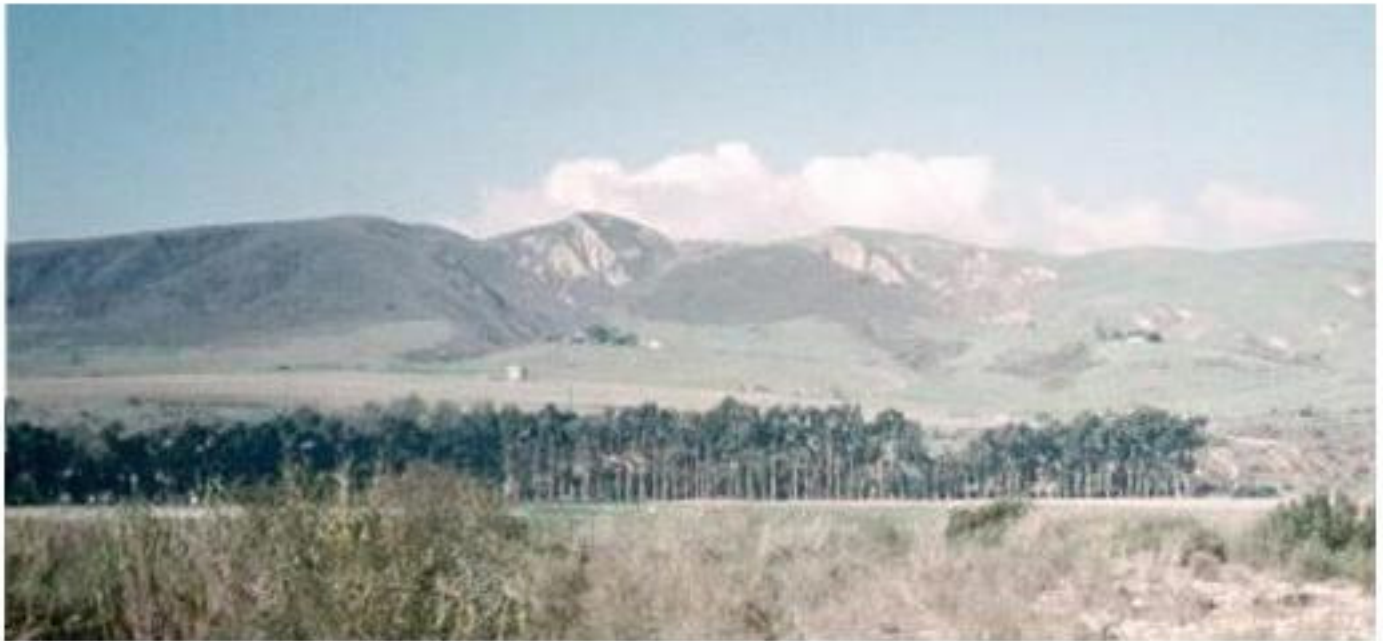
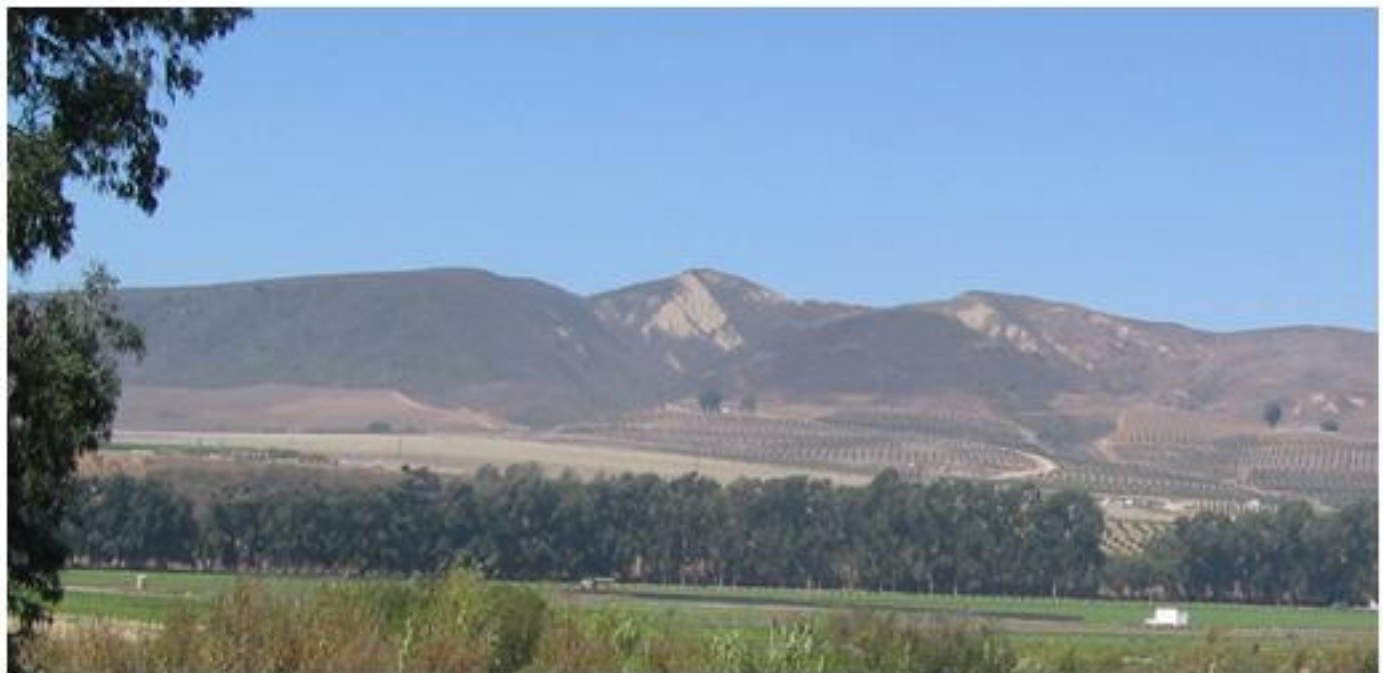
Figure 5. The view to the south: (above) March 2002, (below) September 2008. Intensive development of the mid-elevations slopes began after 2006. The development continues even further south, rounding, and even heading up the reverse side, of the ridge seen on the far right

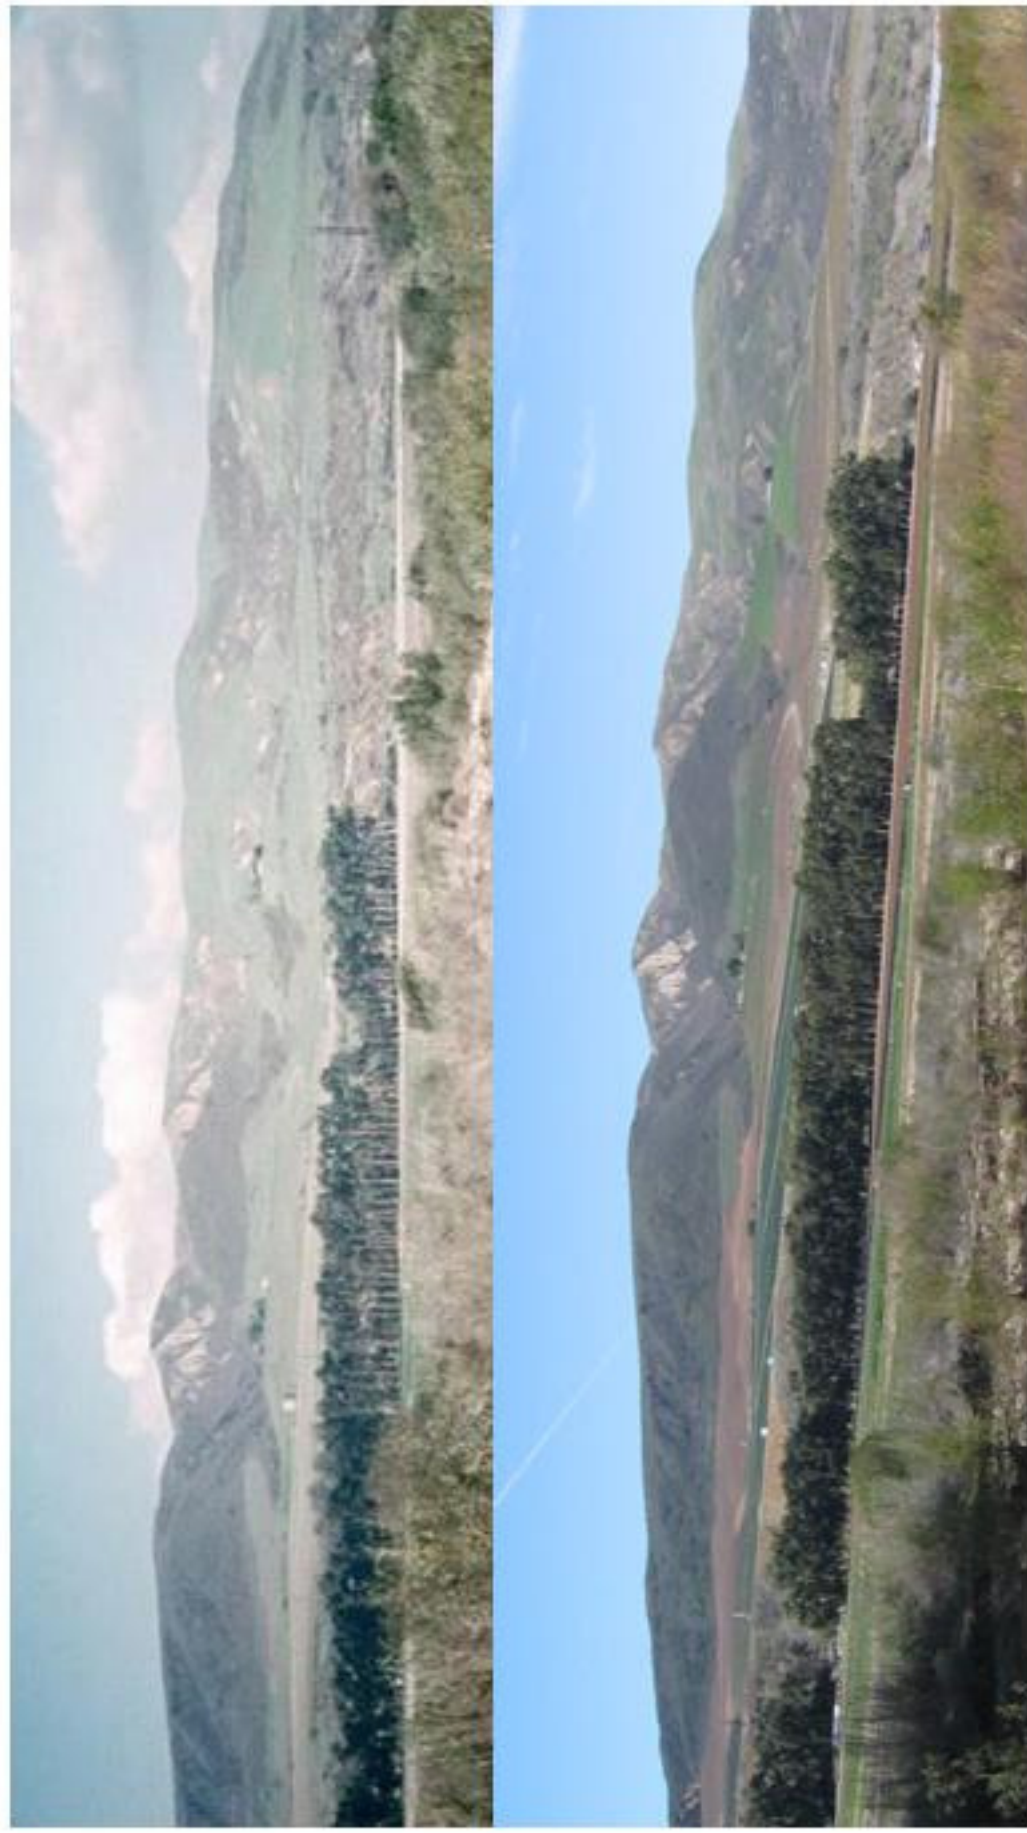
Figure 6. A panoramic view (or at least as panoramic as I have available) : the upper photo shows the scene on March 2002 and the lower was taken in February 2008. Agricultural development of the mid-elevation slopes and the establishment of the greenhouse complex seen on the right are the most obvious changes. I also believe there have been some modification in the types of crops being cultivated, but have no direct evidence.
