## Some Thoughts on Trees and Algae:

During the last Santa Barbara Channelkeeper (SBCK) Ventura sampling exercise (April 6, 2013) the group I was with talked about the extravagant tree growth at a number of monitoring locations in what once was the river channel. To move a step or two beyond the anecdotal, I've put together some photos taken at roughly the same locations over the past six years. Most of the figures that follow show photos from the years 2008, 2010 and 2013; all but one of the photos taken during the month of April. Photos from the intervening years only reinforce the story of continual growth told by those shown.

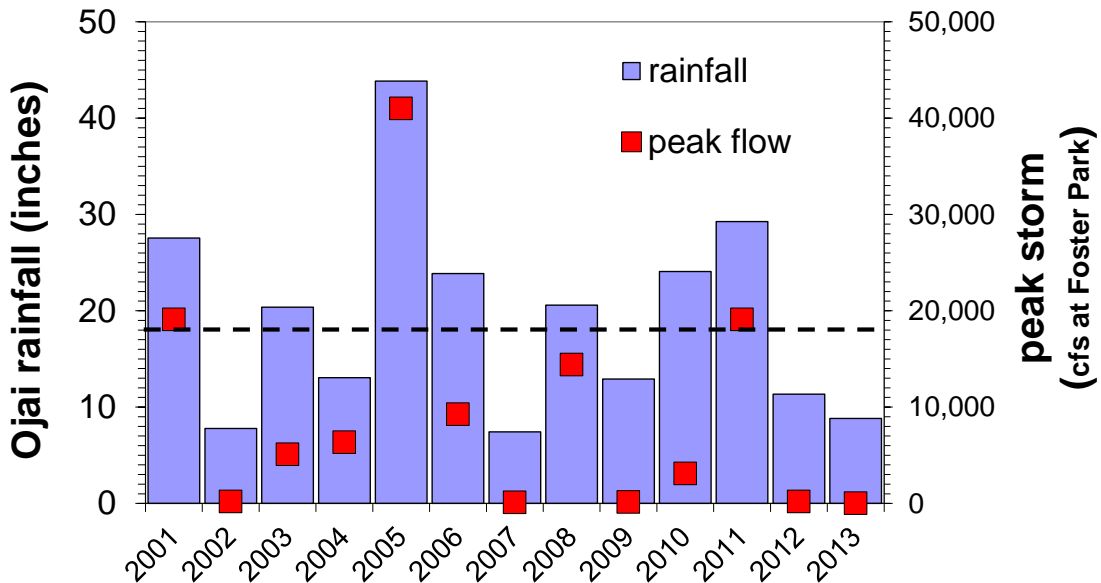
The graph shows annual Ojai rainfall (water years, i.e. October through September) and the peak flow produced by the largest winter storm during the era of SBCK Ventura sampling. The dashed line represents median Ojai rainfall: 18 inches a year. This can be considered the expected annual rainfall: half of all past recorded years have had rainfall less than this, half have had greater. The last big clock-cleaning event was 2005. In 2008, higher than normal rainfall, but more importantly, a relatively big flood removed aquatic vegetation and gave us our last big algae year. As the subsequent photos will show, the sparse, newly established, riparian growth (mostly dating from 2006) remained relatively undisturbed.

Although 2010 proved to be an even bigger rainfall year, the peak flood was much smaller (only one fifth the size of 2008's), and not even aquatic plants were greatly disturbed. 2011 was an even bigger rainfall winter with an appreciable flood flow – as great as 2001's – but by this time the well established riparian vegetation was not much bothered and subsequent algal growth was greatly diminished. The dry winter of 2012 was followed by the even drier winter of this year, but what makes 2013 rather exceptional is not the low rainfall per se (rainfall was even lower in 2002 and 2007) but that it is the second very dry year in a row and the total absence of any sizable stormflow (we would have to go back to 1951 to find a worse year).

We are now two winters past the last big storm and the river bottom has become even more armored against flood. To change the situation will require more than a big rainfall winter, it will require a big flood – something approaching, or exceeding, what we had in 2005, 1995 or 1993. Our big years are most often El Nino years. The 1990s had three of them: 1993, 1995 and 1998. But we are in a different cycle now and haven't had a big El Nino since 1998 (2003, 2007 and 2010 were El Nino years, but rather puny ones – 2007 even produced a drought). That's the bad news. The good news, of course, is that there will be no substantial algal problem as long as the current situation continues.

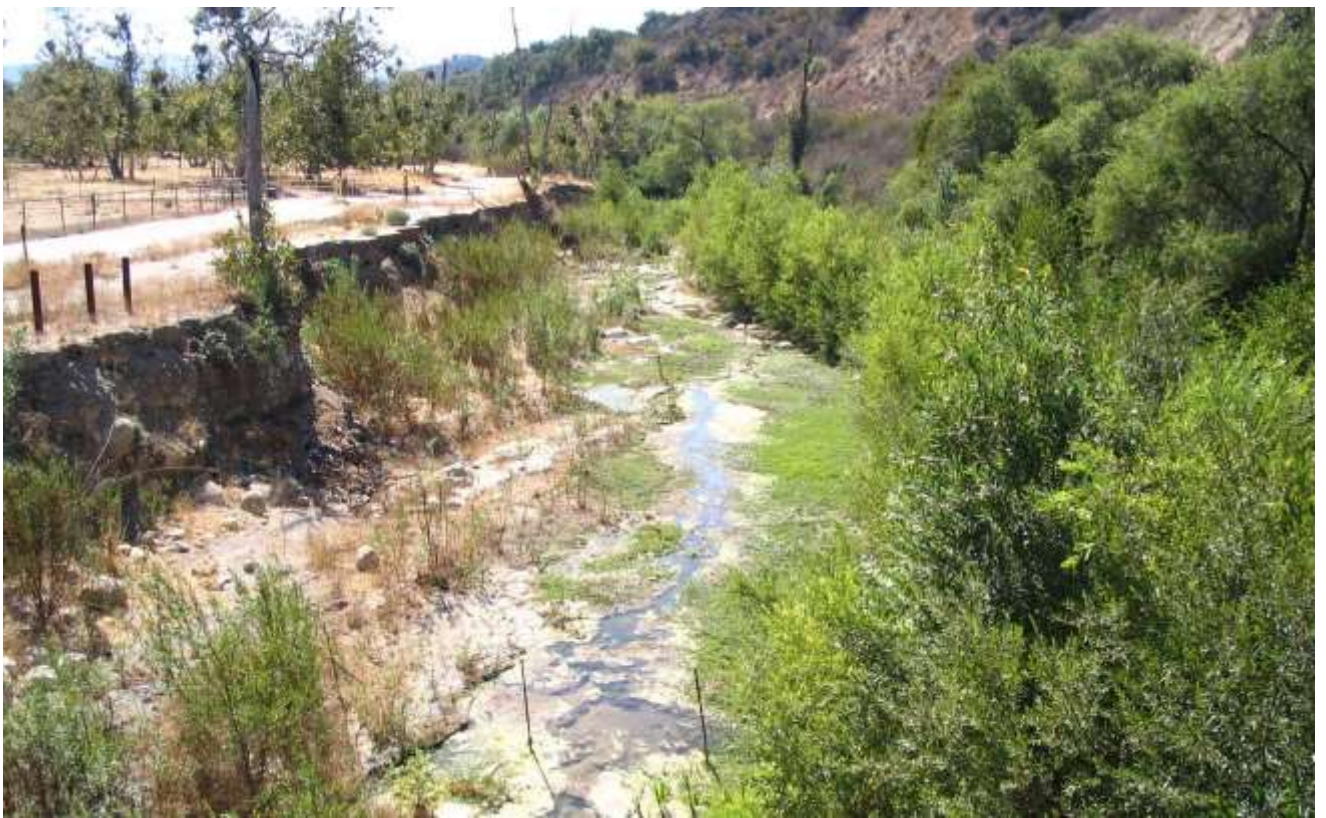
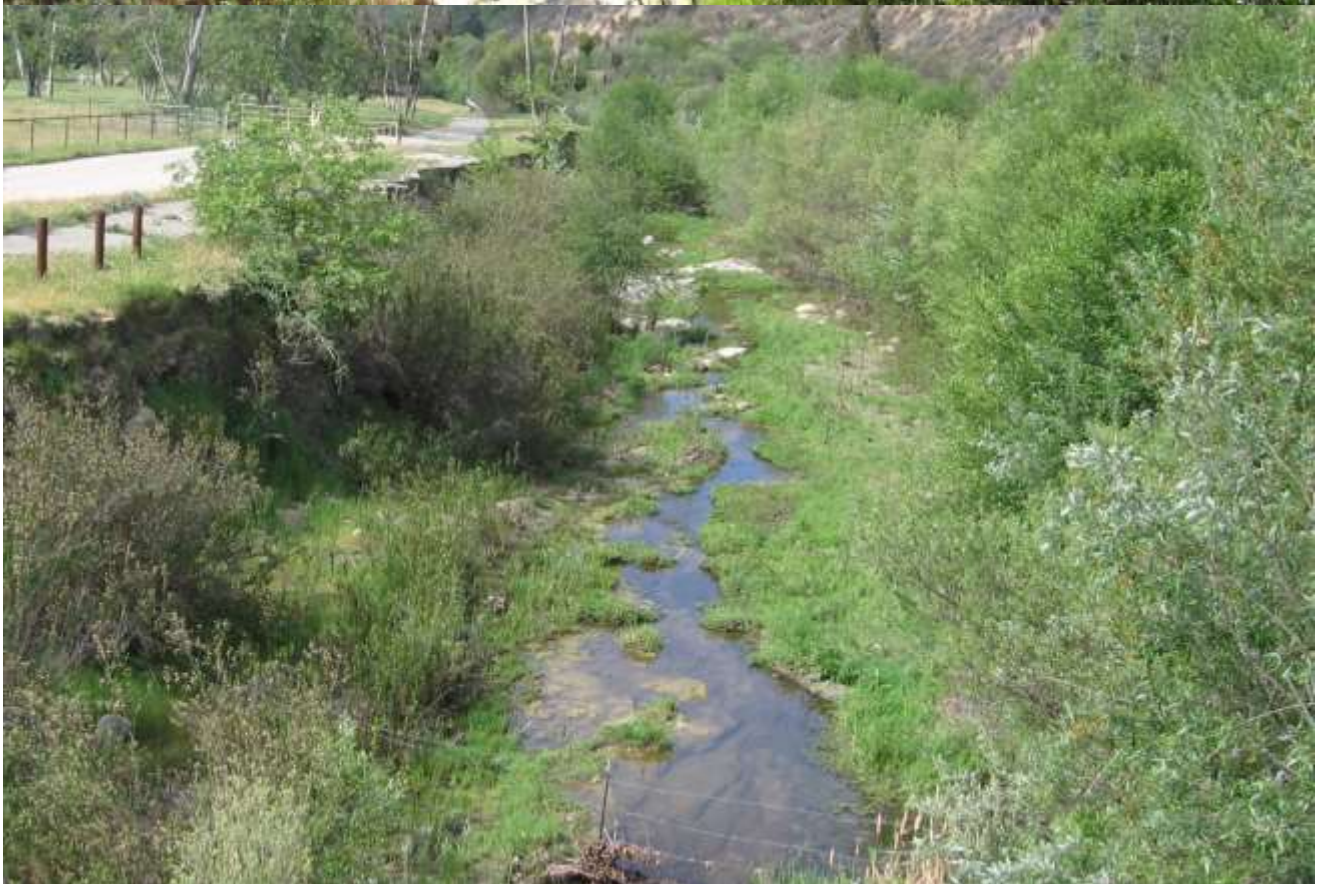
Middle San Antonio (VR17): upper photo Sept. 2009, lower Apr. 2013. The photos show a reasonable amount of vegetation growth on both sides of the stream – roughly a doubling of brush height on the right-hand side of the creek.

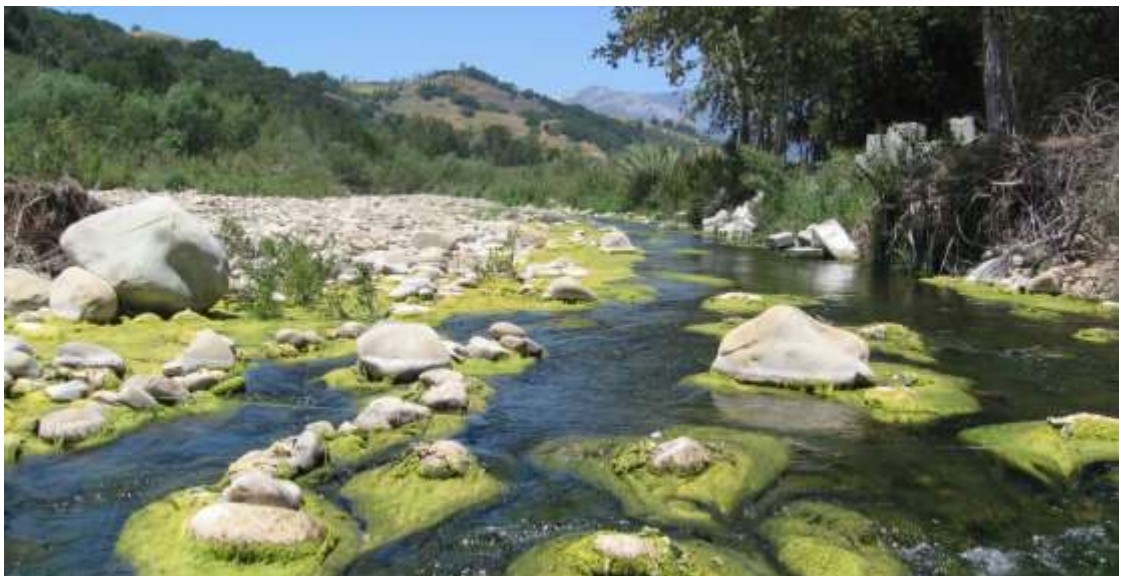
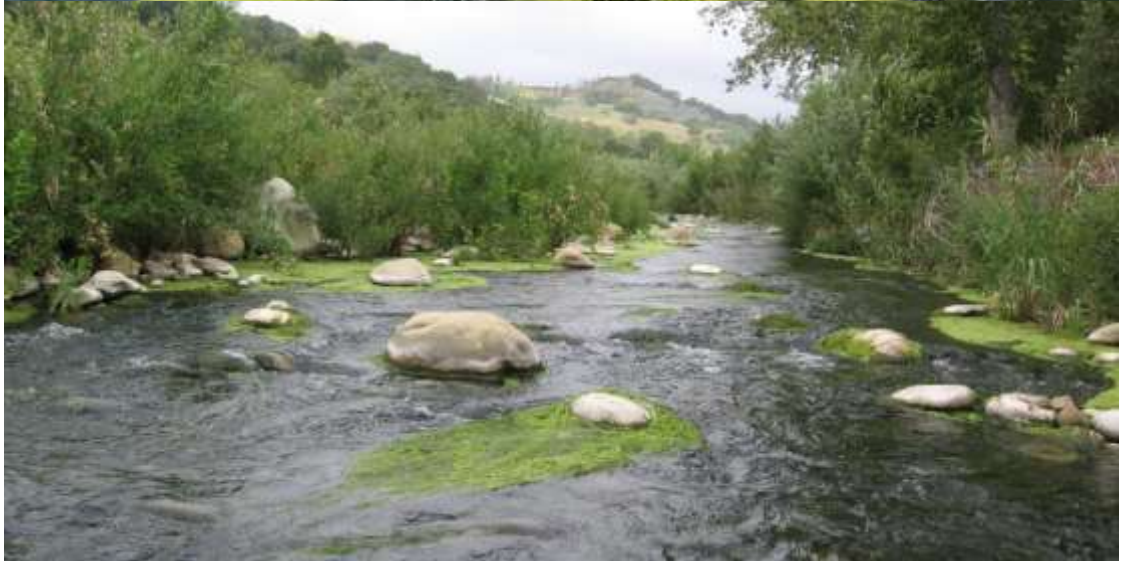
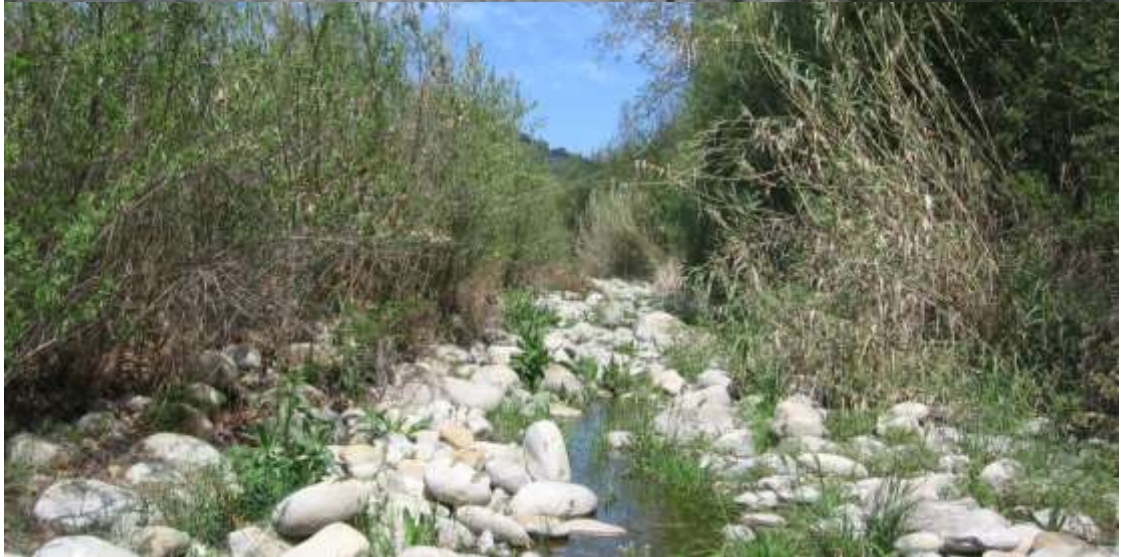
Ventura River @ S. Antonio confluence (VR06.3): looking upstream in April, 2008 (upper), 2010 (middle), 2013 (lower). Growth here has been dramatic, the riparian brush is now over 10 ft. high.

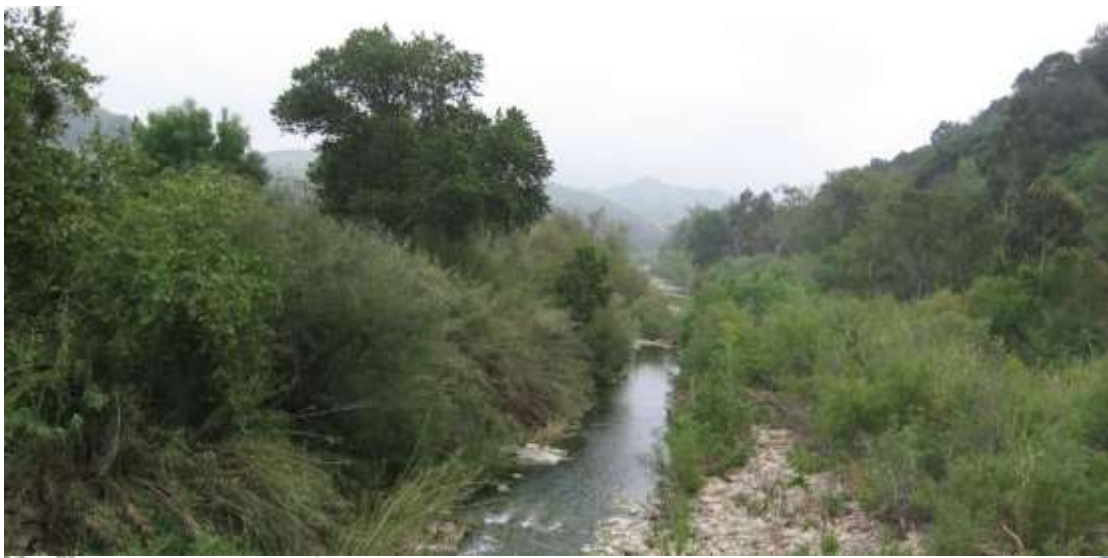
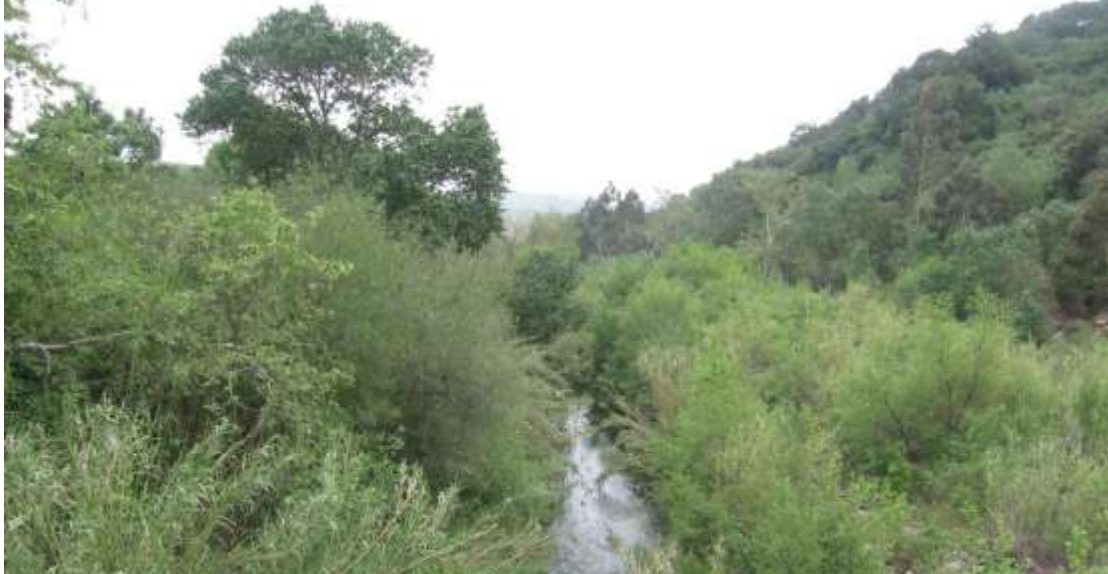
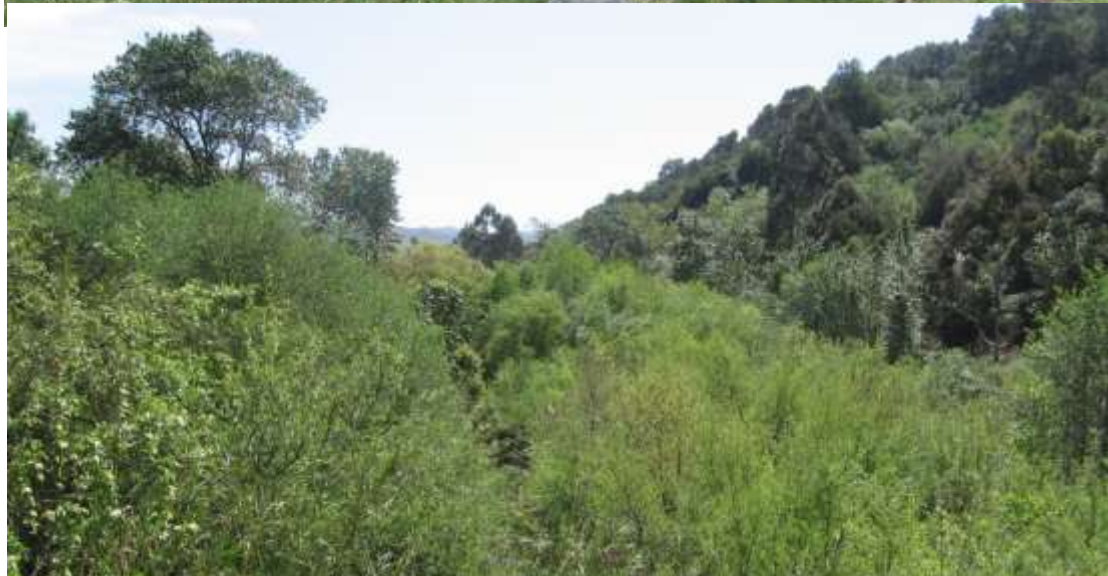
Ventura River @ Foster Park (VR06): looking downstream from the bridge in April, 2008 (upper), 2010 (middle), 2013 (lower). Growth at Foster Park is even more dramatic, trees in what was the center of the river are now about 25-35 ft. high.

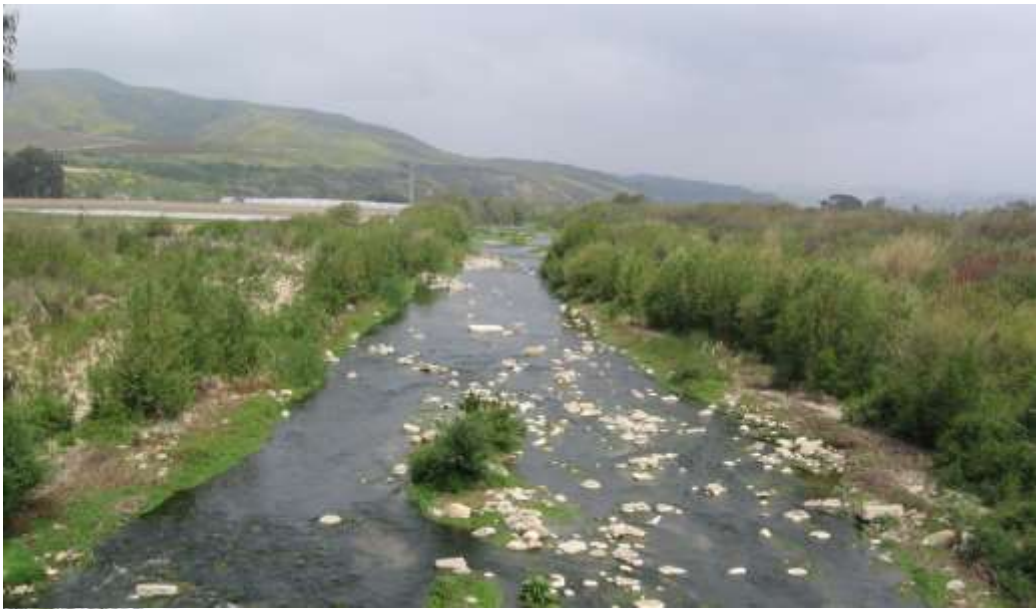
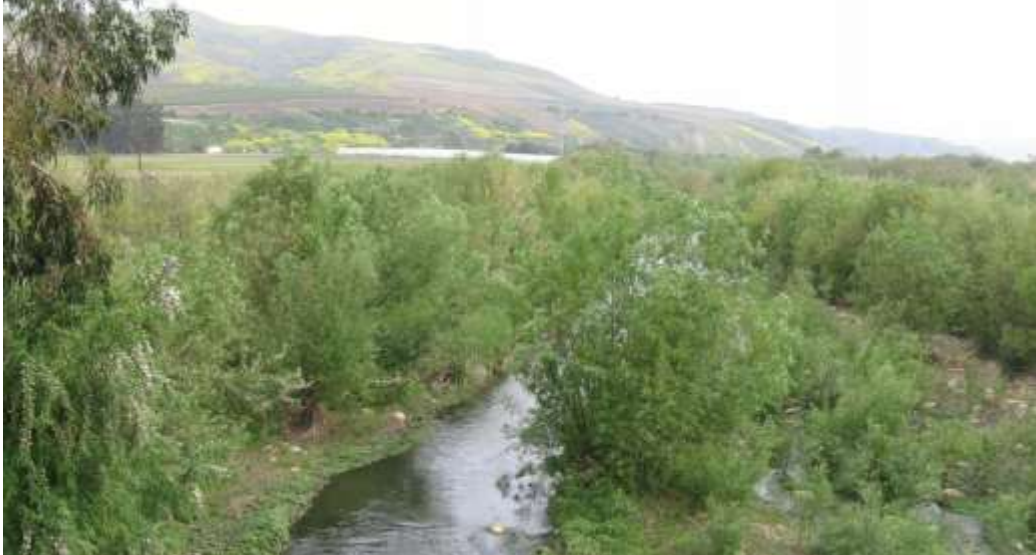
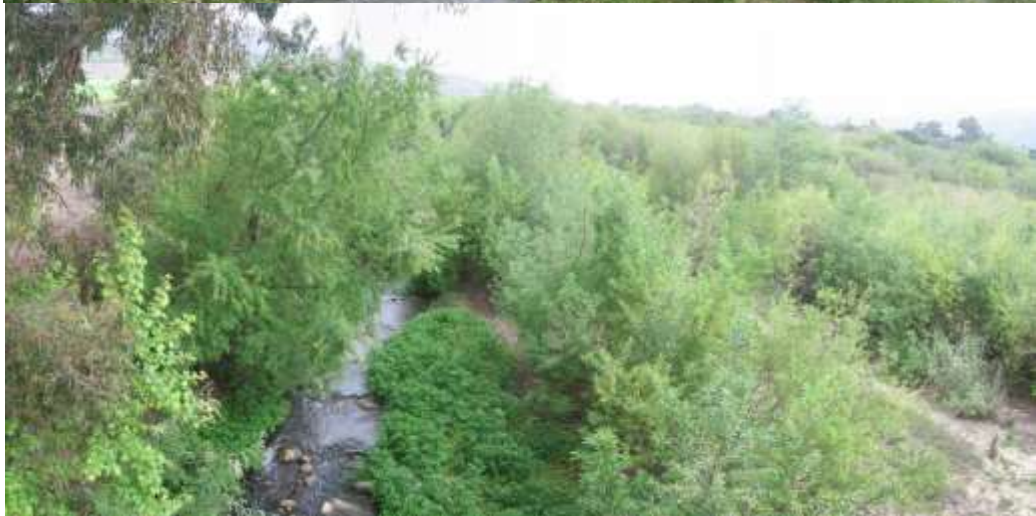
Ventura River @ Main Street (VR06): looking upstream from the bridge in April, 2008 (upper), 2010 (middle), 2013 (lower). Growth below Foster Park is equally impressive. Note that by 2013 the river is increasingly confined within an ever narrowing channel.

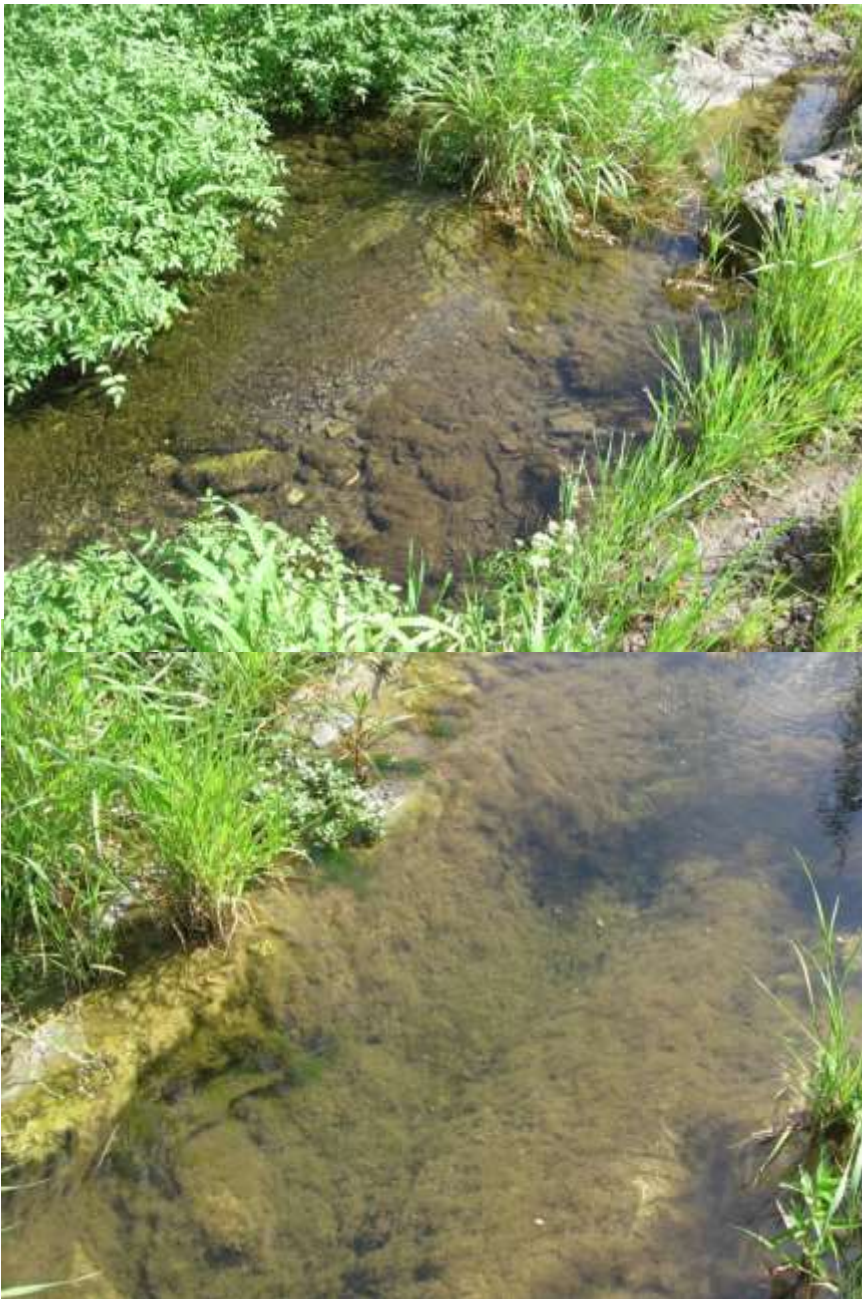
## Middle San Antonio

(VR17): These two photos were taken on April 6, 2013. In the upper, on top of the rock in the lower left-hand corner you can light green crustal algae growing. This is the typical alga at this location (and at others) near the end of winter and at the beginning of spring. Crustal algae thrive at this time since they're able to resist fast-flowing water and take advantage of normally high nutrient concentrations at the end of the rainy season.

Interestingly, there is no cladophora in these photos, nor was it growing at other San Antonio or middle Ventura River locations we visited.

Instead, we found lots of dead and rapidly-fading spirogyra – a very slimy, dark-green alga that you can see signs of in the lower photo. I've never seen spirogyra growing in such profusion this early. Typically it only appears late in the year as it requires almost quiescent water and is better adapted to low nitrogen concentrations than cladophora. The presence of spirogyra indicates a number of things: (1) we've had no appreciable runoff for a very long time (otherwise these fragile algal conglomerations would have been swept downstream); (2) nitrogen (mostly nitrate) concentrations are probably very low since there has been no meaningful groundwater recharge (older groundwater is typically much lower in nitrate); that spirogyra has been unable to thrive may also indicate nitrogen exhaustion at this location); and (3) we are in for an unusual year – and I don't mean that in a good way.
