On June 5, 2008, Kristi and I arrived at the Ventura Estuary to begin algal sampling on the research contract UCSB has with the LA Regional Water Quality Control Board. In my previous report, "*Diel cycle_May 15, 2008*," (which can be downloaded from either my download site or the Channelkeeper Stream-team website) I documented the changes that had occurred since the last visit for pre-dawn/mid-afternoon sampling on April 9. The green soupy color of April, indicative of phytoplankton in the water column, had disappeared by May 15 and in it's place were extravagant growths of macro-algae (photos in the May and April reports, and additional photos available on my download site, show the transformations). A sand berm had sealed off the lagoon from the Channel and water levels had risen 2-3 feet. And it was all freshwater: conductivity in the lagoon was about the same as that measured in the river at Main Street.

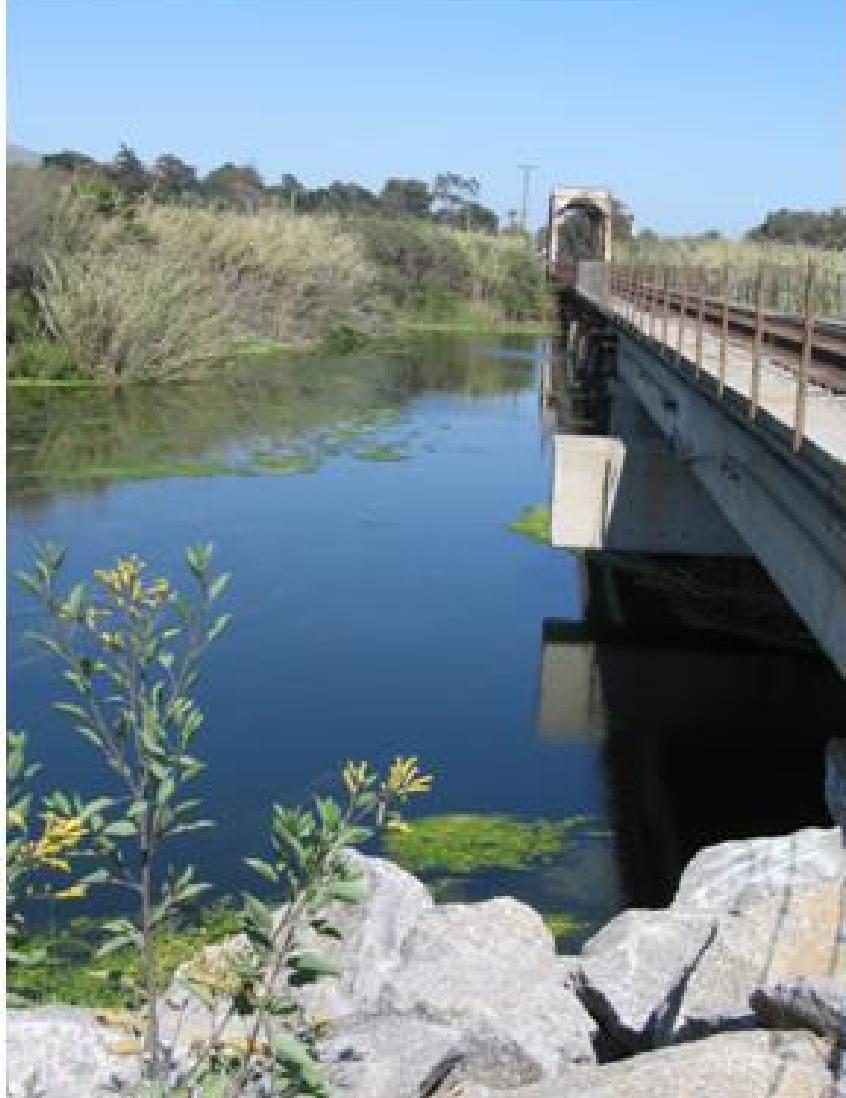
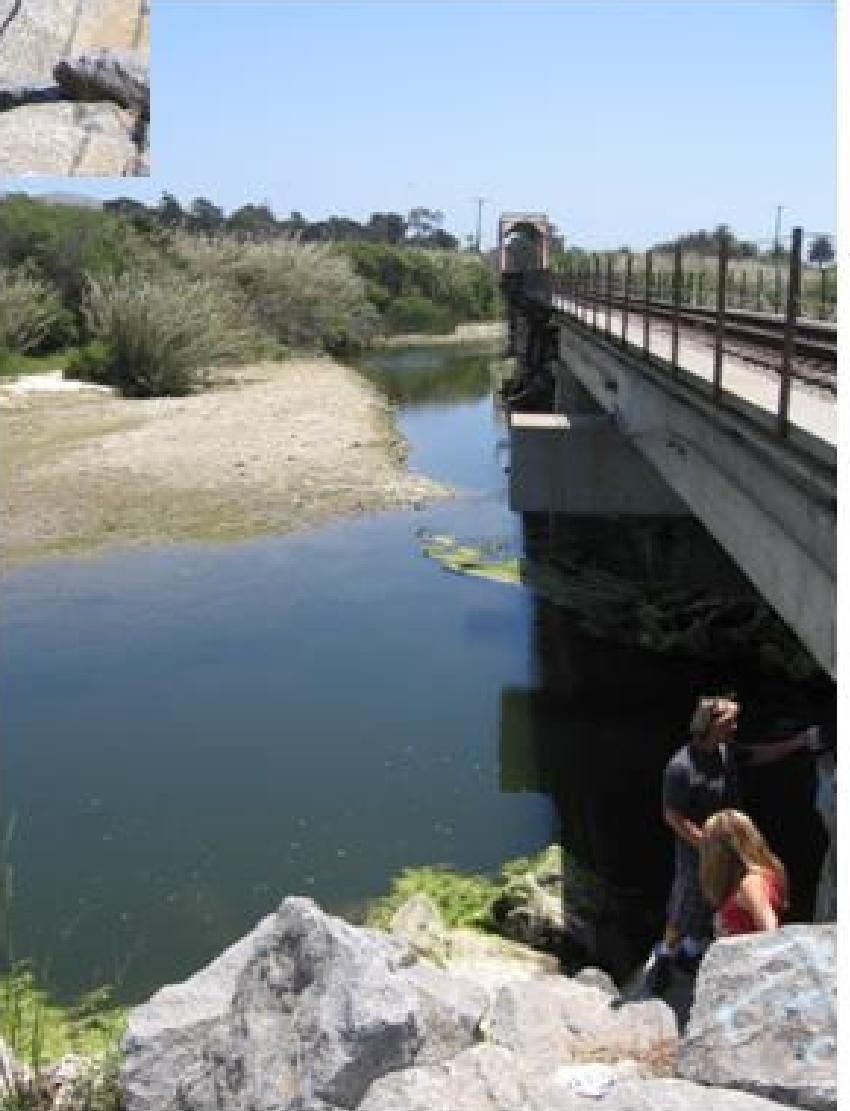
Figure 1. On the left, photo taken on May 15, 2008. The lagoon had risen about 3 feet since I last saw it on April 9 due to the formation of a solid sand berm across the river's outlet to the ocean. On the 15th the lagoon was filled with dense macro-algae and had lost the green color (due to planktonic algae) seen in April.

On the right, photo taken on June 7, 2008. The lagoon level dropped almost 4 feet during the evening of June 4. Rising lagoon water levels overtopped the sand berm, probably at low tide, causing a rapid outwash from the estuary. On the 5th, collapsed macro-algae littered the banks, but by this date most of it was gone – the white patches in the center left of the photo are the remaining remnants.

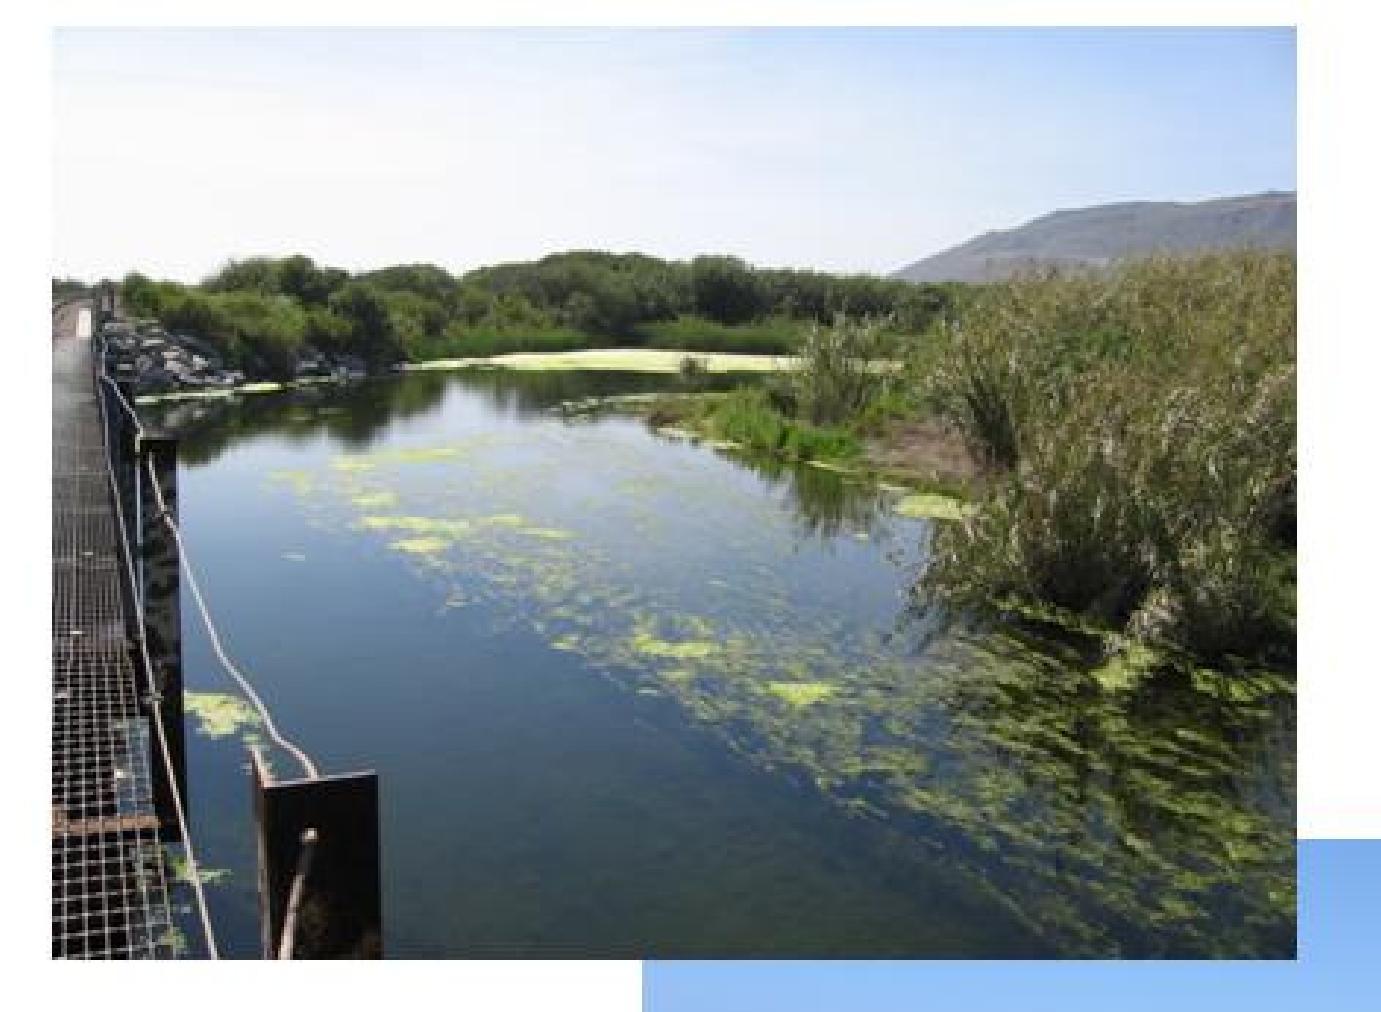
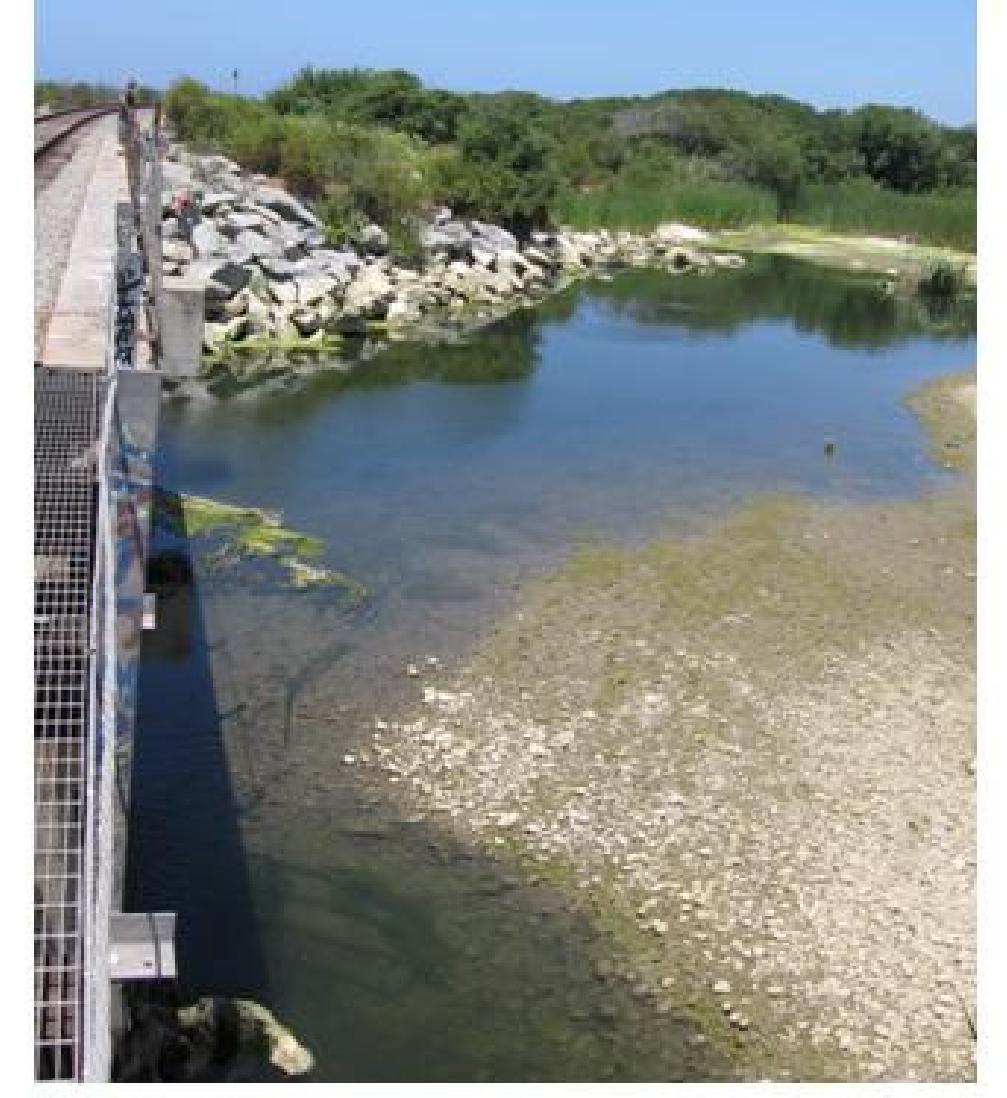
Figure 2. Above, photo taken on May 15, 2008. Macro-algae and a blue water color are clearly visible. On the right is a June 7th photo of almost the same scene. The former lagoon level is visible as a whitened region on the riprap protecting the bridge abutment - some of the collapsed algae is still green in this area. The shoreline exposed on the right of the photo has been swept clean of collapsed algae by subsequent tides. Watermarks on the bridge abutments showed an approximately 4 ft. drop in water level.

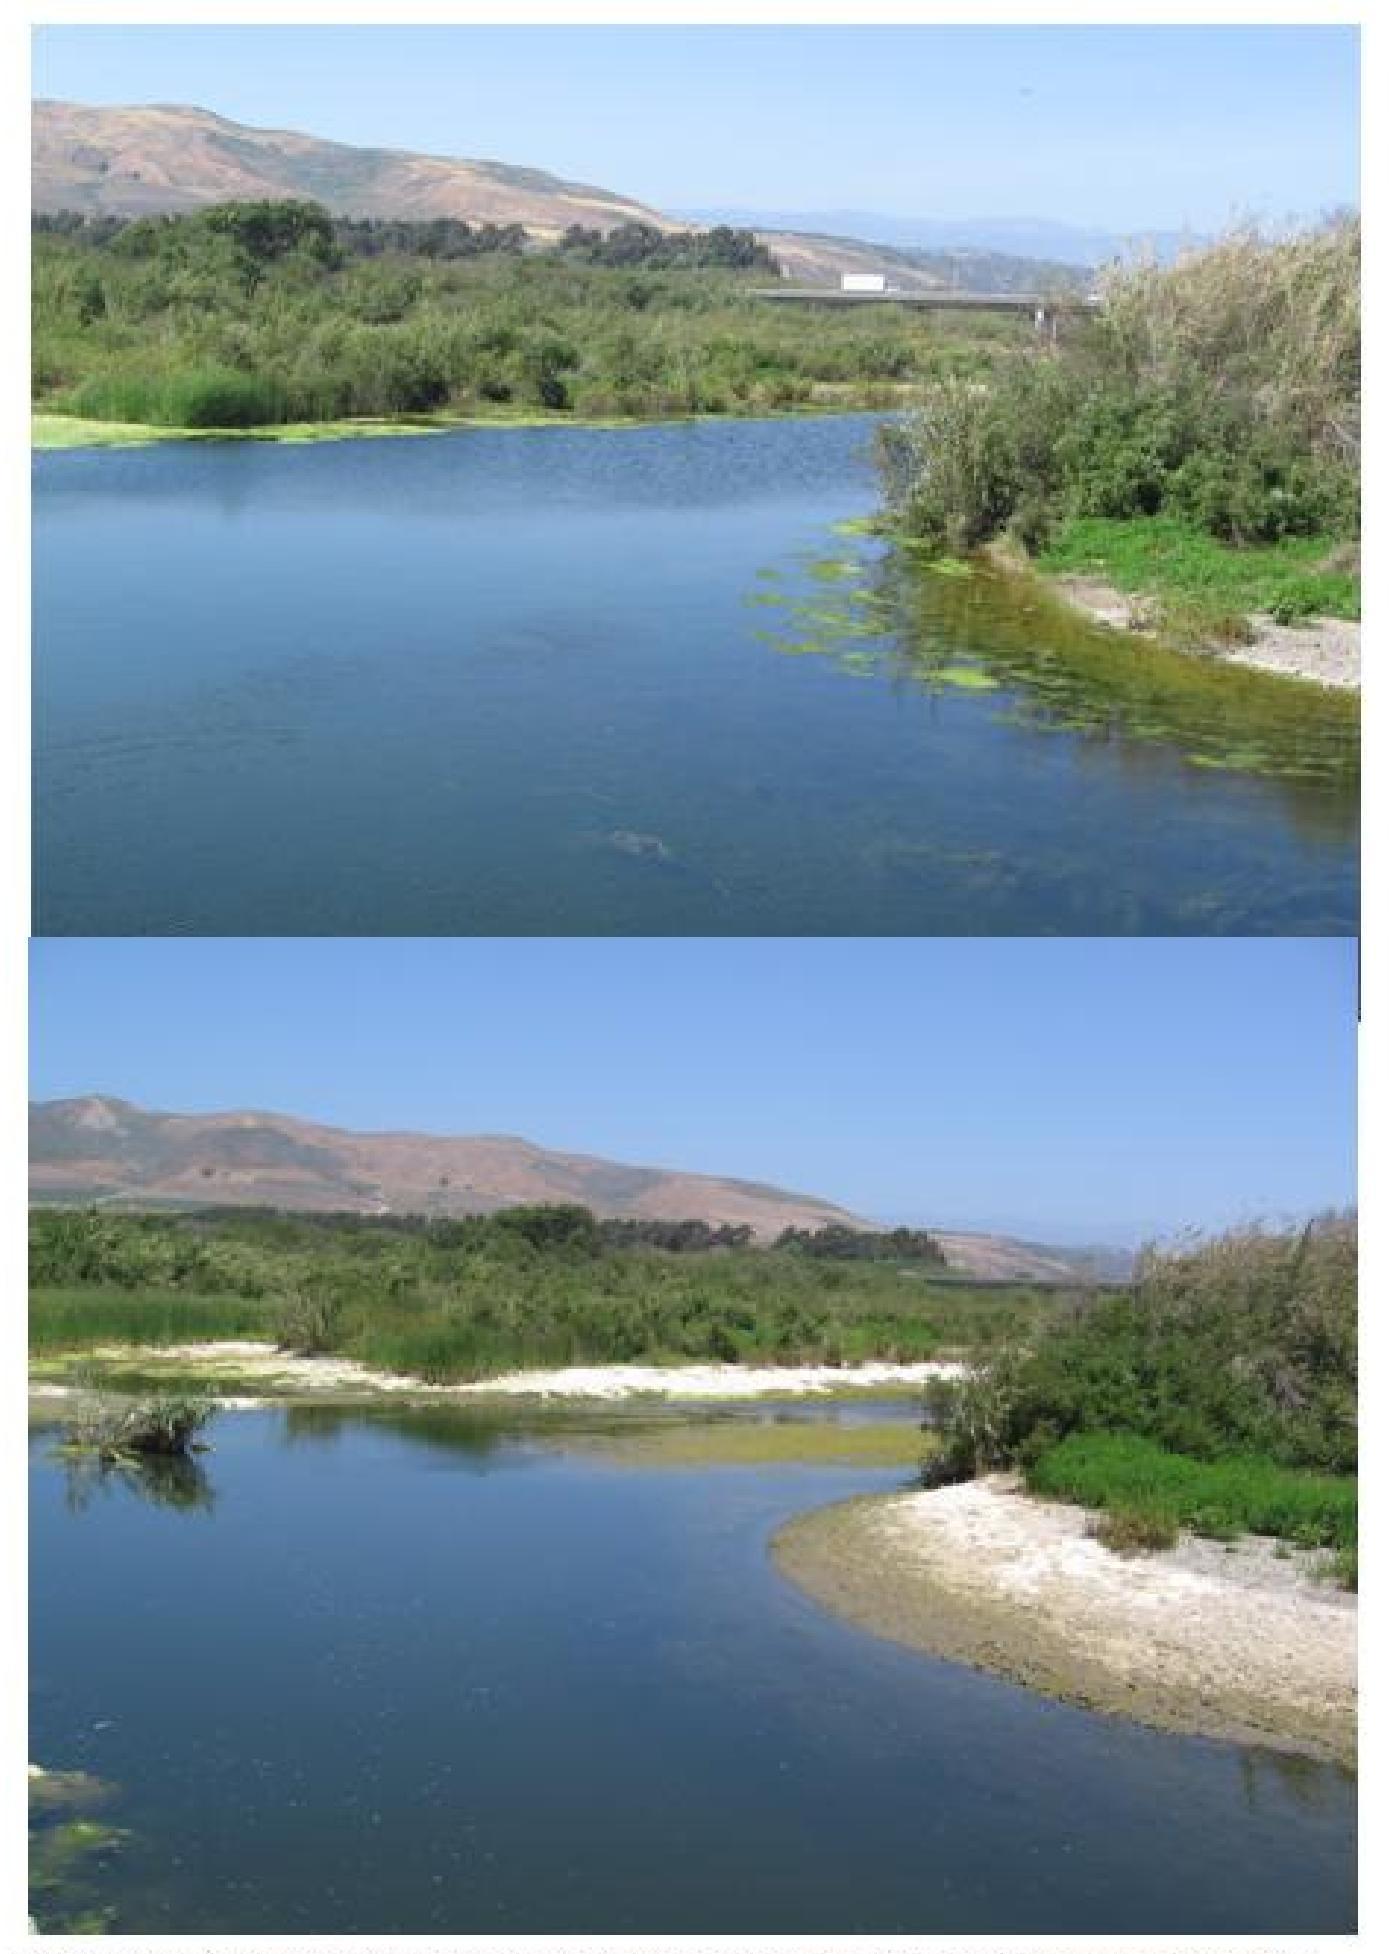
Figure 3. A little further upstream from the scene in Figure 2: on top, May 15, 2008, below, June 7^a. Again, the white patches are the now dried-out, collapsed macro-algae (almost all entromorpha).

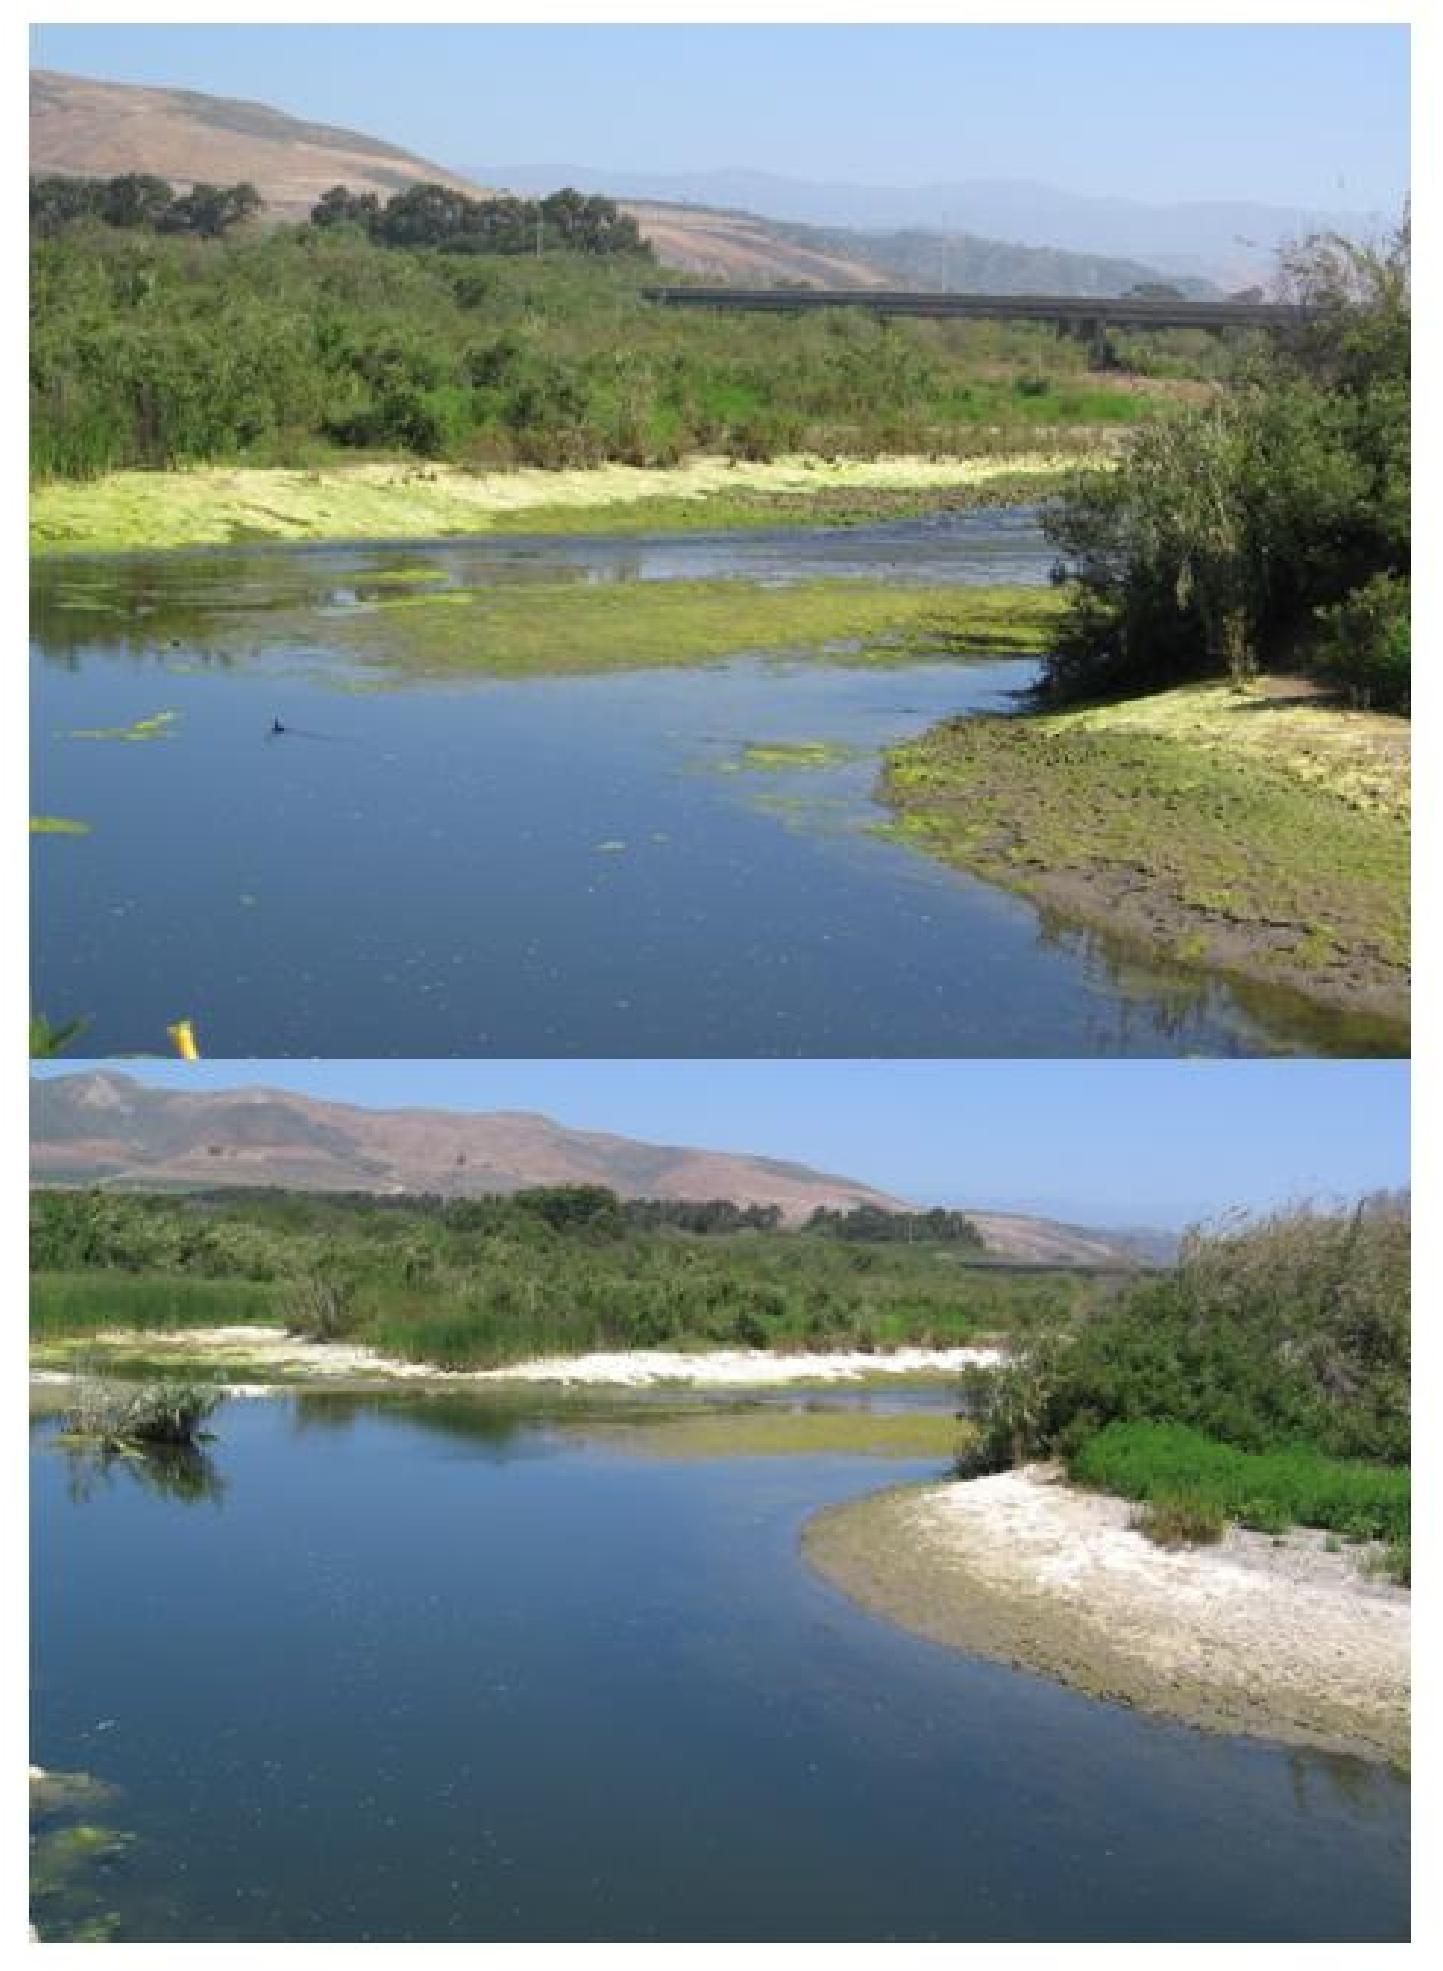
Figure 4. The tidal cleaning-out and algal-drying processes were rapid. On top, June 5, 2008, below, June 7 (the same photo shown in Figure 3).

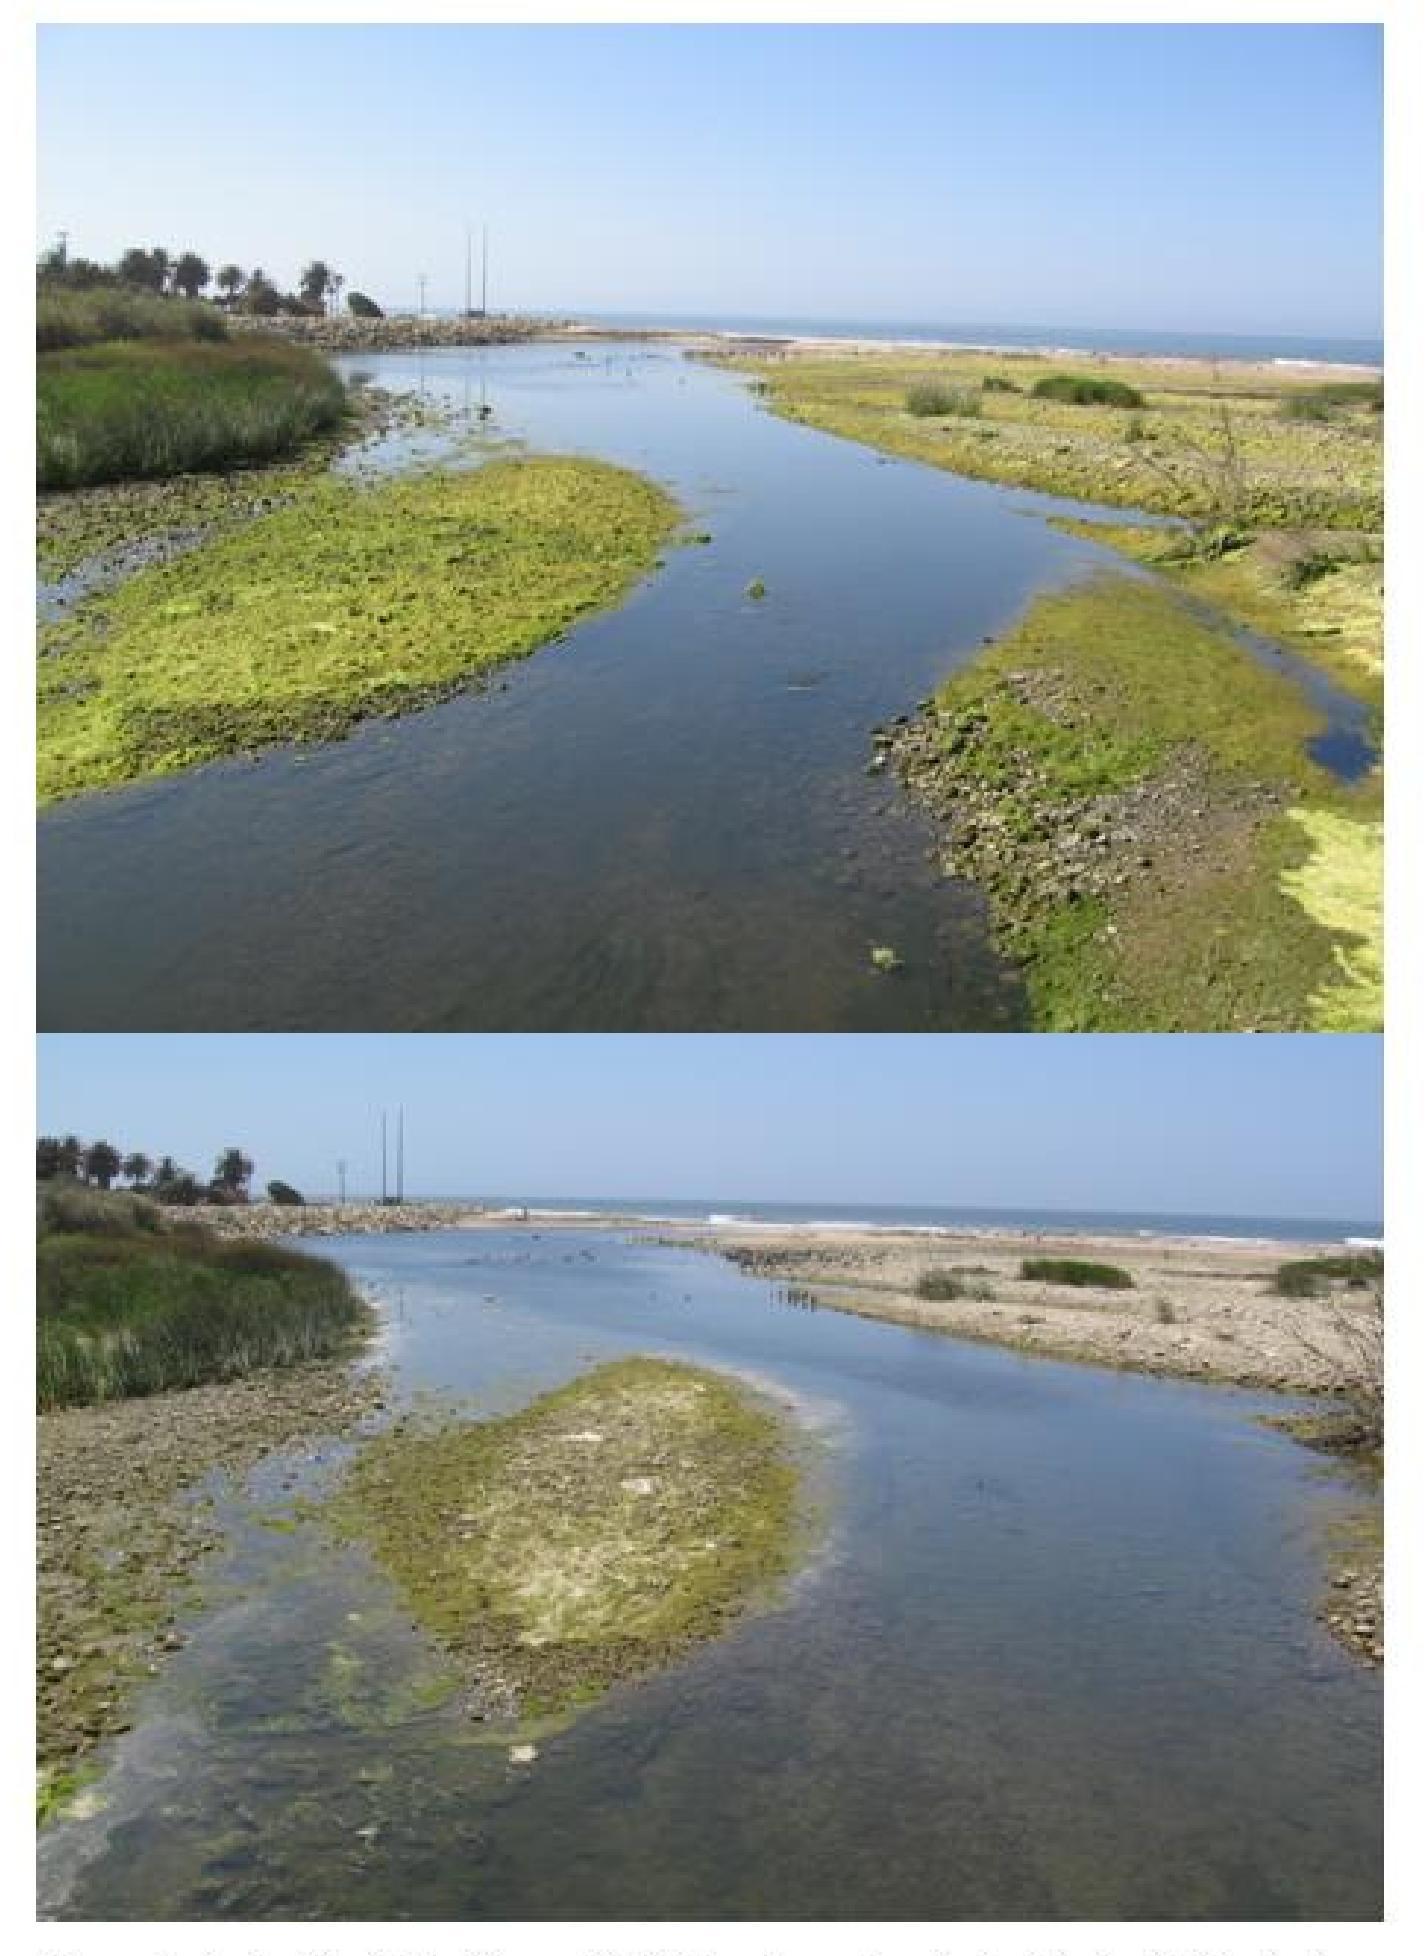
Figure 5. Again, illustrating the rapid tidal cleaning-out and algal-drying that took place between June 5 (top) and June 7 (bottom).
