July 15, 2008

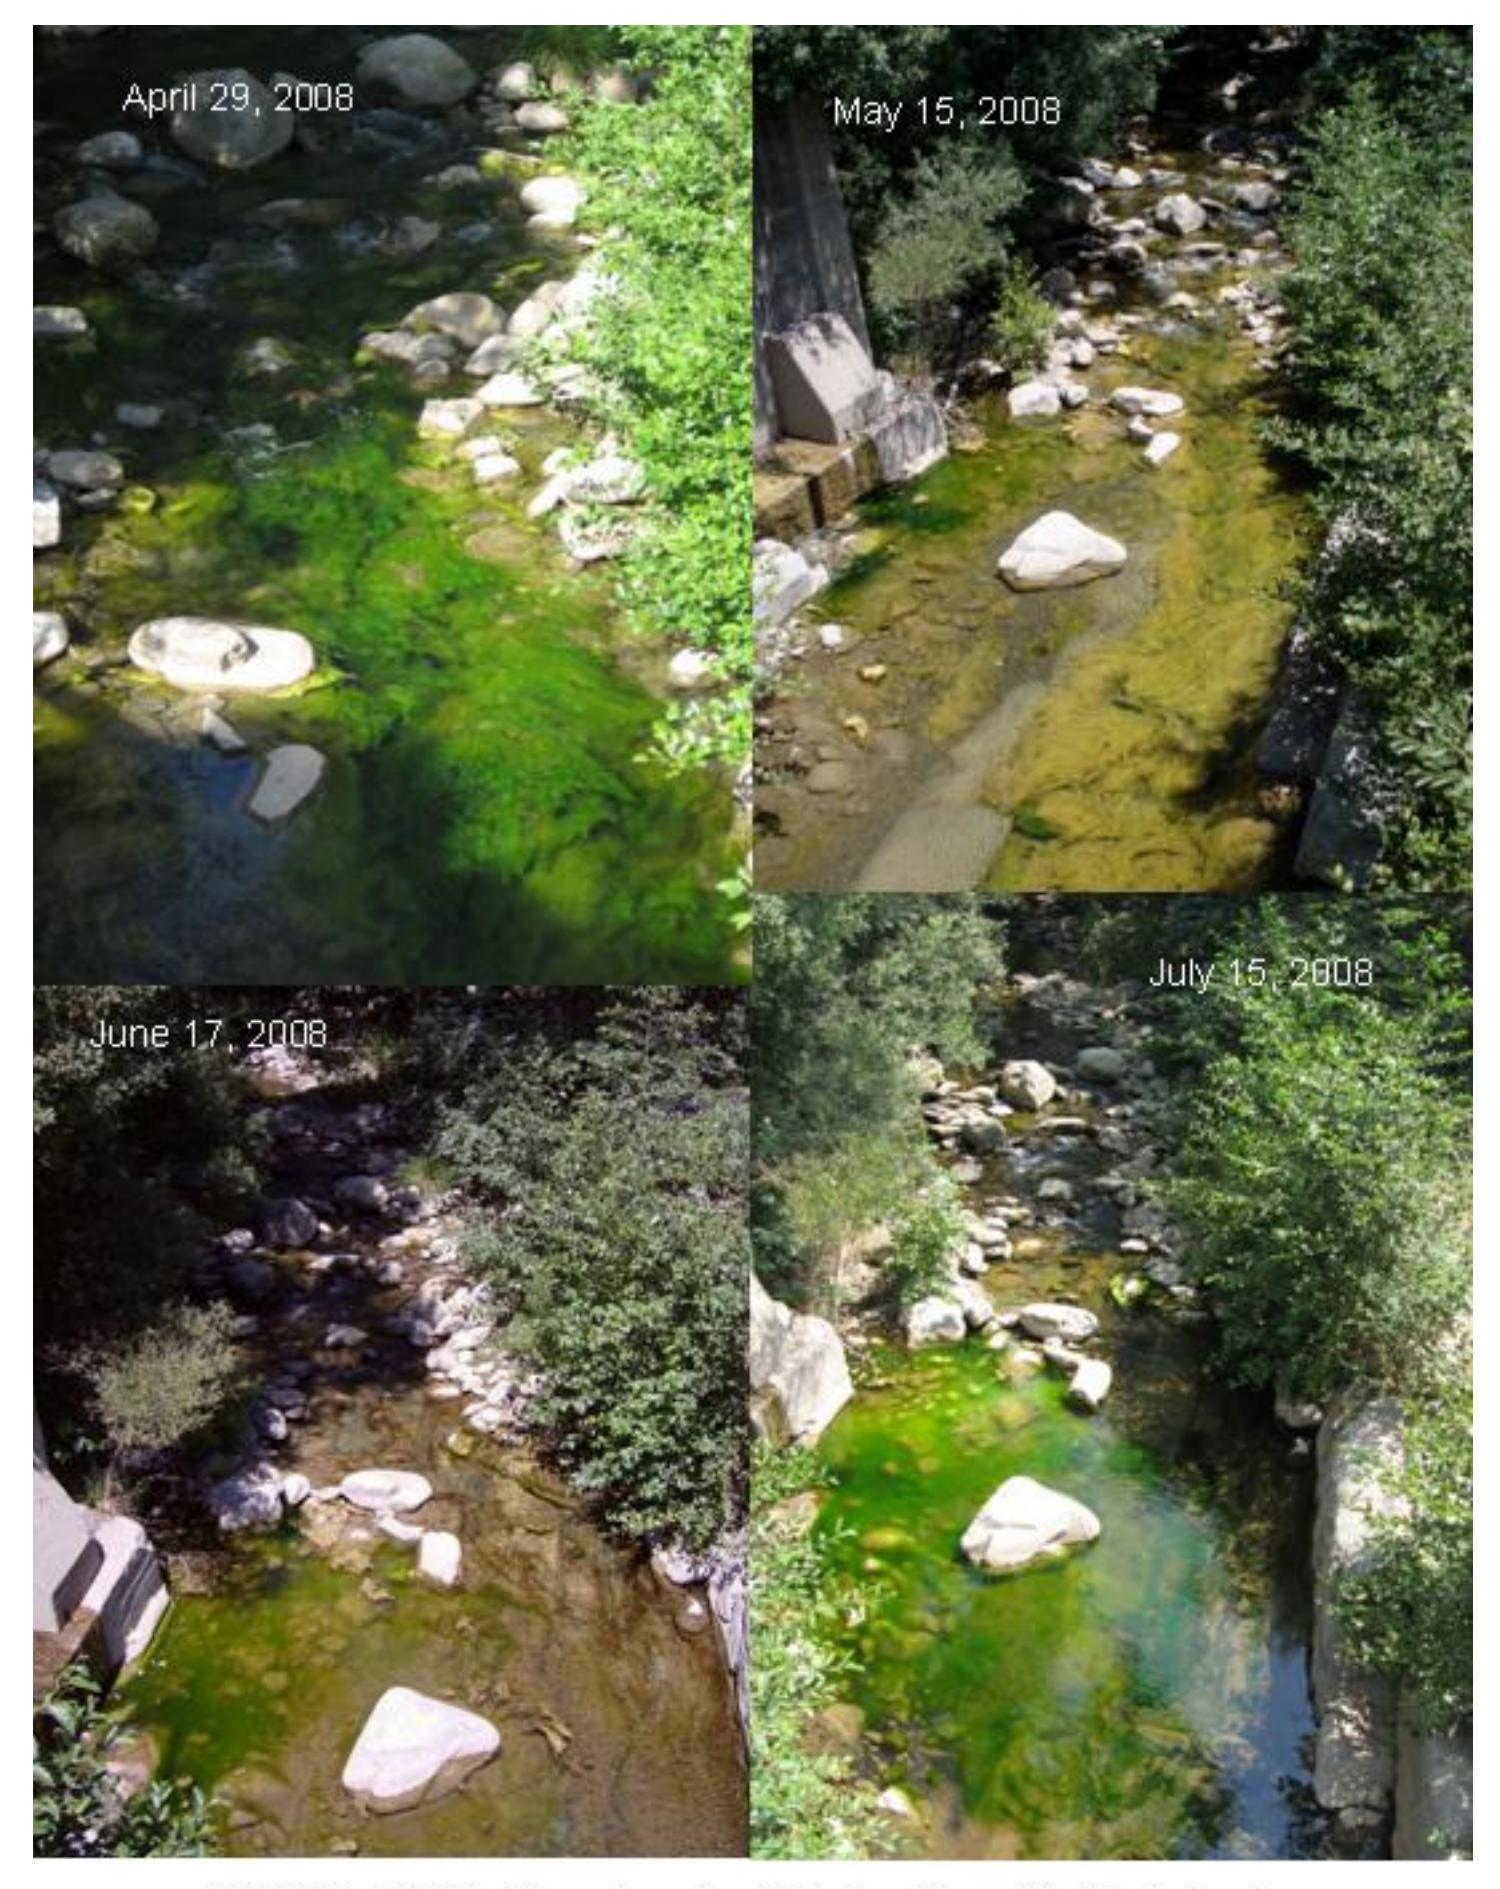
Figure 1. VR14, looking upstream from the bridge at the pool by the abutment.

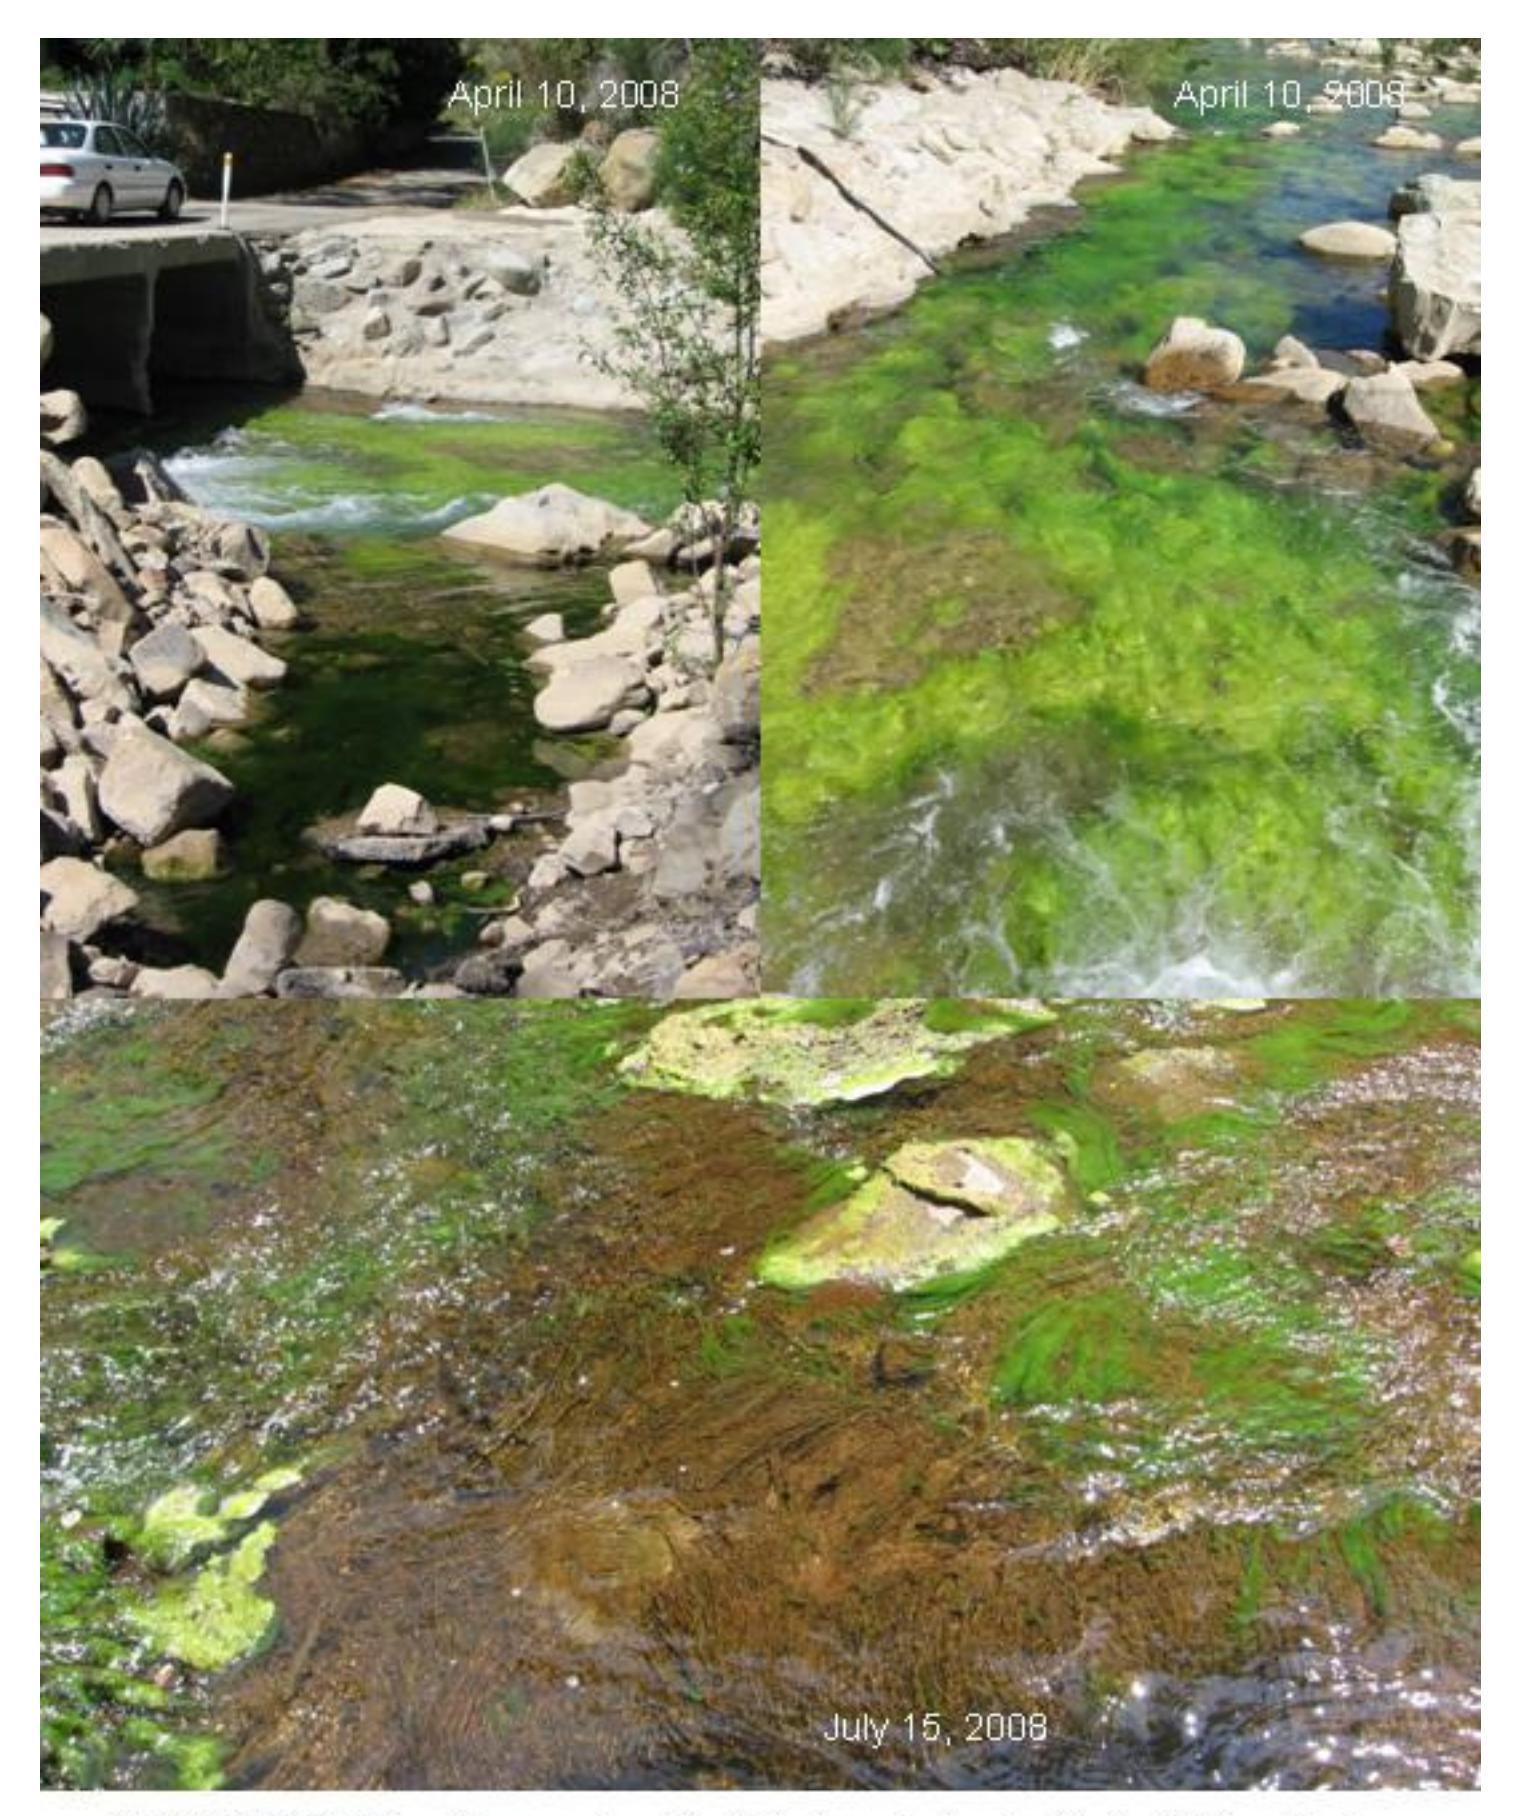
Figure 3. VR12.9: The pale green color of the cladophora struck me back in April. The cladophora, long dead, is now topped, in this section of rapid flow, with new spirogyra – also pale green. Meanwhile, side-channel spirogyra (in foreground of upper left photo) was dark green then and is still dark green.

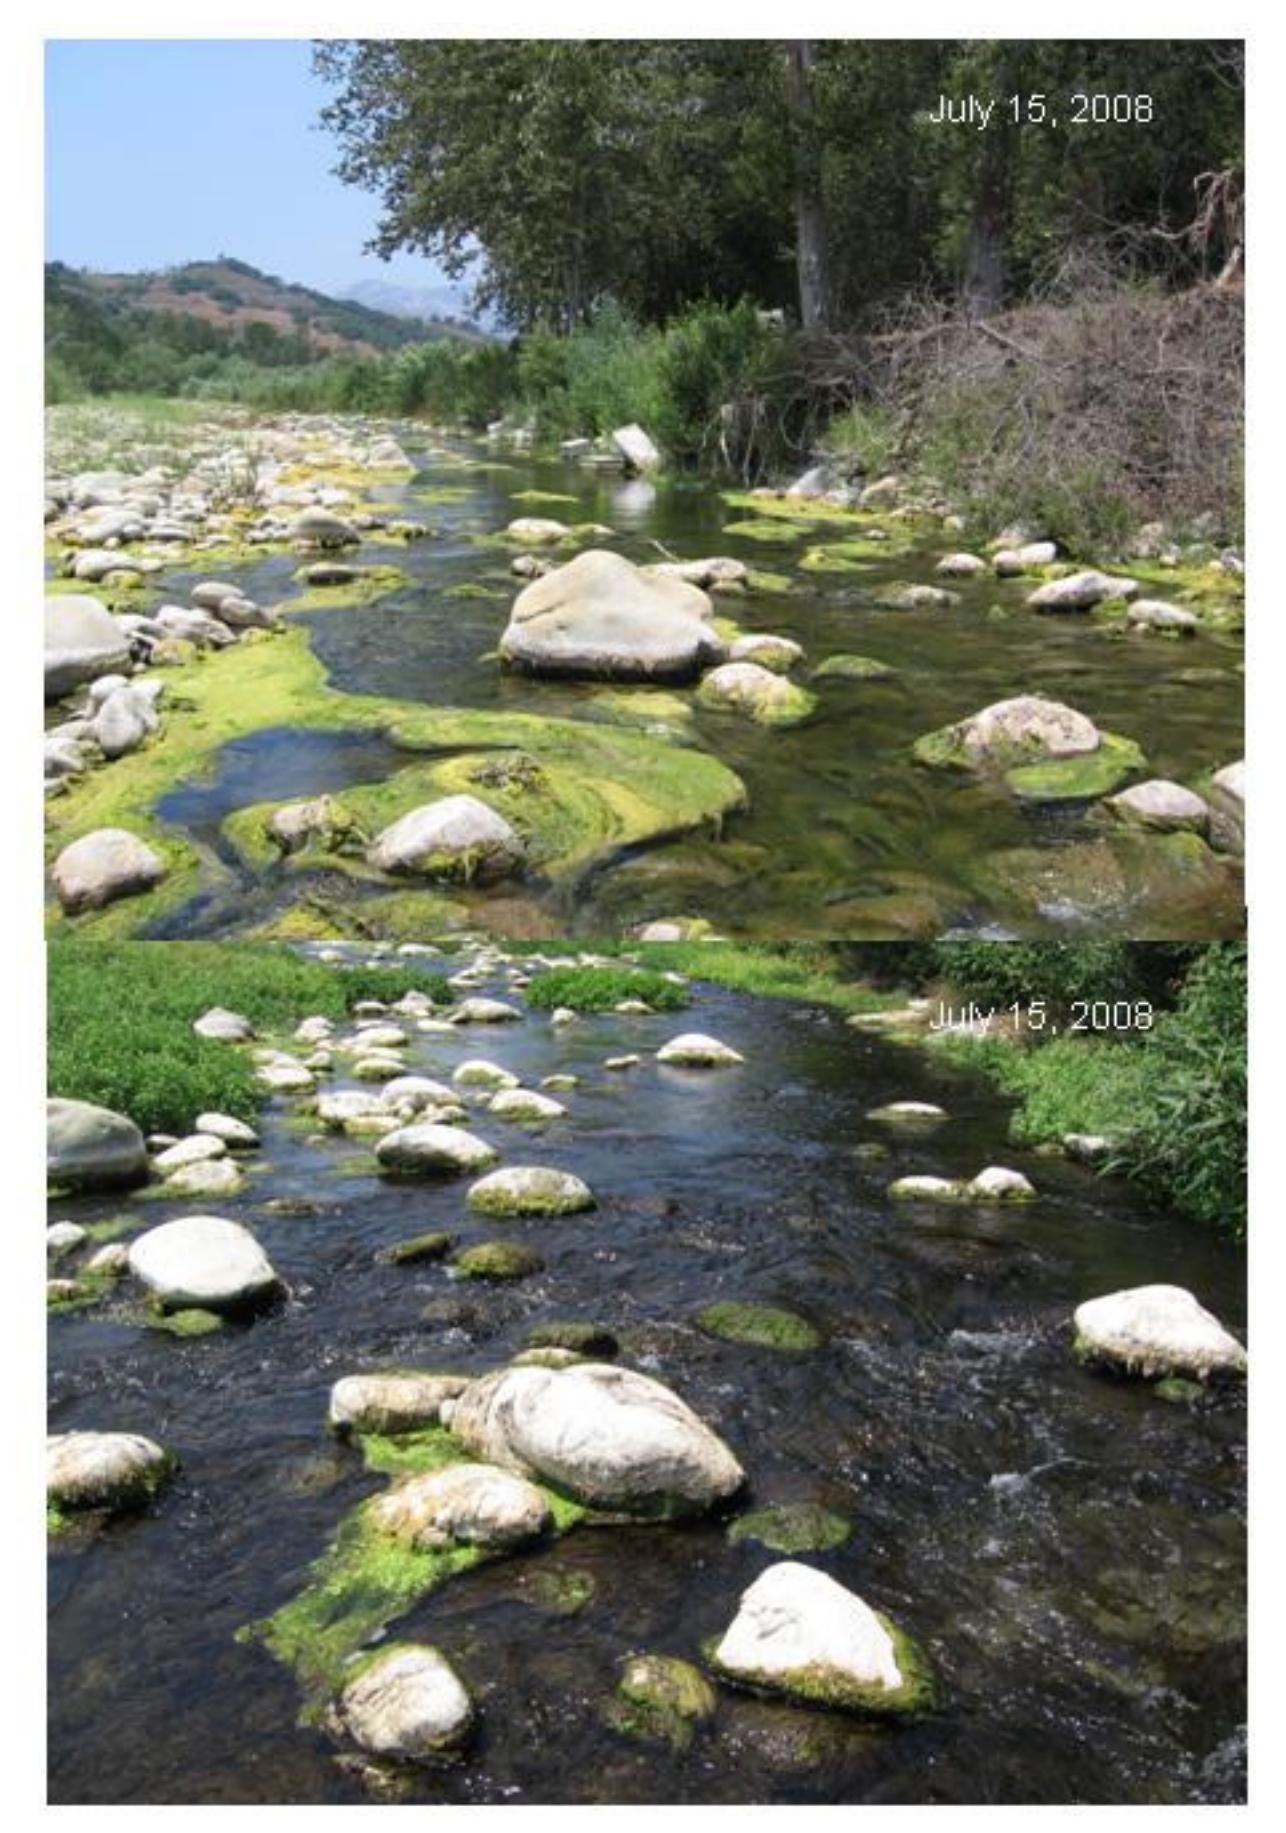
Algae at VR06.3, just above the San Antonio confluence, was fading, but still active. This is in contrast with the dead cladophora found everywhere in the main channel below the Ojai Sewage Treatment Plant (Figure 4). In these reaches, diatoms have colonized the dead clado and dominate the river bottom, giving the water a decidedly dark-brown cast (Figure 5, see also 4 & 6). The interesting question is why? Was it simply time for cladophora on the lower river to go? And if so, why is it still going reasonably strong at the San Antonio confluence (and at Foster Park), i.e., above the treatment plant? Julie and I saw something like this back in 2003 – cladophora still highly productive at Foster Park, dead at Shell Road – and speculated on the possibility of some deleterious substance in treatment plant outflow killing off cladophora, but presenting far less of a detriment to diatoms. We decided then that it would be impossible to prove, but that this phenomena is occurring when treatment plant outflows are increasingly dominating lower-river flow is suggestive (treatment plant outflows now provide about 35 % of total lower-river flow compared with 17 % on June 17th).

Figure 4. (top) VR06.3, the Ventura River just above the San Antonio confluence. (bottom) VR03.5, just above the Canada Larga confluence (and below the Ojai Sewage Treatment Plant.

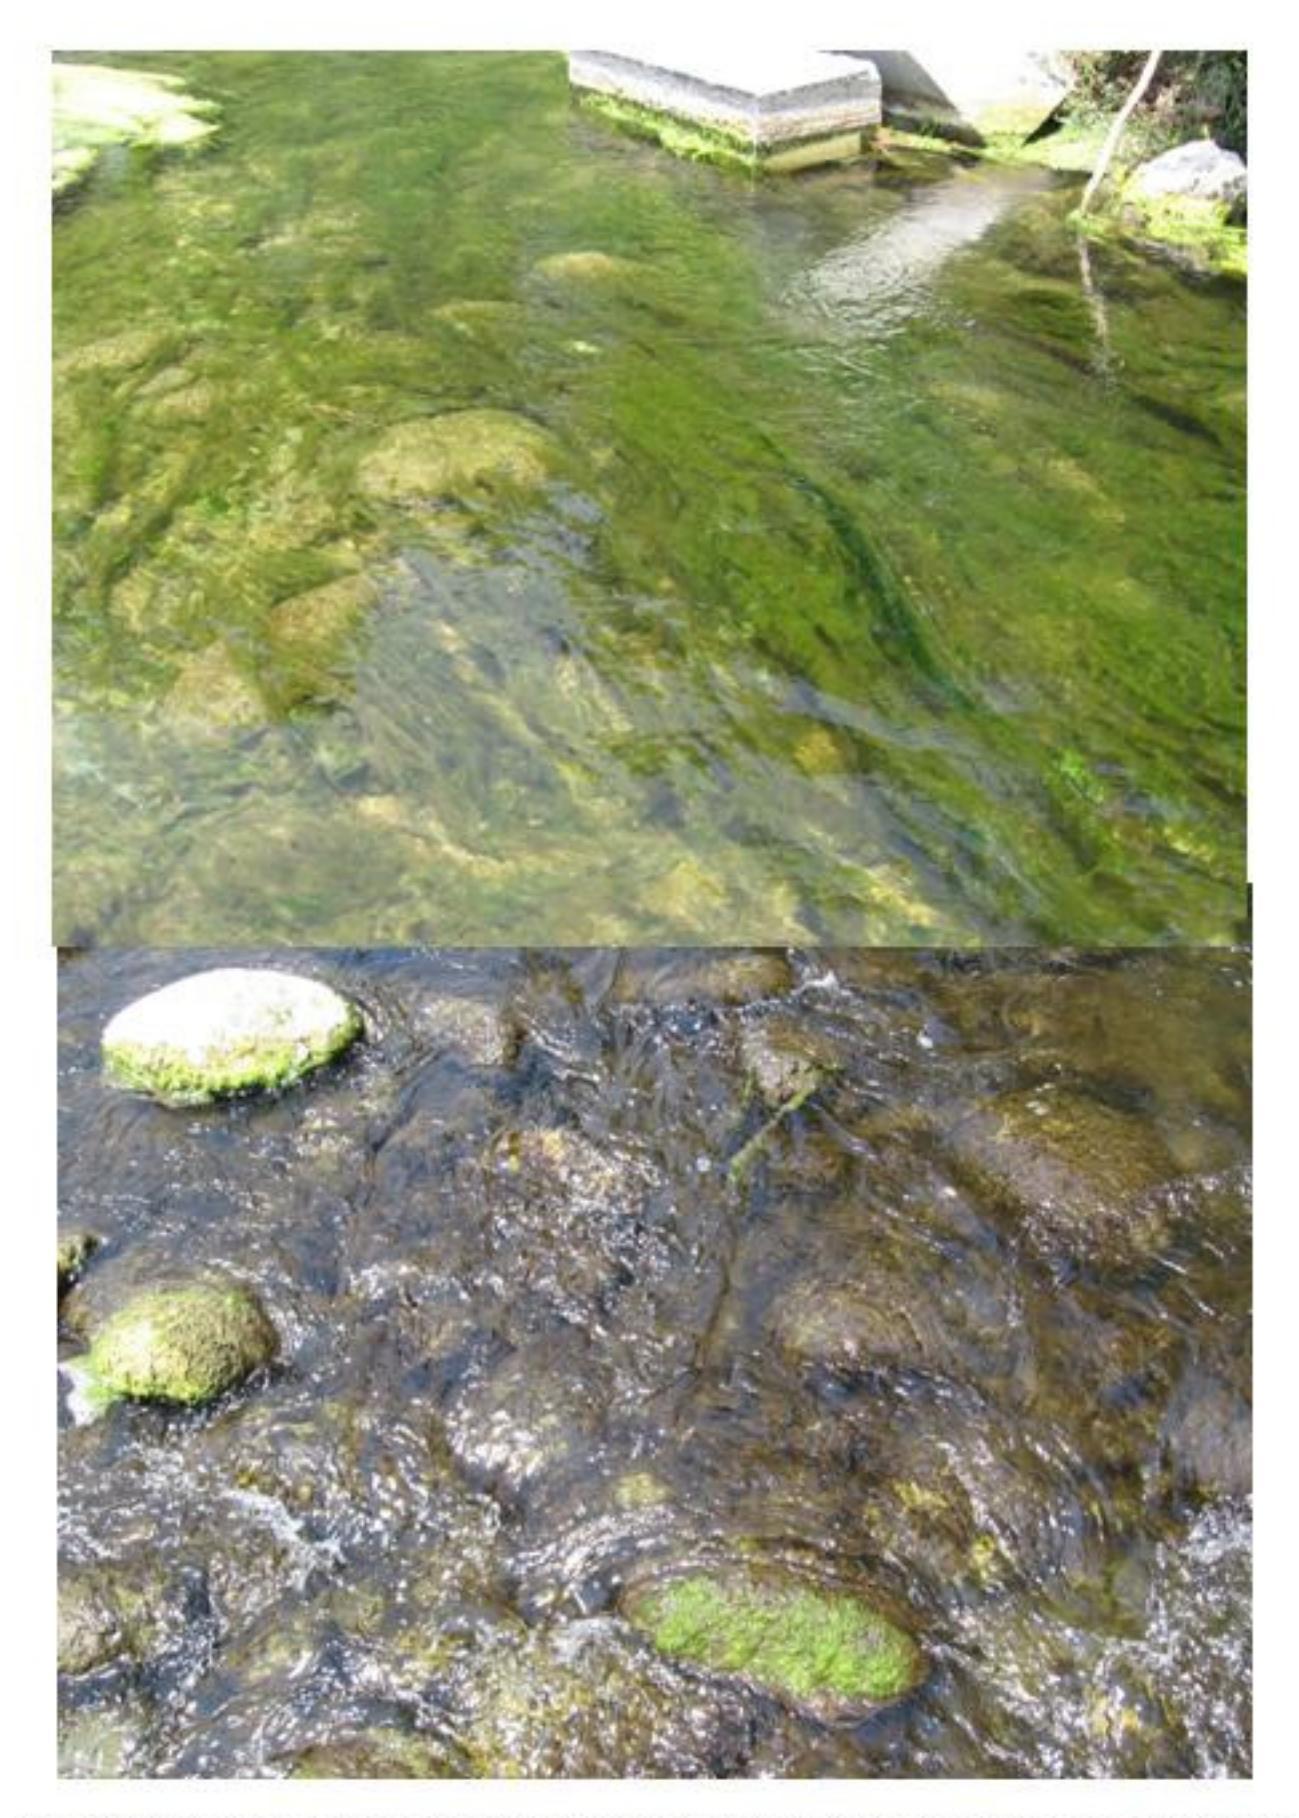
Figure 5. Algal close-ups, July 15, 2008: (top) VR06.3 (just above the San Antonio confluence); (bottom) VR03.5 (just below the Ojai Sewage Treatment Plant).

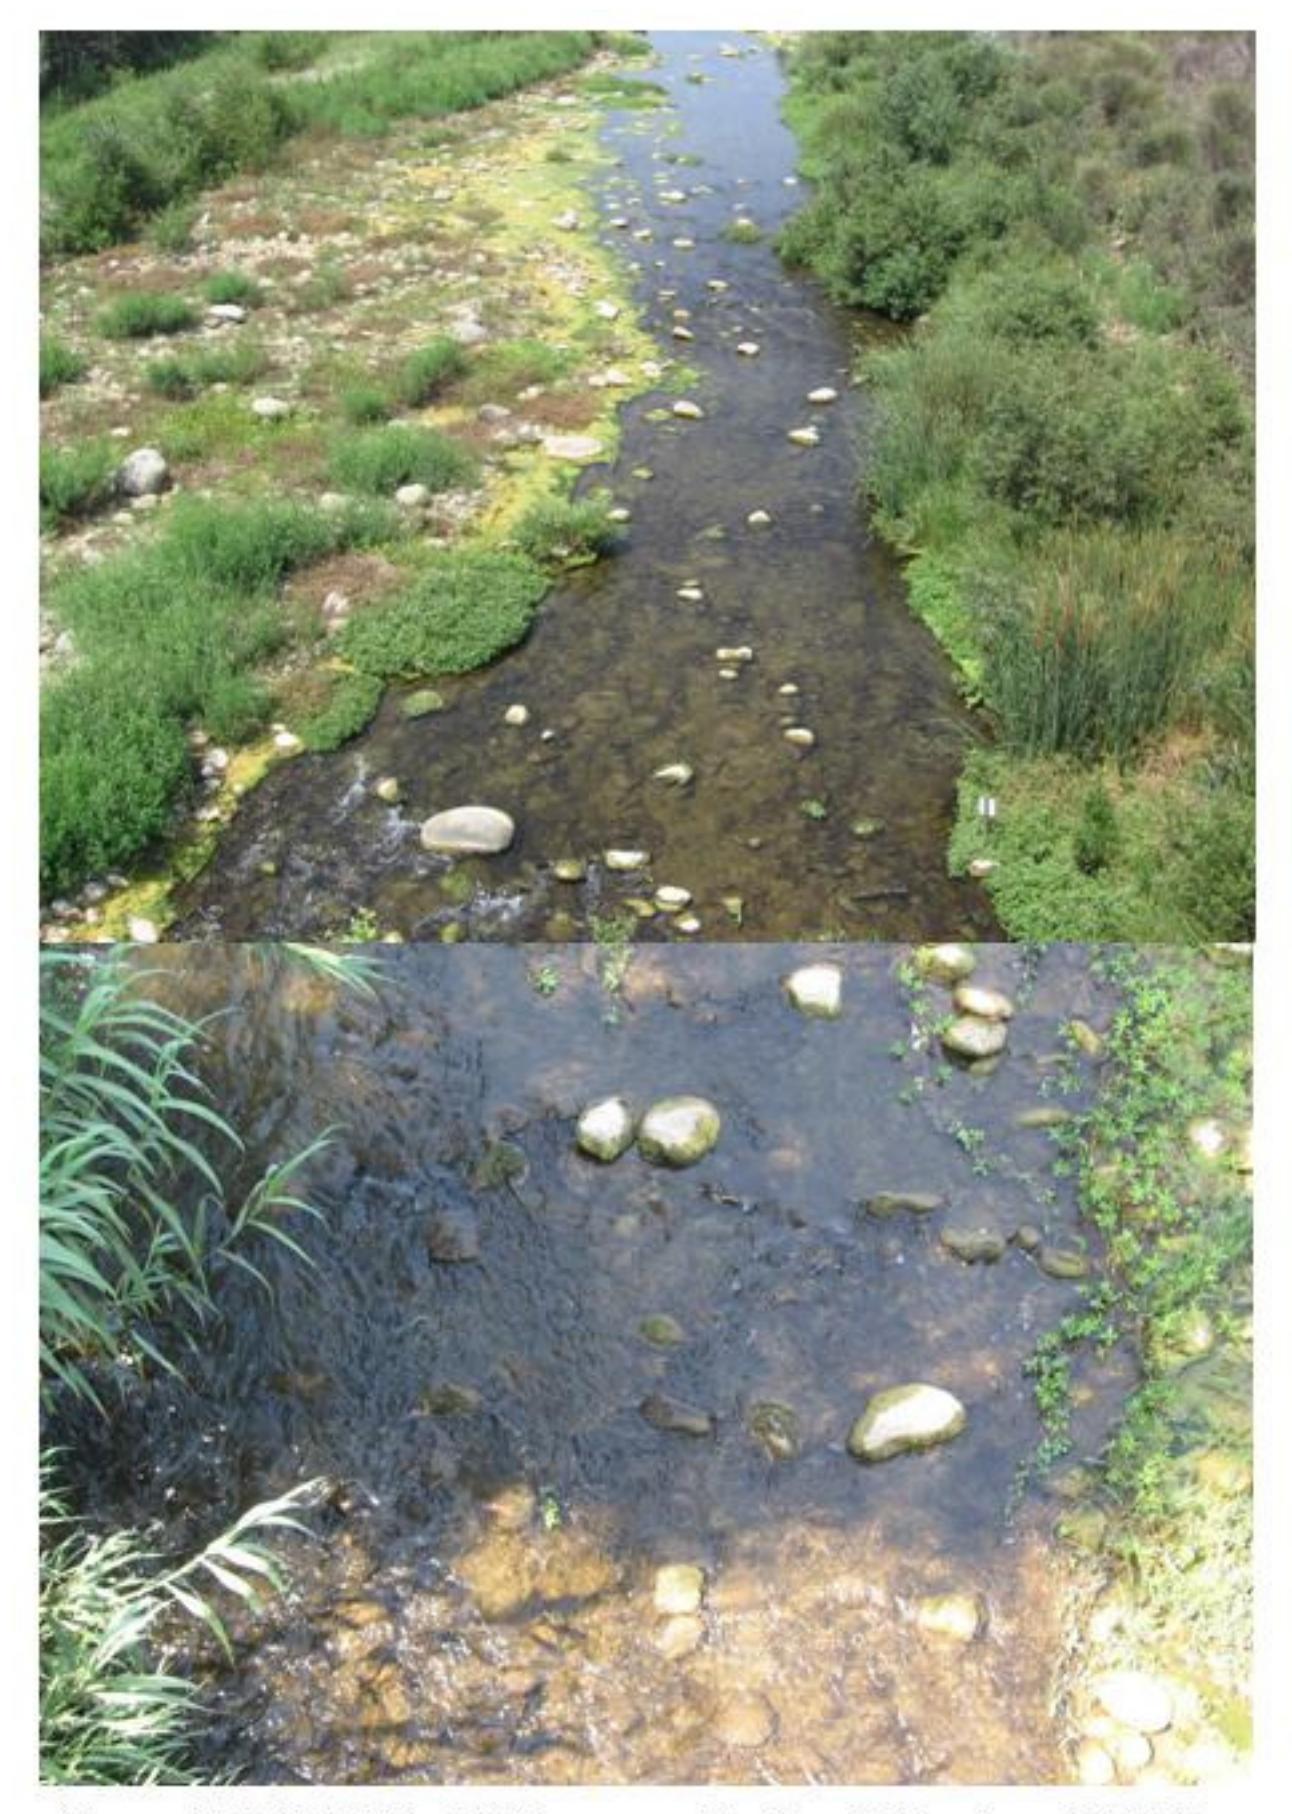
Figure 6. July 15, 2008, (top) VR03 upstream of Shell Road Bridge, (bottom) VR01 (just upstream of Main Street Bridge. Note dead cladophora in both locations.

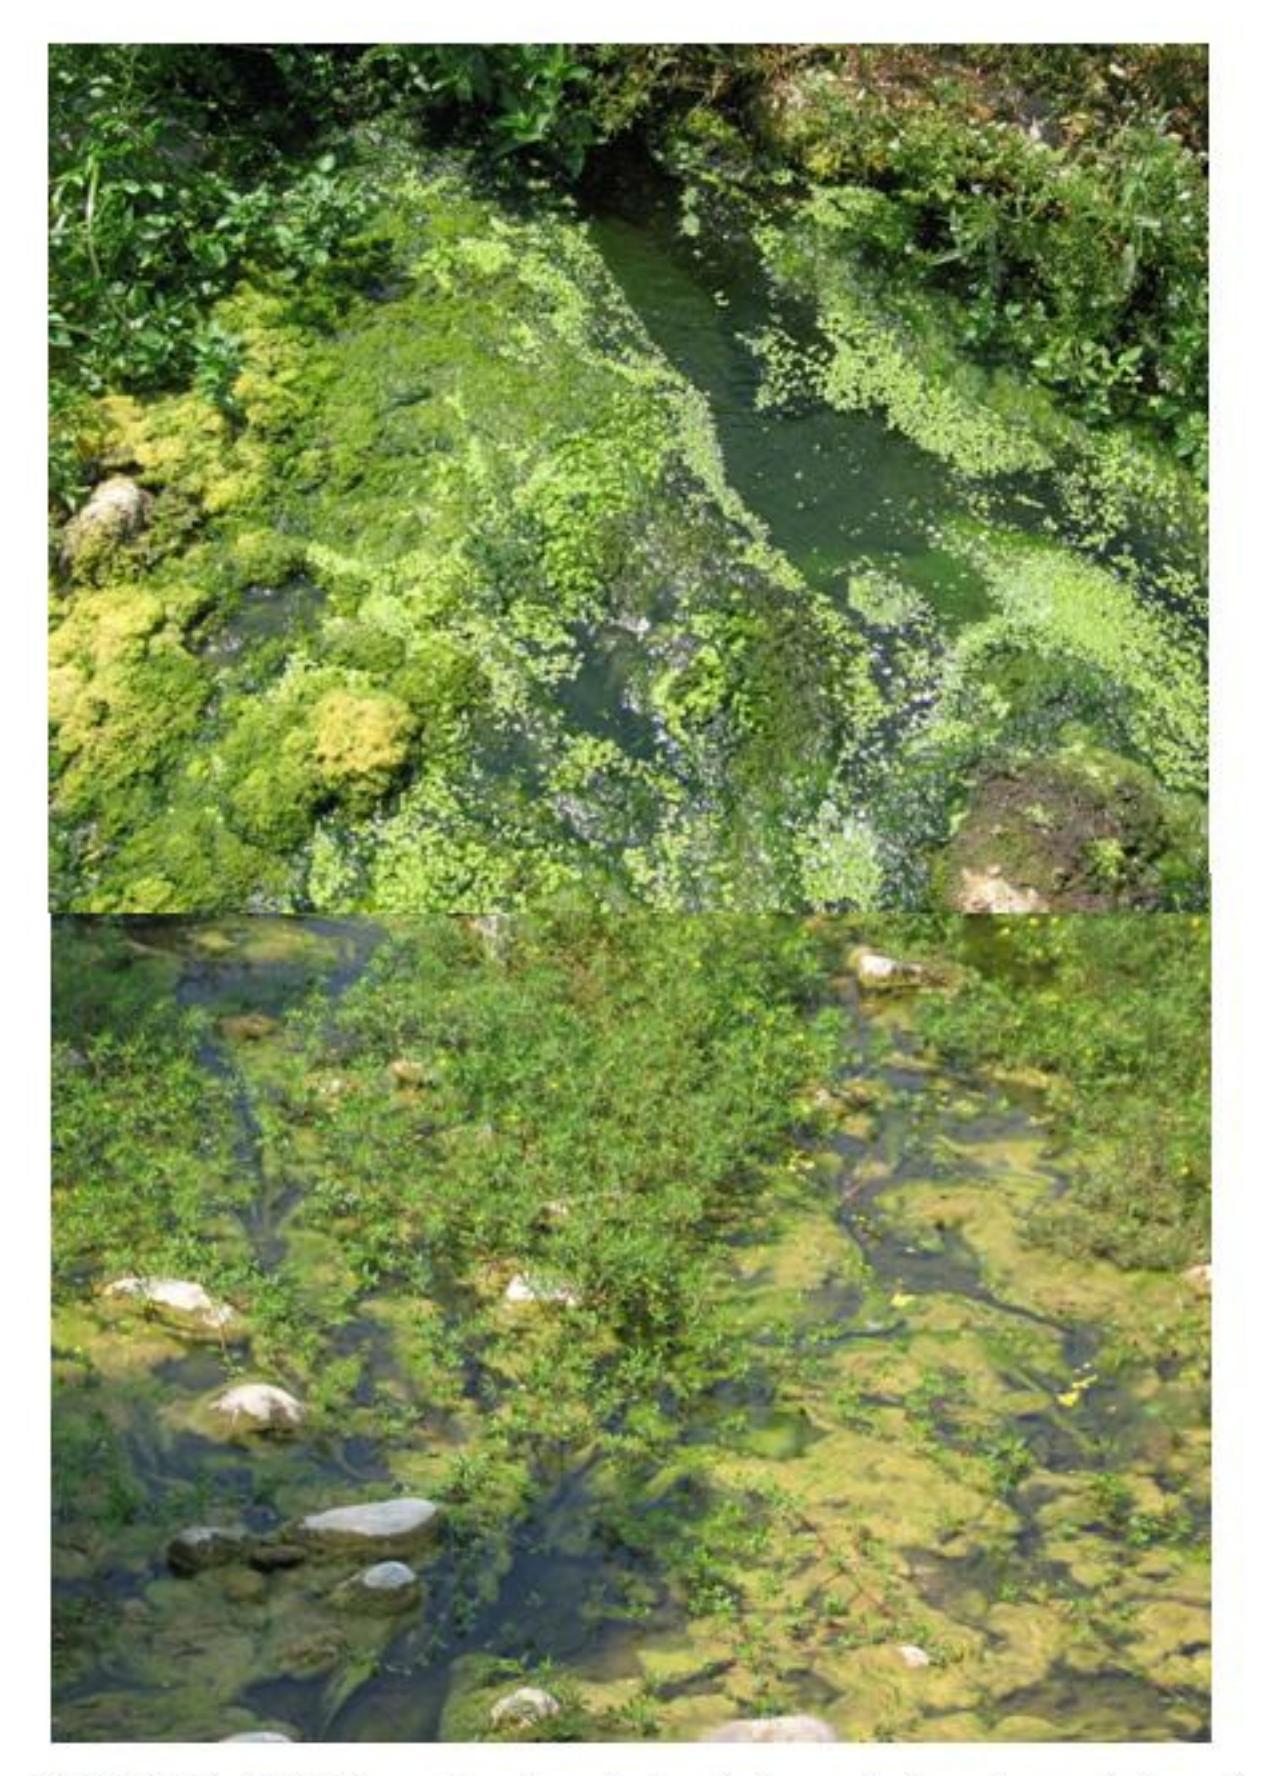
Also suggestive are patches of still active cladophora found at edges of the main channel. Figure 7 (and the upper photo in Figure 6) shows some of this. These areas are characterized by very low or stagnant flows, often trickles that first flow over soil (as is the case in both Figure 7 photos). As in 2003, there is no way to prove, or disprove, this possibility since it may have as easily been caused by some discrete event in the past as by some ever present effluent constituent.

Figure 7. July 15, 2008, away from the main channel algae on the lower river are doing much better. On top, cladophora, spirogyra and duckweed adjacent to the island at VR03.5; on bottom, cladophora and Ludwiga in the ponded area to the west of the main channel.

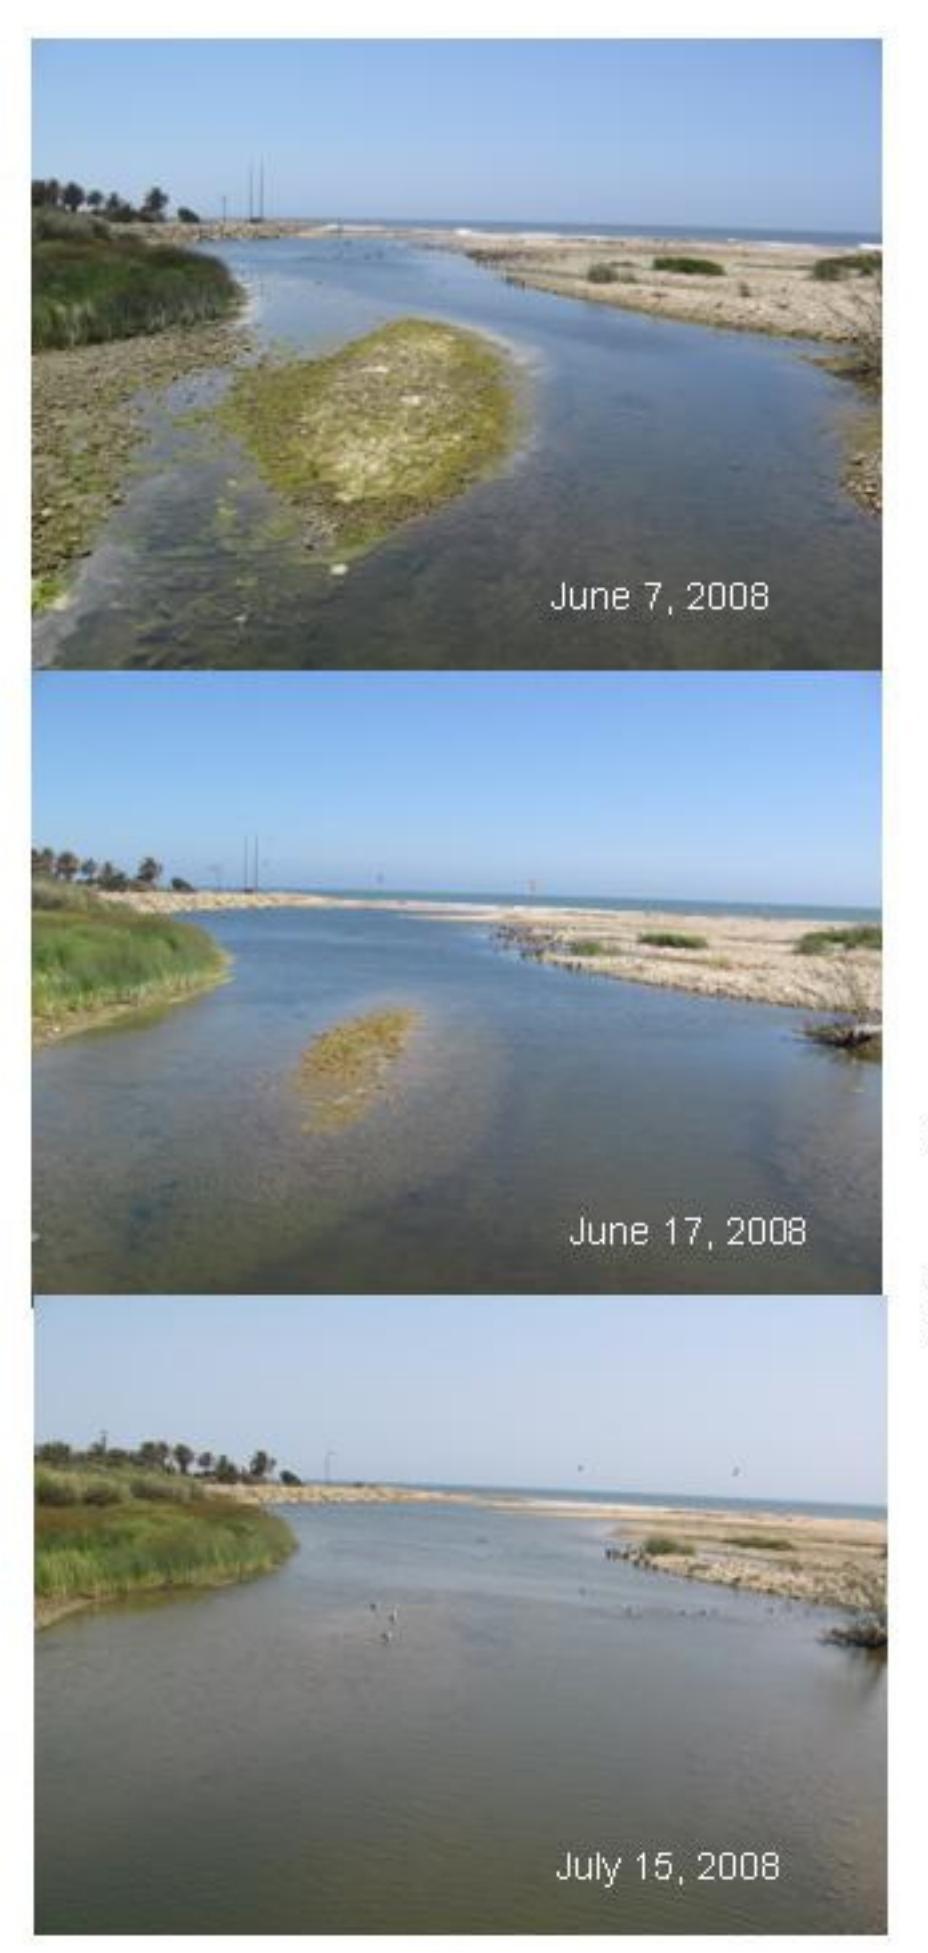
Figure 9. Looking towards the ocean from the RR Bridge: the effect of slowly increasing water levels, since the reestablishment of the sand-berm, can be seen on the nowsubmerged island in the foreground. During this period planktonic algae have dominated. The slowness of the water-level rise can probably be attributed to reduced lower-river flows and increased. evapotranspiration.

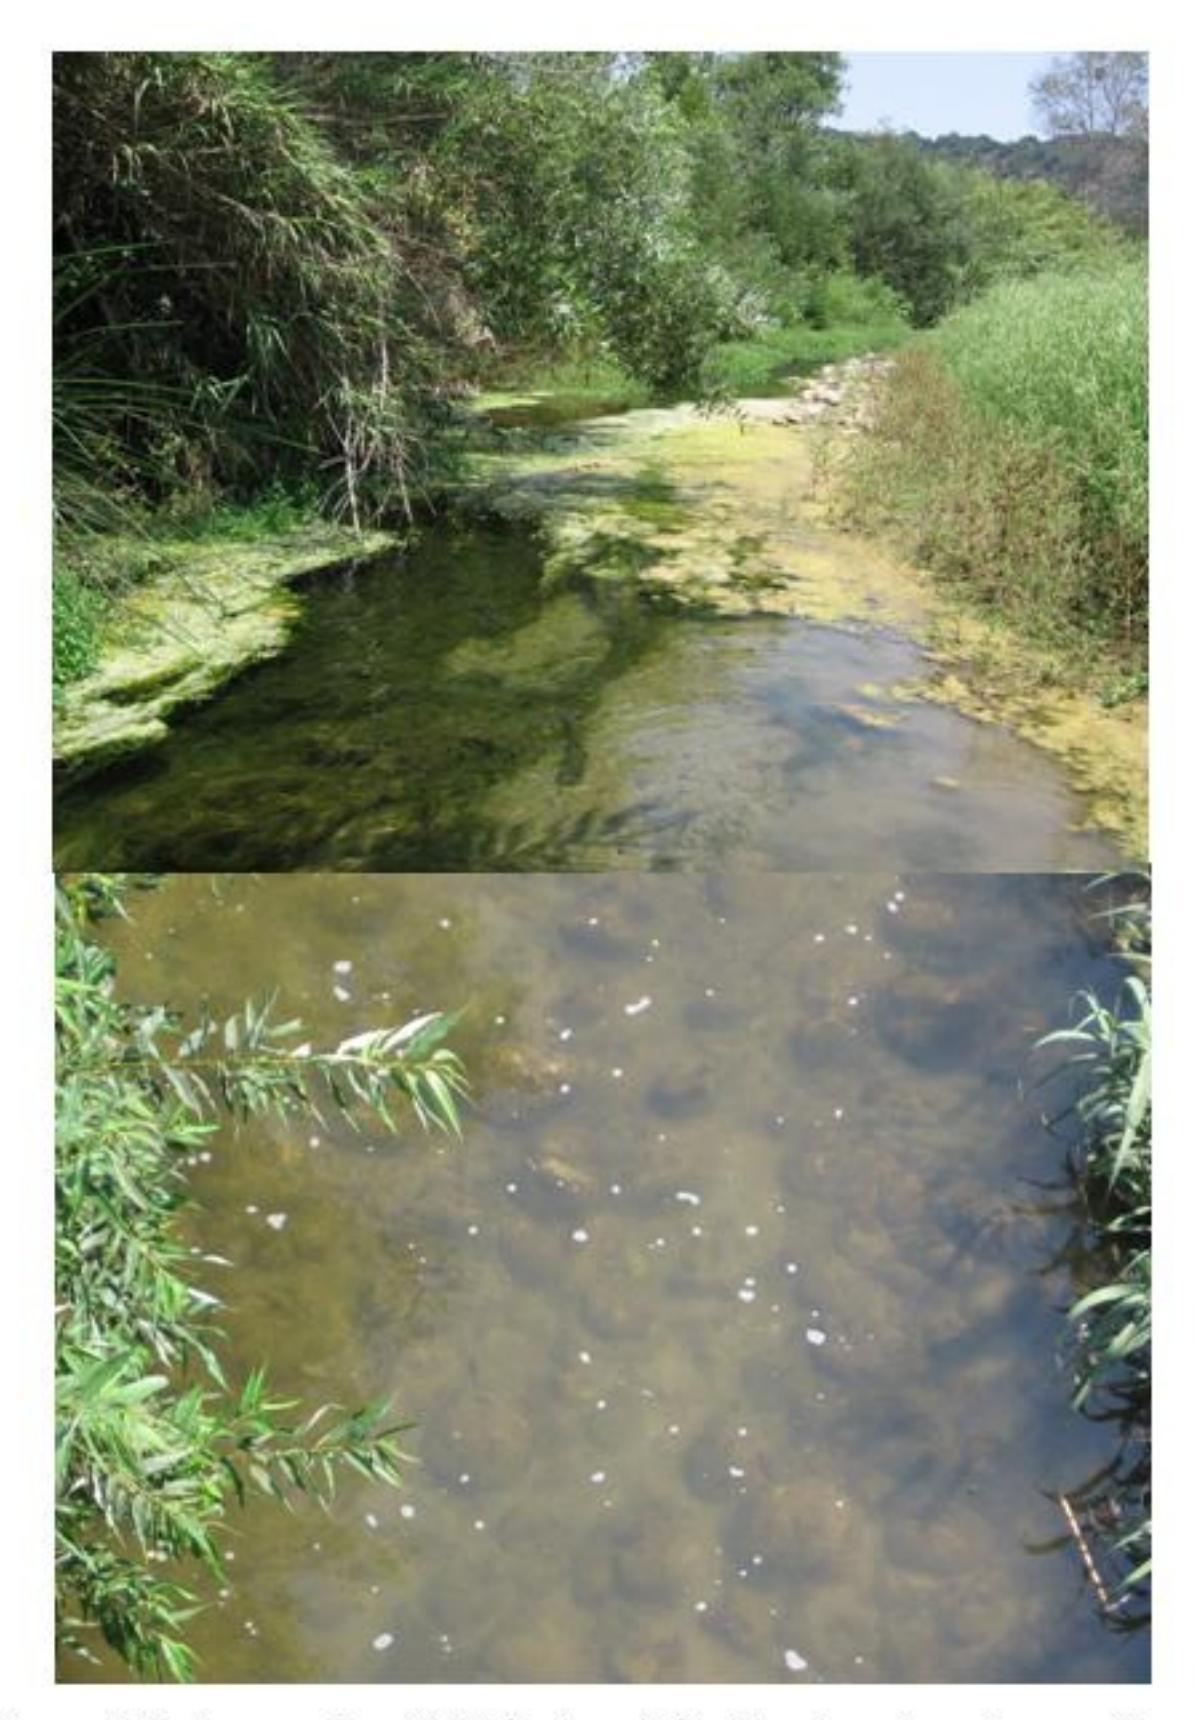
Finally, Figure 10 shows a photo of VR07 (lower San Antonio Creek, it's actually a photo of Kristi's study reach, located below the Channelkeeper site) and one taken from the Main Street Bridge (VR01) of flow immediately downstream. I found the extravagant growth of dense, tall weeds along the south bank of San Antonio interesting – the bank was quite bare on May 16th. I wish my garden would give an equal performance. Lots of algae were still present – all enteromorpha.

The Main Street photo shows appreciable sediment being carried by the flow. This sediment almost certainly originates in agricultural land grading operations taking place on the west bank upstream. This situation has persisted at least since June 7th, and may have also been captured in photos on May 3rd. The Basin Plan has no hard and fast sediment limits, simply stating "waters shall not contain suspended or settleable material in concentrations that cause nuisance or adversely affect beneficial uses." We should carefully monitor turbidity readings taken at this location with an eye on possible fishery impacts. A walk upstream, to identify actual sources of this sediment, would be another good idea.

Figure 10. In the upper photo, VR07, San Antonio Creek just above the confluence. Almost all the algae is enteromorpha. Also notable is the extravagant growth of dense and tall weeds on the right-hand bank. Finally, the sediment problem at VR01 (probably caused by west-bank agricultural land grading operations continues – it has now been over two months – as can be seen by this photo from the Main Street bridge.
