On August 27th Ben and I collected full-suite samples (metals, pesticides, etc., etc.) from the Ventura River, and its San Antonio tributary. We didn't see anything memorable, except at VR03.5, the location just upstream of the Canada Large confluence and a short distance downstream from the Ojai Sewage Treatment Plant.

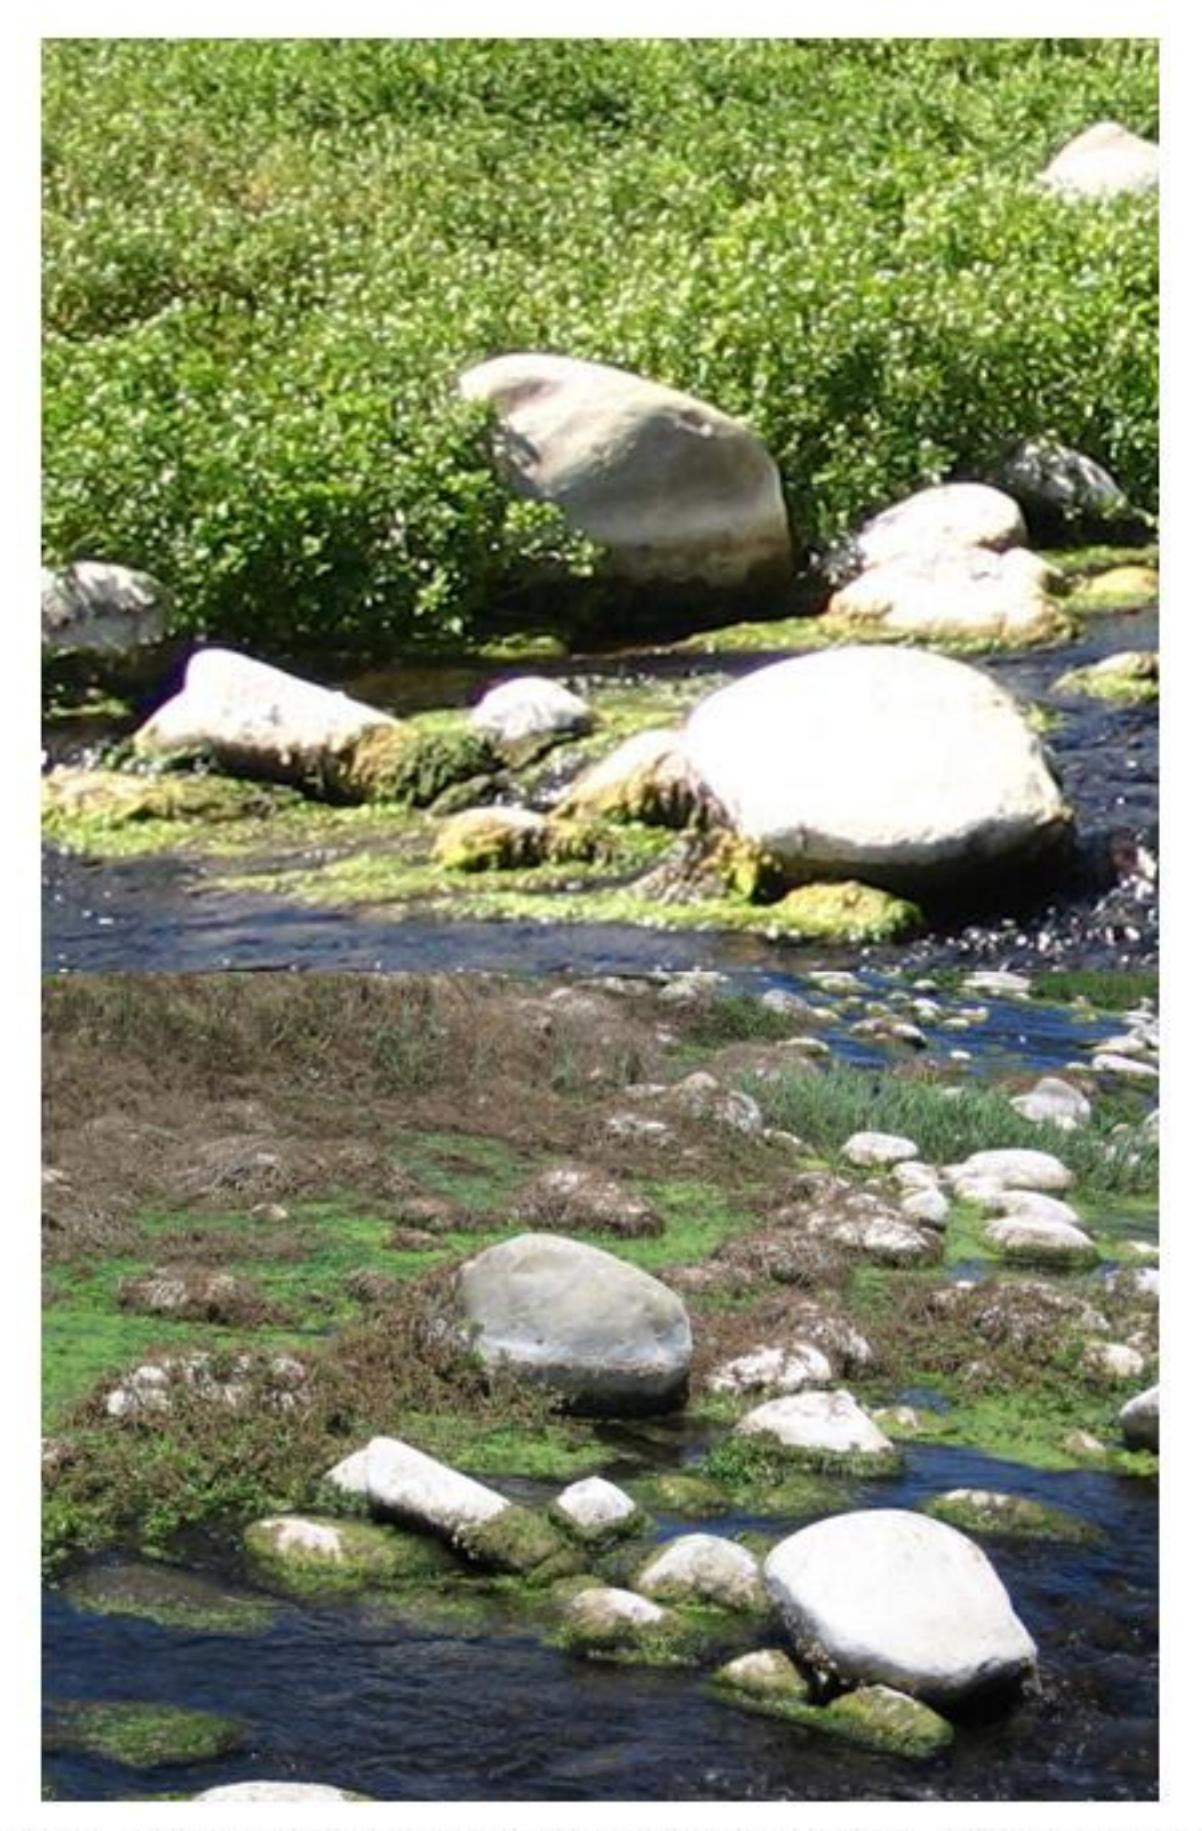
Be that as it may, on the 27th Ben and I saw lots of dead aquatic vegetation at VR03.5. There were noticeable changes since I last visited this location on July 25th, it looked a hell of a lot like someone got carried away with a sprayer filled with Roundup. Figure 1 gives a close-up view of the changes between the two dates. The aquatic plants are probably watercress. I say "probably" because I can not positively identify them in the photos, but they appear to be watercress (identifiable dead stalks were a mixture of watercress and the veronica that's also quite common). Figure 2 is a more distant view of what I'm calling the "island." The river splits upstream of this location leaving this relatively marshy center area of aquatic vegetation.

Figure 1. VR03.5, the same rock group is shown in both photos: above – July 25, 2008; below – August 27. Note that the aquatic plants (probably watercress) are now dead.

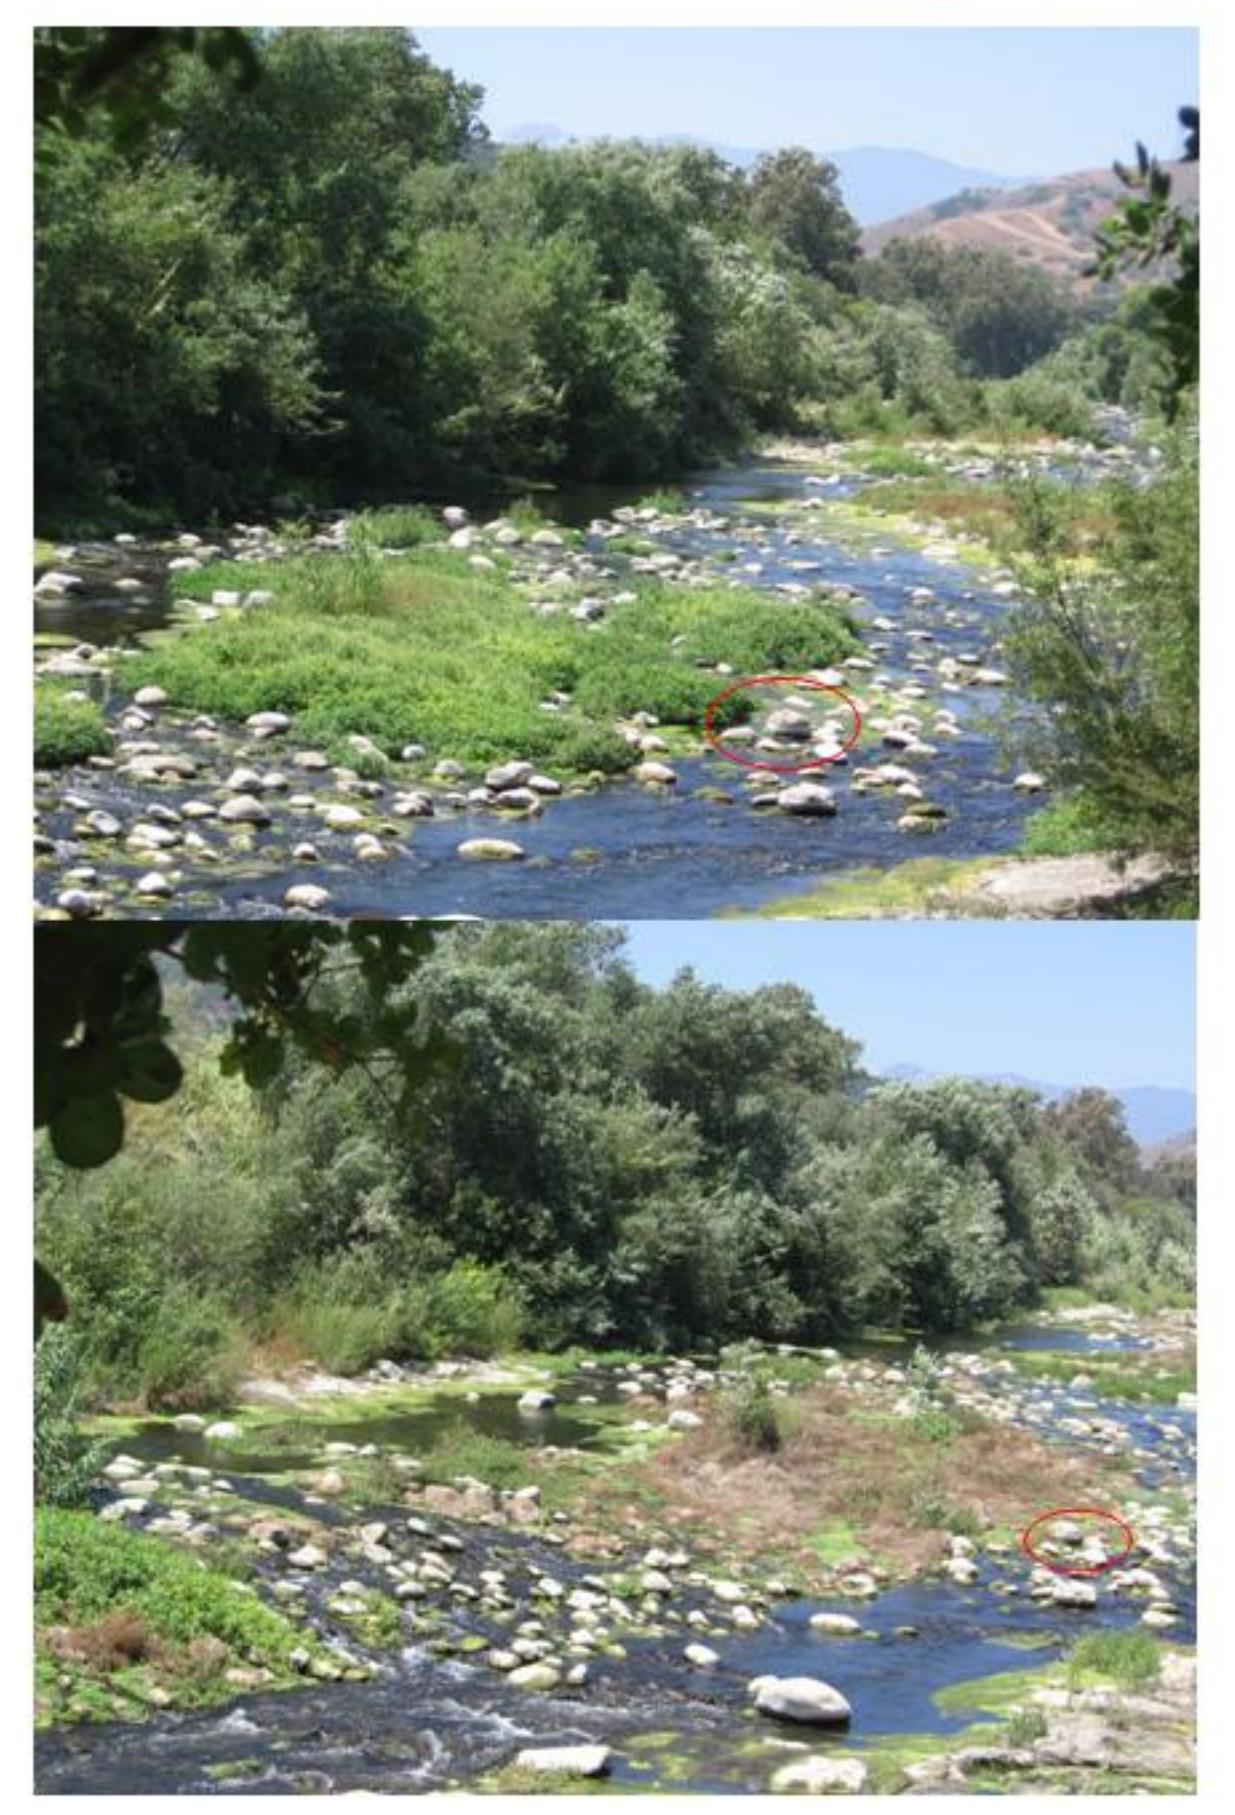
Figure 2. VR03.5, a more distant view of the "island": above –June 17, 2008; below – August 27, 2008. I've circled the rock group shown in Figure 1 in both photos.

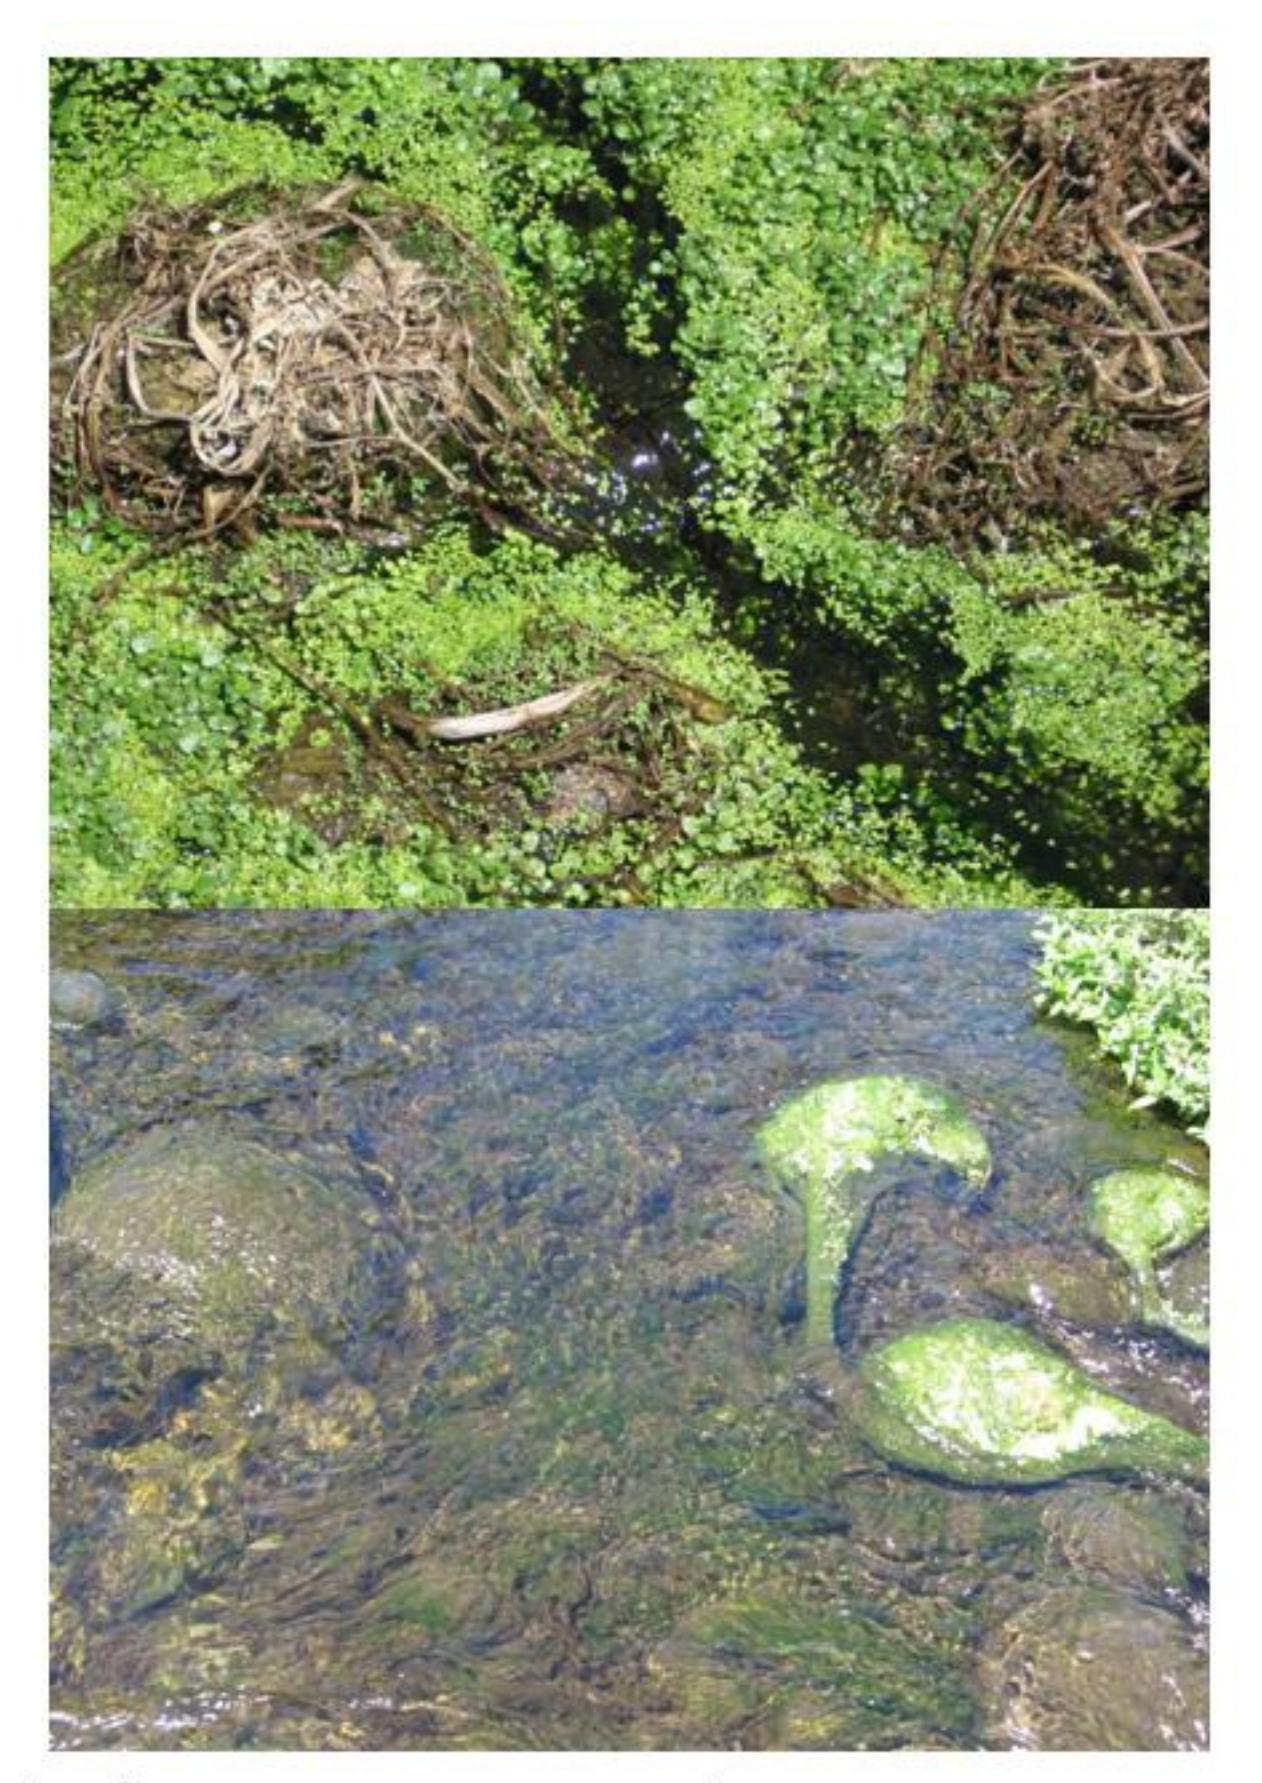
Figure 3. VR03.5, other changes noted on August 27th: above – spyrogyra and new watercress (with a duckweed dusting) growing between patches of dead vegetation; below – cladophora is making a comeback in the main channel – new growth on old dead patches; or is it resurrection?
