## A Darth of Riparian Vegetation: lack of sediment or lack of water?

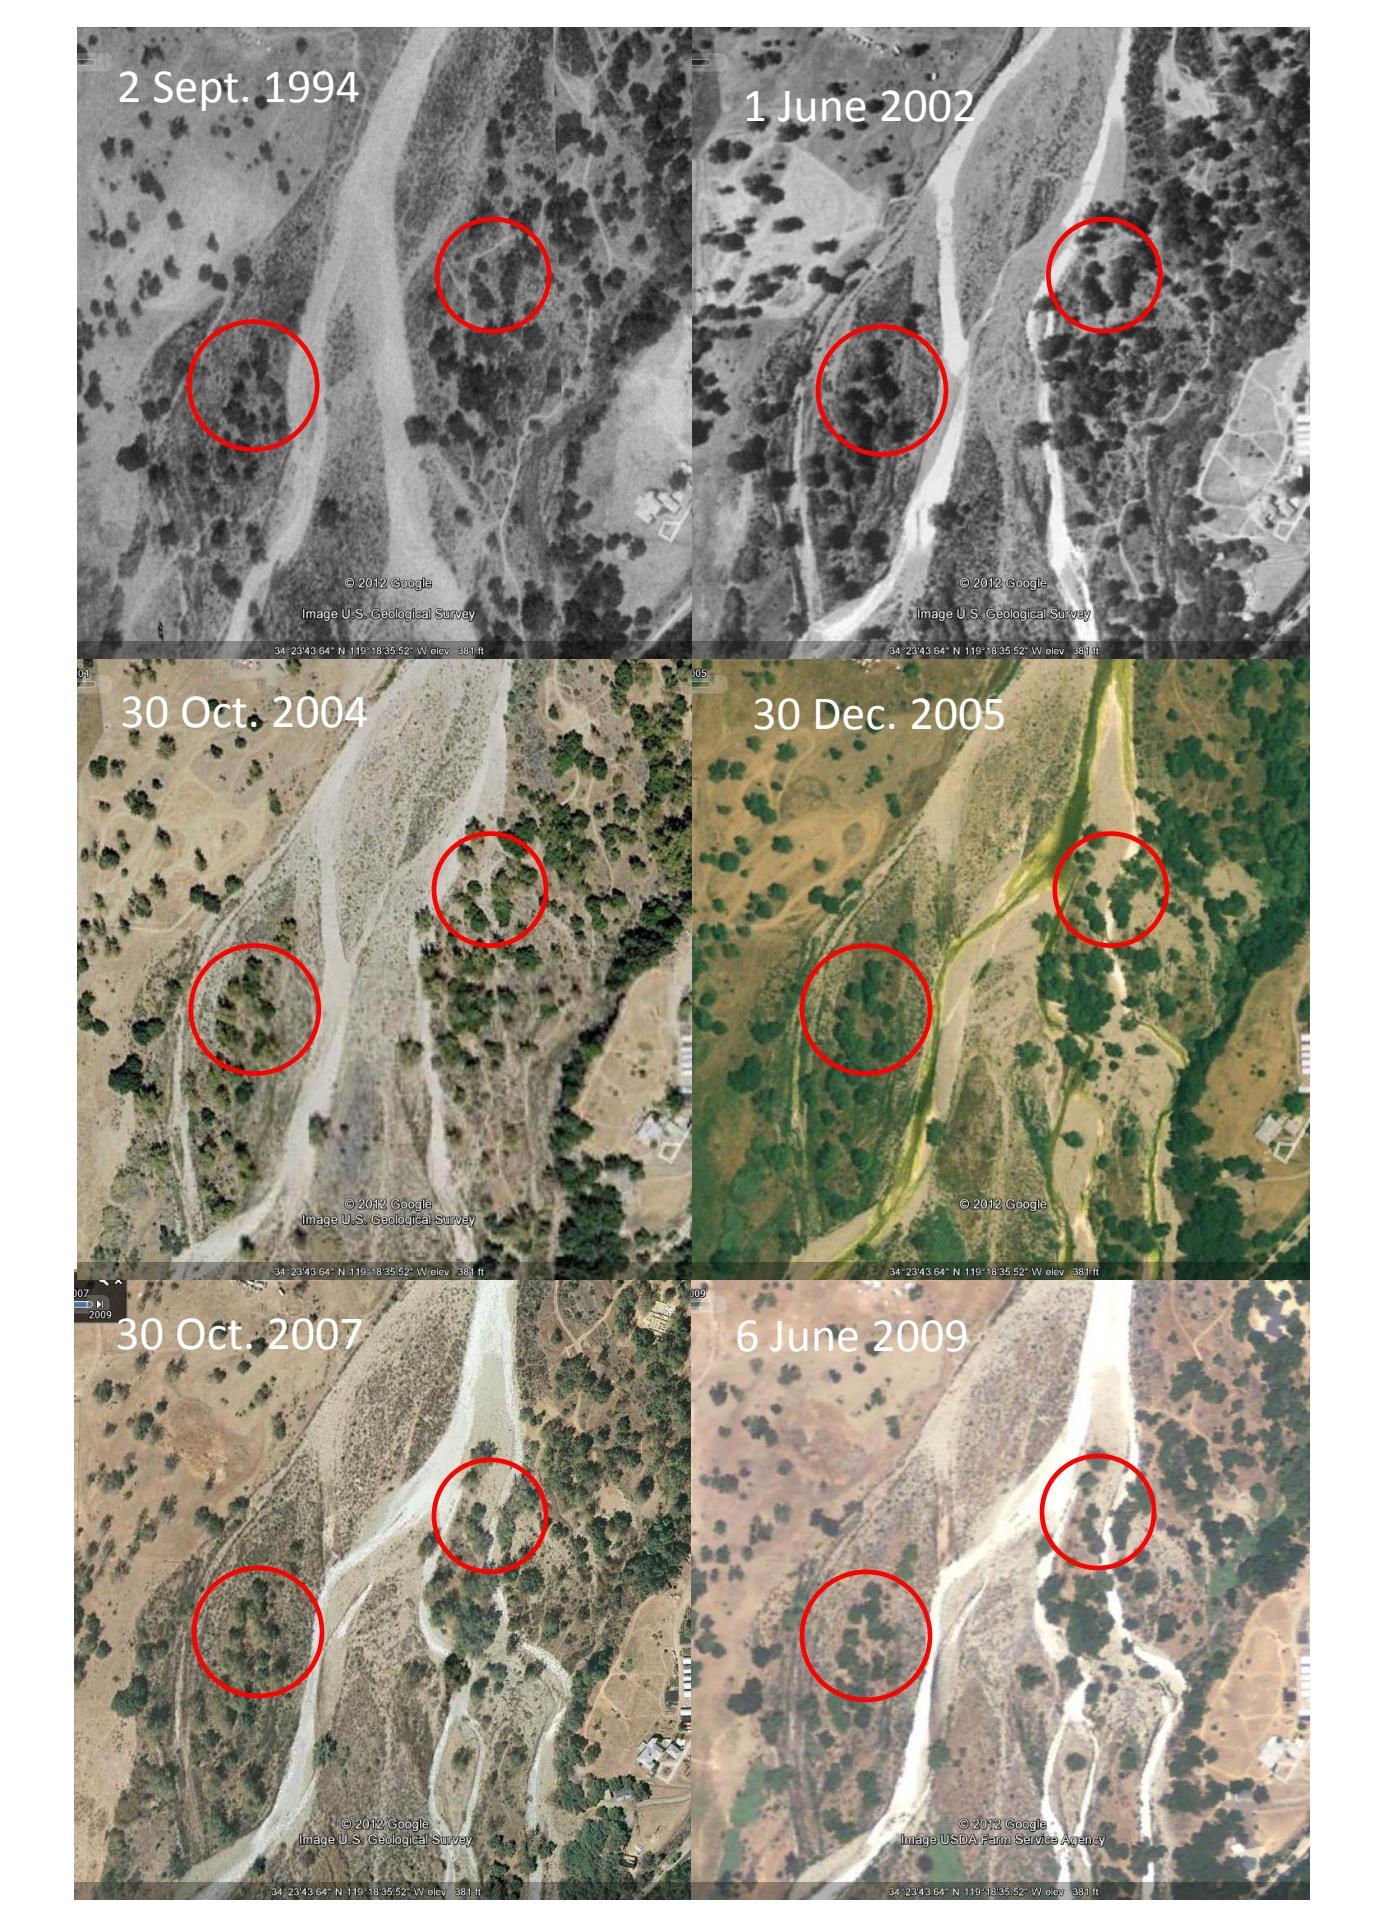
In an effort to give the sediment hypothesis a fair chance I decided to play CSI-Ventura using photos from Google Earth. The next sheet shows a range of photos, taken from 1994 to 2009, of a location just below the Santa Ana Bridge (I've left out a few photos when multiple sets covering the same year were available). This is just a single spot, but I looked at 5-6 different locations and came to the same conclusion at each. I've circled two areas in each of the photos, both red circles identify a recognizable clump of trees.

There have been some course changes in the river over the years – the most noticeable being between 1994 and 2002 – but, by and large, most of the channel changes have been relatively minor. What I find most amazing is what has not changed: all the trees seen growing in 1994 are still there in 2009, *and there appear to be absolutely no new trees*. No change in almost 18 years, in neither circled area, *nor*, as far as I can tell, *anywhere else*. To illustrate how extraordinary I find this, I've shown two photos of the Ventura River further downstream – taken from the same spot – the first in May of 2005, following the extreme flow flows of that winter, the second taken approximately two years later.

The first S. Ana aerial photo was taken late in a dry-year (16" rainfall in Ojai) and substantial growth seems to have occurred during the 8 year interval until the next photo (2002, an even drier year with 7.8"); not much of a surprise since the 90s were one of the wettest decades on record, with 3 very big water-years (1993 with 41.4", 1995 with 42.4" and 1998 with 49.2"). The next big wet year was 2005, and we can see water still flowing (and algae still growing) in the Dec. 2005 photo. We can also see additional areas of green – areas that do not appear in any other photo. Besides the trees, there are what must be dry-land shrubs that hang on from year to year, but growth is extremely sparse and plants are widely separated – exactly what you might expect in an extremely arid environment.

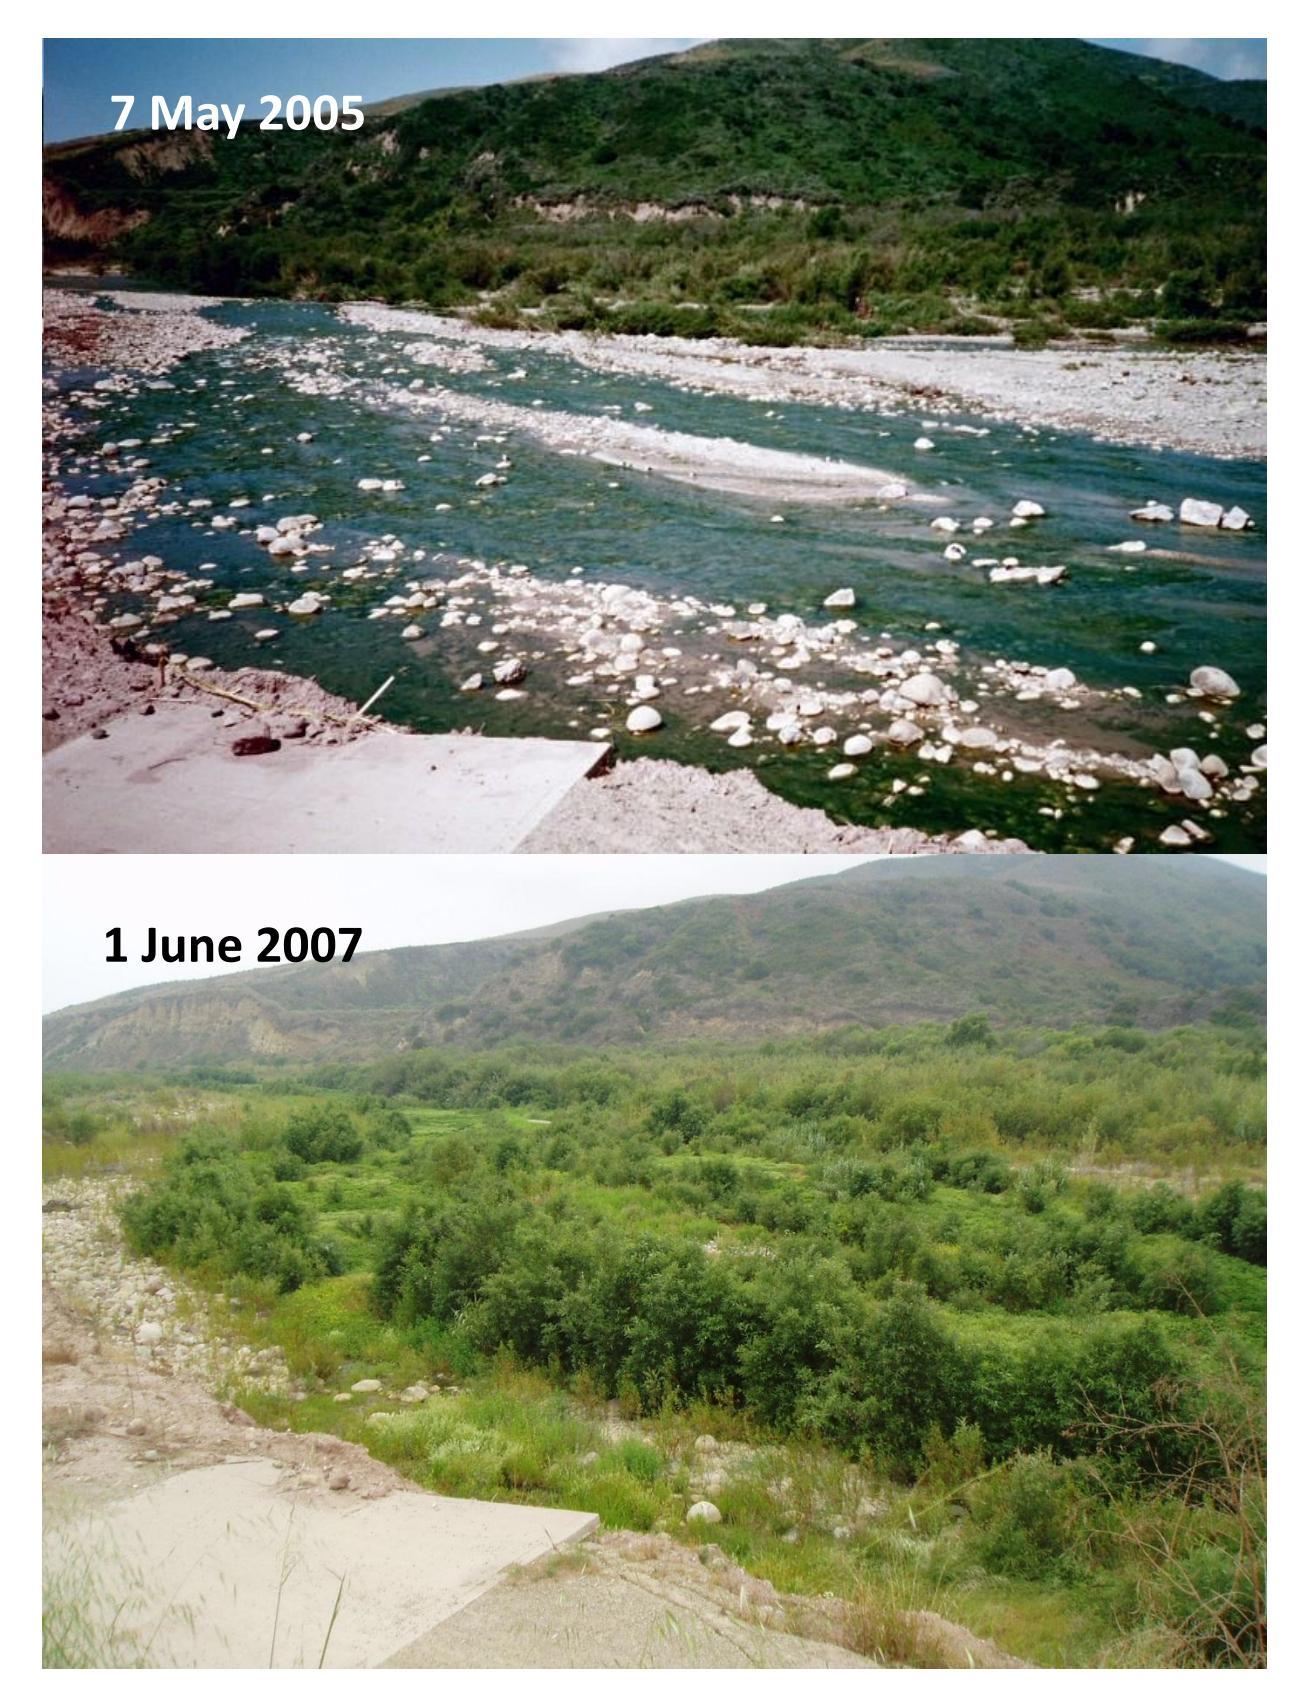
Photos of VR02 (off of Stanley Drain) taken from the freeway turnout at the upper levee gate; note the vegetative growth that had taken place in only two years following the flood flows of the winter of 2004-05.
