This is a story in graphs and pictures of what's been happening at the confluence of San Antonio Creek with the Ventura River. The big floods of 2005 shifted the Ventura River about 500 ft. to the east, to its present position alongside the bike-path, and carved a large pool just downstream of the confluence. The pool, and indeed the whole situation at the confluence, only came to the attention of SBCK during the dry-season of 2008 when this location was included in the UCSB algal study. Since that time we've been monitoring the pool's condition as it serves as a focus for recreation (typically 6 ft. deep with easy access by bike-path and road), for wildlife, and as refuge for stranded fish during drought year dry-seasons when the river, both above and below, and lower S. Antonio Creek, go completely dry.

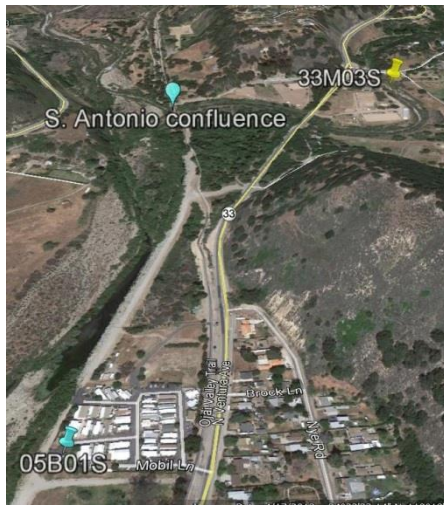
Each of the final pages feature a graph showing average monthly flow in the Ventura River (measured at Foster Park, about 2 miles below the confluence), and the depth-to-groundwater for either or both of the two wells shown in the above Google image: well 33M03, adjacent to lower S. Antonio Creek at roughly the same location as the former SBCK sampling site known as VR07 (at the Old Creek Road ford, about a half mile upstream of the confluence); and well 05B01, alongside the river a little over a half a mile downstream. Surrounding each graph are dated images of the confluence pool, from Google Earth on page 3, from SBCK monitoring visits on pages 4 & 5.

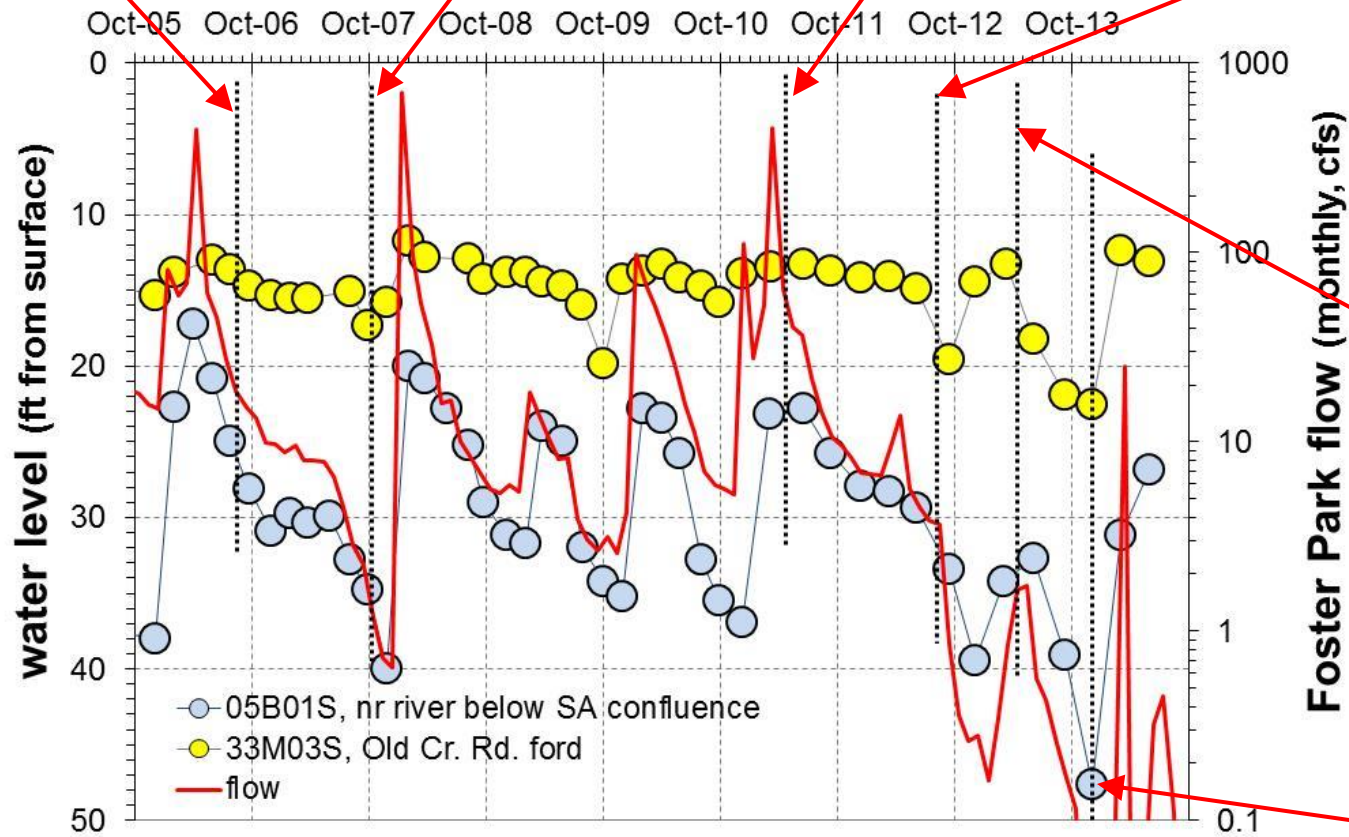
All of these data should be well correlated since winter rainfall either recharges or fails to recharge groundwater throughout the watershed, and groundwater levels then determine both river flow (the use of average monthly flow moderates the influence of flows associated with individual storms) and the measurement of water depth in wells. And it's solely local groundwater conditions that determine the depth of water in the confluence pool once river and creek inflows have ceased. And indeed, as you can see from the graphs, all these data are well matched.

On page 3, the dotted lines represent the date of each Google image. Things to note are the rapid growth in riparian vegetation since 2006, and appearances when both river and creek ran dry (Oct. 2007 and Dec. 2013). Differences in the pool on these dates show the importance of even small decreases in the groundwater table (about 3 ft. at 33M03, 8 ft. at 05B01, when comparing 2007 with 2013—both dry years). I used to think that most of the dry-season flow seen at the confluence came from surfacing groundwater flowing down from the north below the Ventura channel. And that we would periodically see this same groundwater source surfacing in the last few hundred ft. of S. Antonio.

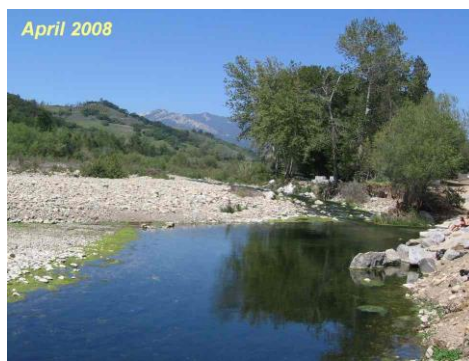
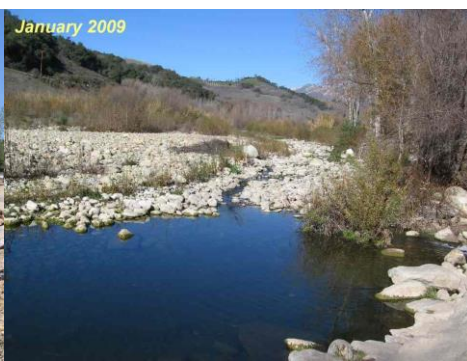
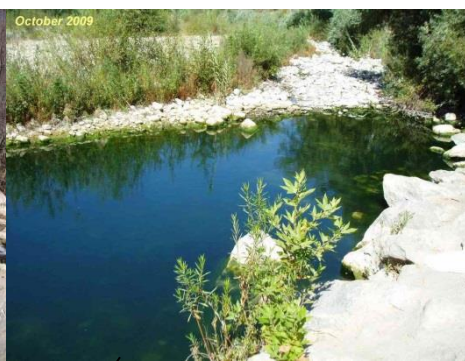
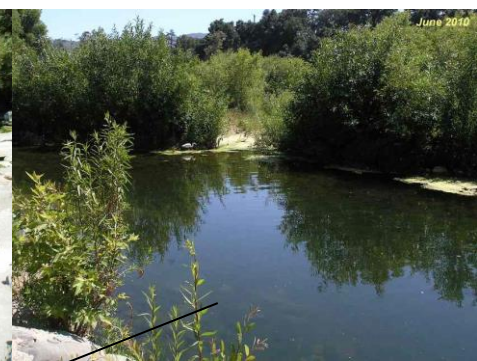
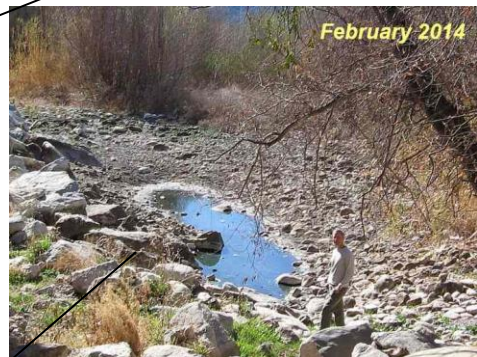
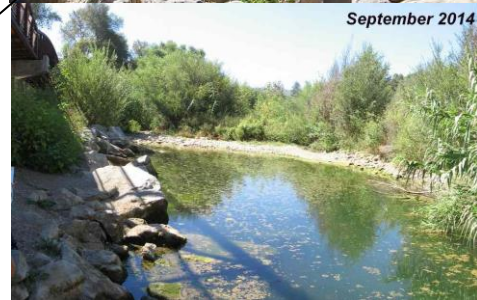
On pages 4 & 5 the arrows point to the approximate groundwater depth for each of the wells shown. For convenience, I've used a line to connect sequential depth-to-water measurements, but the true unmeasured depths remain unknown and, especially in dry periods, do not follow this line. The arrow points represent my best guess as to actual depth. That the depth measurements for 05B01 provide a slightly better fit with the pool photos may indicate some continuing contribution by Ventura River groundwater at the confluence.

Once river and creek flows into the confluence pool stop, water depth in the pool reflects fluctuations in the local groundwater elevation. These variations in depth do not just vary from month-to-month, but change from day-to-day (and possibly hourly). Both the overall seasonal drop in depth, and the day-to-day variation, result from groundwater pumping of wells in the general vicinity. The green algal-band in photo on the left shows a recent (much less than 24 hour) decrease. We know it's recent because algae doesn't stay green for many hours once it's left high and dry. You can see the same phenomena if you look closely in the October 2009 and September 2014 photos.

My last photo is from Sept. 2014 and the pool looks in fair condition, thanks to the rains we had back in March. These rains restored flow in both the river and S. Antonio and raised the water-table at 33M03 by about 12 ft. It remains to be seen what will happen next year.
